FIG Services LLC d/b/a FOX INSPECTION GROUP
Property Inspection Report # 090307bg
11227 Endicott Lane Houston, TX 77035
(Office) 713.723-3330 (Email) office@foxinspectiongroup.com

2006 Heights Annex Home Inspection

PROPERTY INSPECTION REPORT

March 7, 2009
(Date)

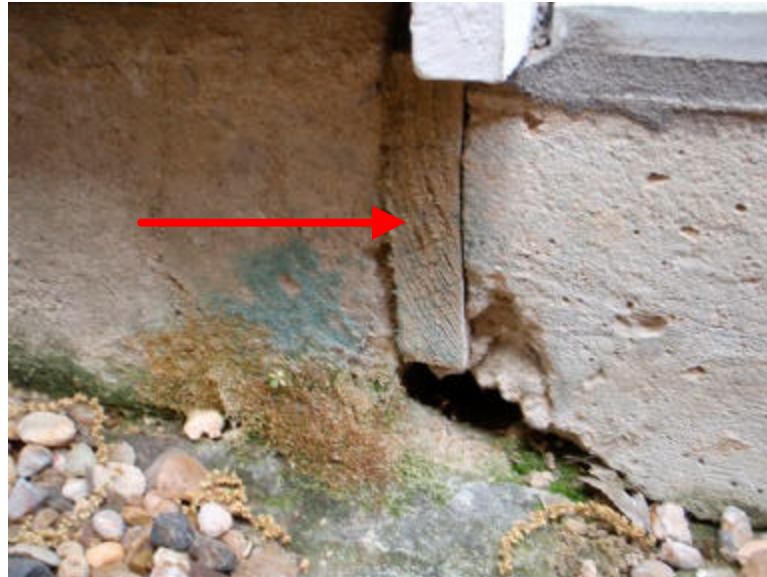
Wood form board(s) around foundation should be removed to reduce chance of wood destroying insect activity. Back of house.

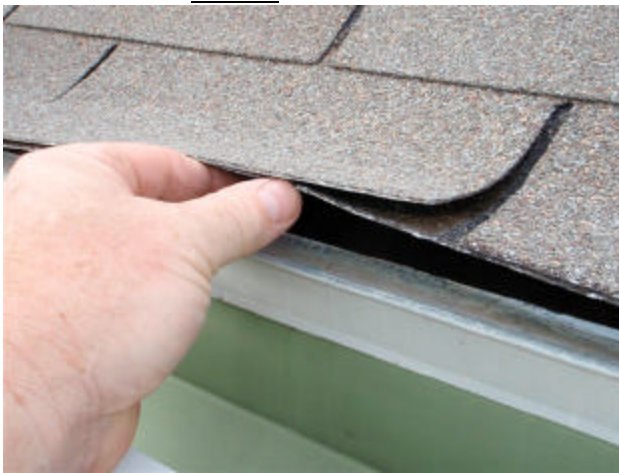
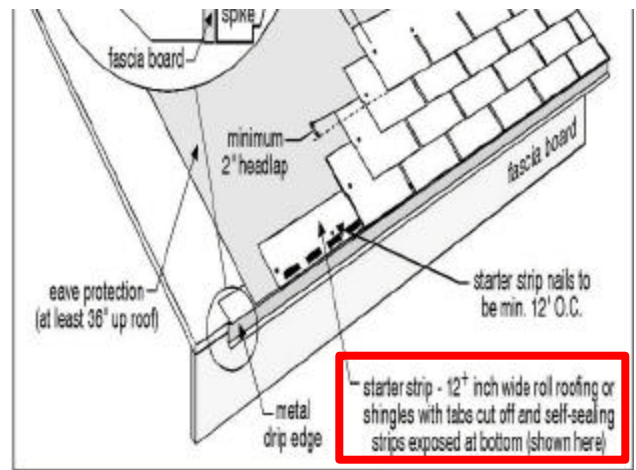
Improper installation of shingle starter course, not installed per manufacture's installation instructions on every bundle of shingle that instructs glue / sealing tabs to be located near lower edge of roofing. When starter course is not installed properly, high winds can peel roofing off. Reference: shingle bundle wrappers. Recommend addition of roof sealant dabs on lower course to mimic / gain effect of properly installed starter course.

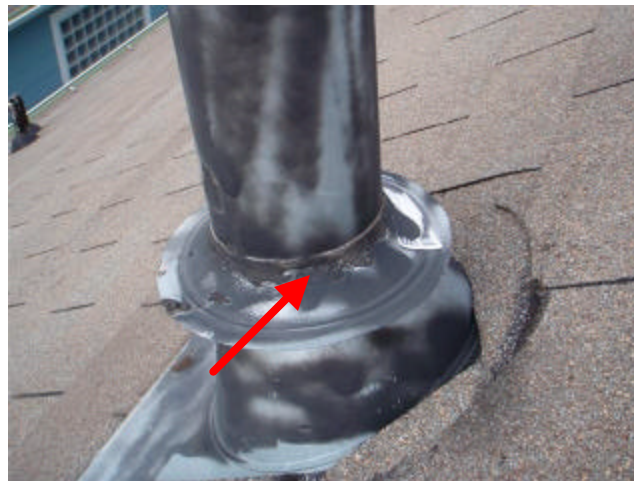
Storm collar needs caulking on all house and water heater vent pipes.

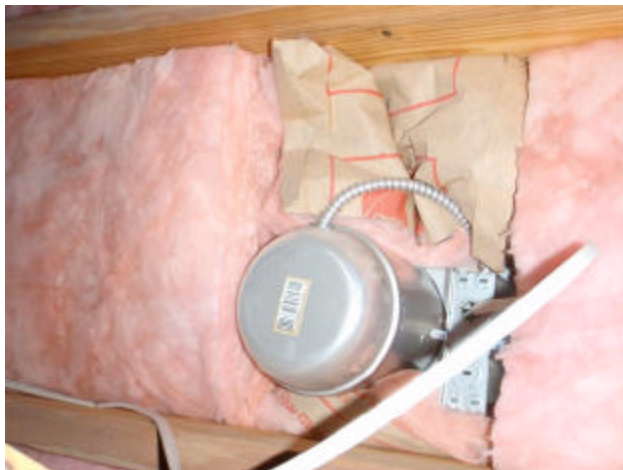
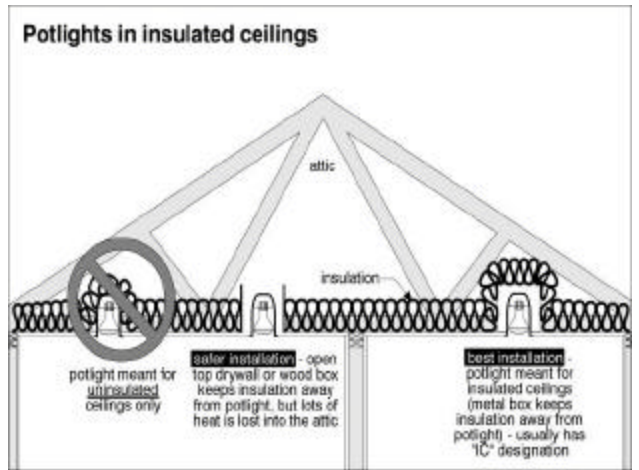
Ensure insulation is maintained a minimum of 3 inches and wood a minimum of 1 inch from around all recessed lights to reduce possible fire hazard.

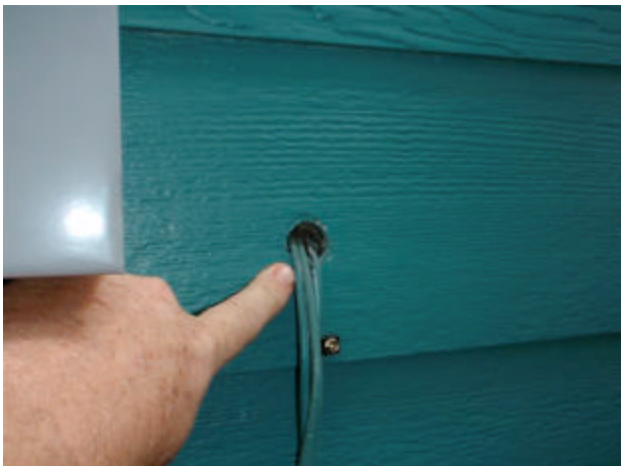
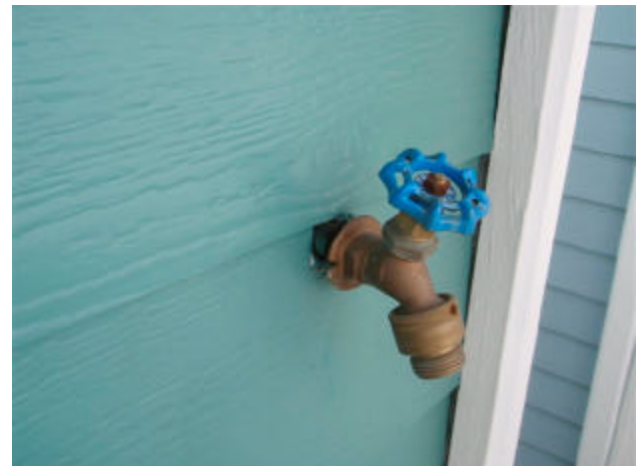
Need sealing / caulking around all holes and exterior siding penetrations on top and both sides, (leave bottom open) to prevent water entry. Including but not limited to dryer, bath and range top vents, light fixtures, etc.
