2004 Heritage Creek Area Home Inspection Report

PROPERTY INSPECTION REPORT

Concerning: 2004 Heritage Creek area, Houston, Texas 77008
(Address or Other Identification of Inspected Property)

March 13, 2009
(Date)

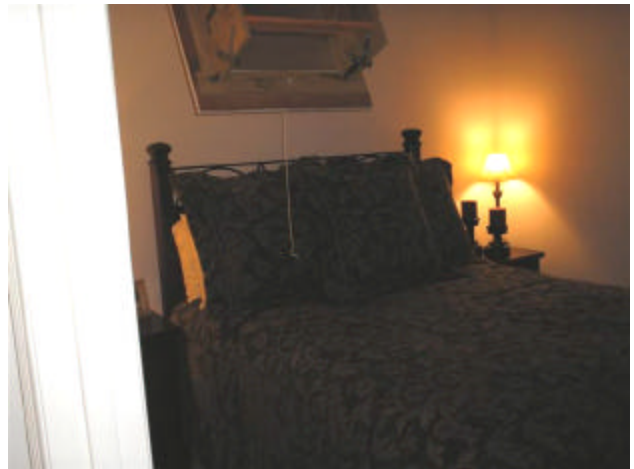
Buyer's Note: *Inspector was not able to access attic due to large bed below attic stairway.*

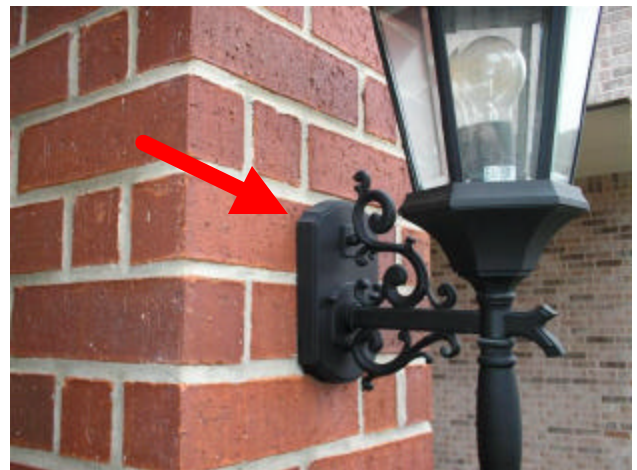
Earth wood contact in some areas, conducive condition to termite activity and wood rot.
Wooden deck and wooden fence

Recommend caulking around electrical disconnect box(s) of A/C unit(s) to prevent water entry behind disconnect(s).

Need sealing / caulking around all holes and exterior siding penetrations on top and both sides, (leave bottom open) to prevent water entry. Including but not limited to dryer, bath and range top vents, light fixtures, etc.

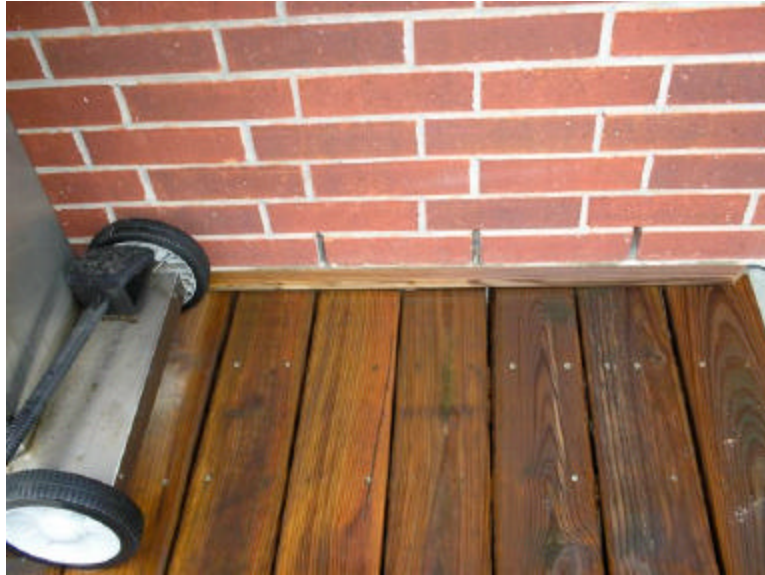
Wooden deck obscures view of foundation and prevents visual inspection for termite and/or water penetration.

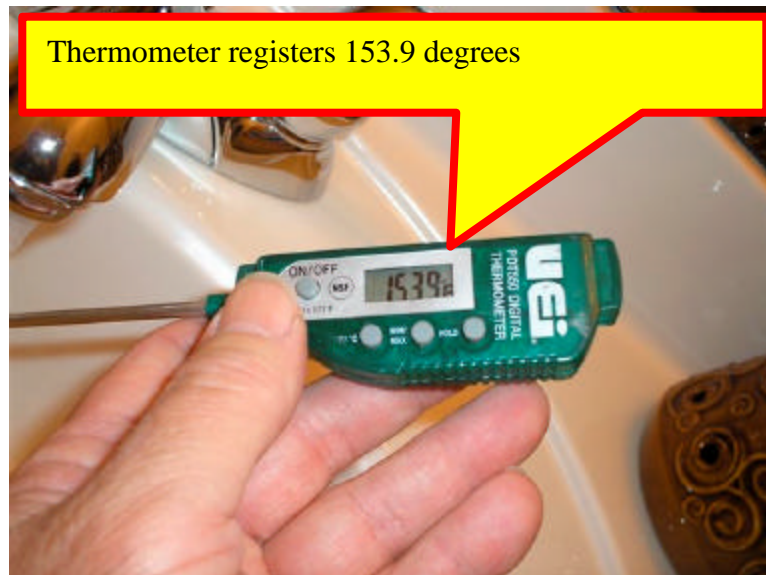
Water temperature is too hot, scalding hazard, temperature measured above 140 degrees.

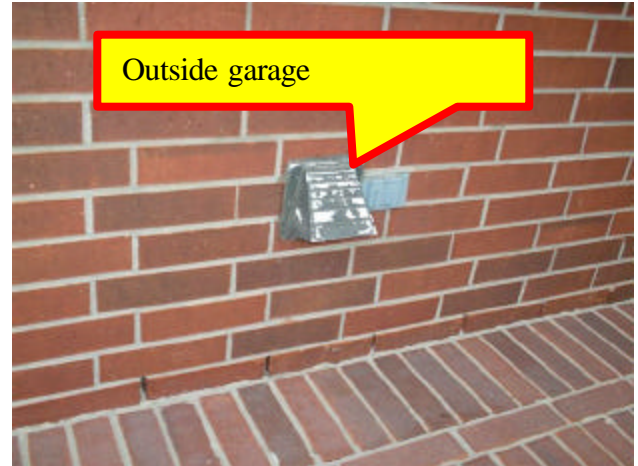
Buyer's Note: Observed a dryer type vent installed in south wall of garage for unknown reason.
