### **2004 Heritage Creek Area Home Inspection Report**

# ***PROPERTY INSPECTION REPORT***

**Concerning:** 2004 Heritage Creek area, Houston, Texas 77008  
(Address or Other Identification of Inspected Property)

March 13, 2009  
(Date)

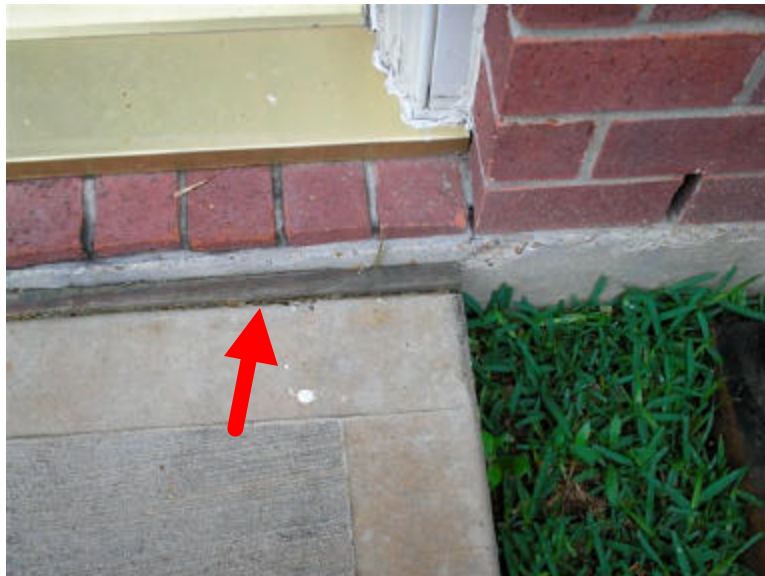
Wood form board(s) around foundation should be removed to reduce chance of wood destroying insect activity.

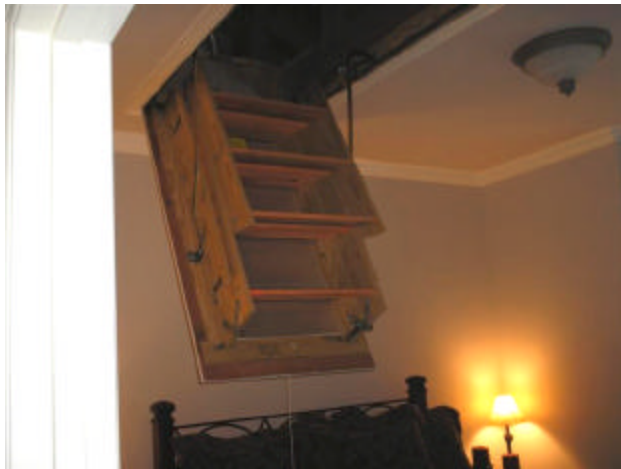
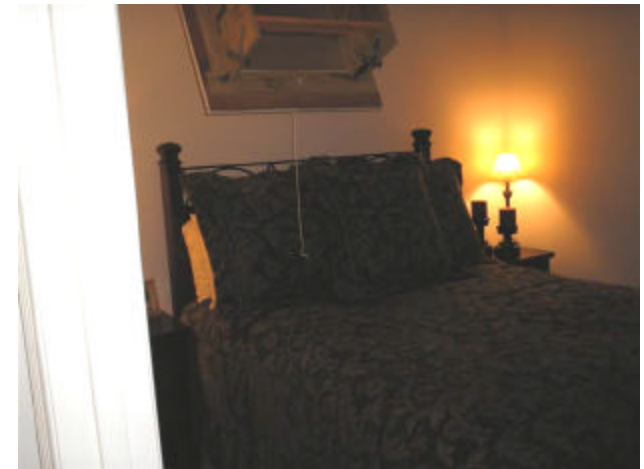
Buyer's Note: *Inspector was not able to access attic due to large bed below attic stairway.*

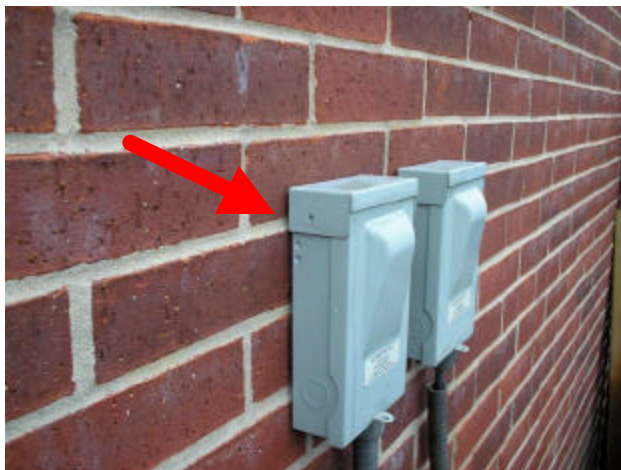
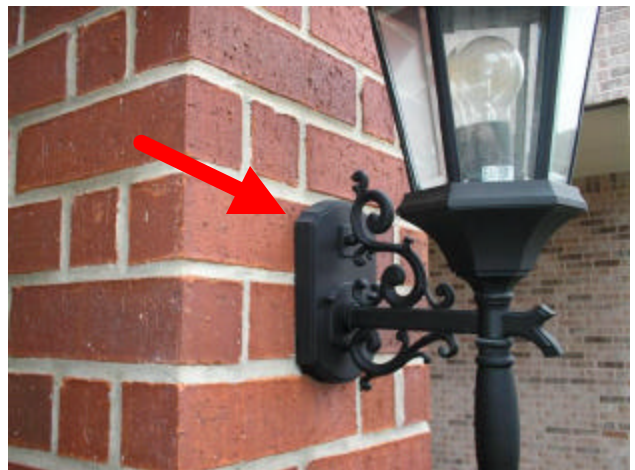
Earth wood contact in some areas, conducive condition to termite activity and wood rot.  
Wooden deck and wooden fence

Recommend caulking around electrical disconnect box(s) of A/C unit(s) to prevent water entry behind disconnect(s).

Need sealing / caulking around all holes and exterior siding penetrations on top and both sides, (leave bottom open) to prevent water entry. Including but not limited to dryer, bath and range top vents, light fixtures, etc.

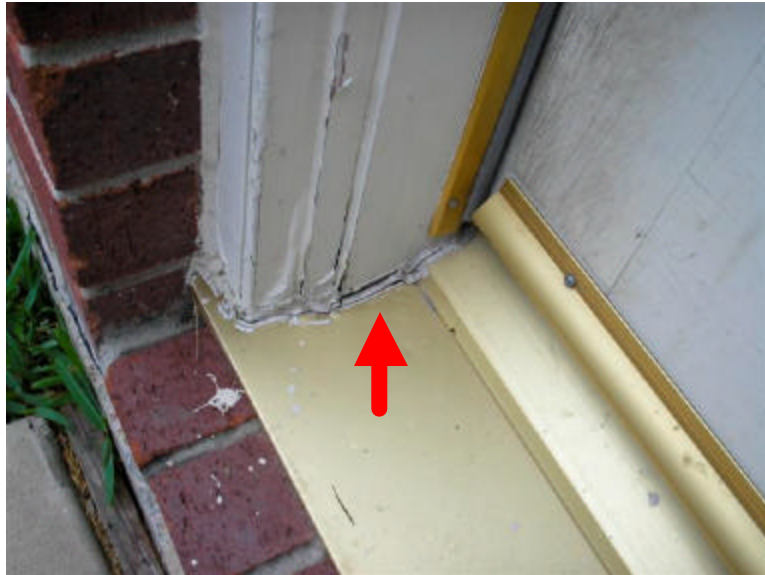
Recommend caulking better interior ends of exterior door threshold water channel to prevent water entry during driving rains.

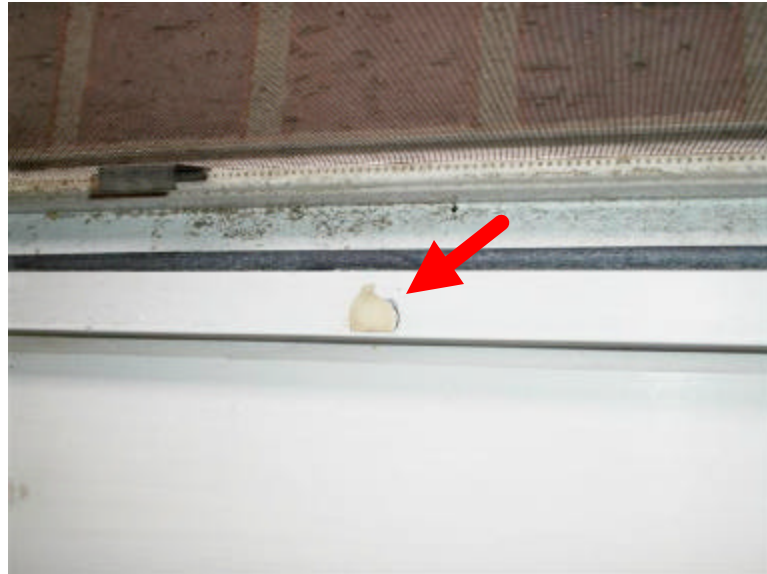
Window jamb alarm sensors in breakfast room needs to be sealed better with silicone seal to prevent water entry.

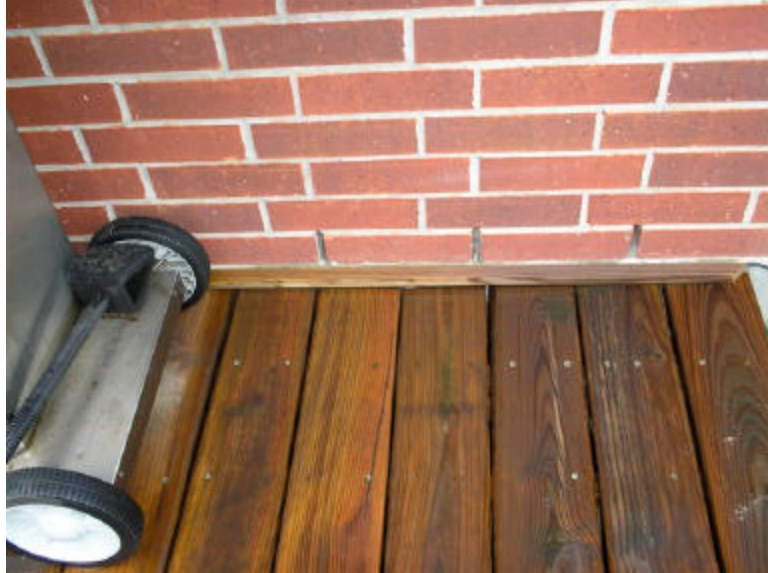
*Wooden deck obscures view of foundation and prevents visual inspection for termite and/or water penetration.*

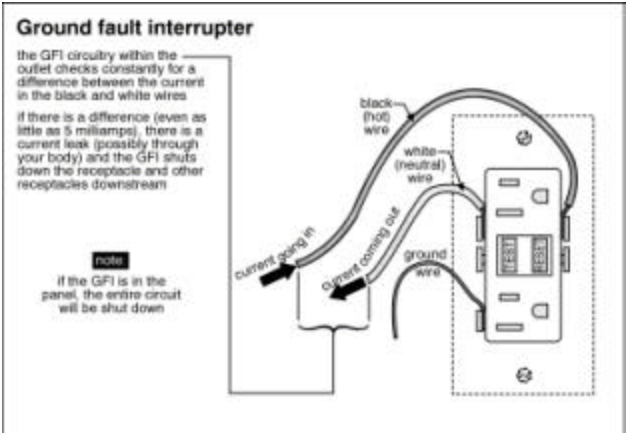
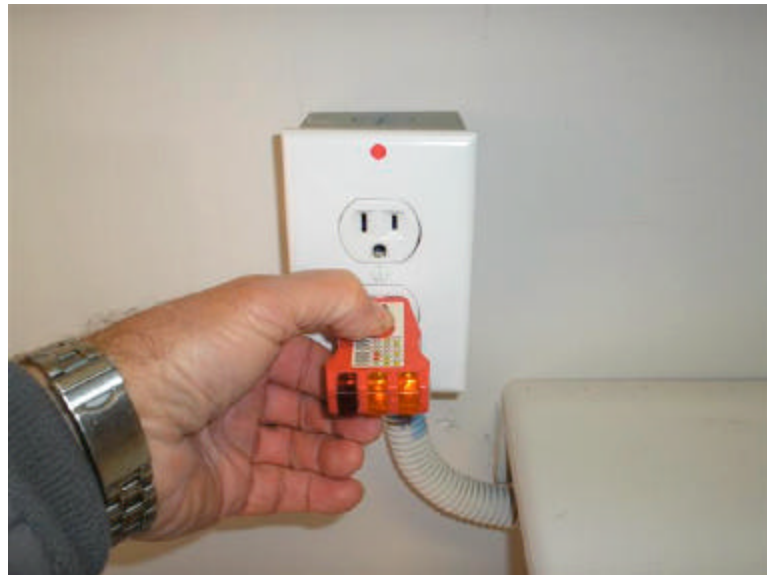
Did not observe GFCI protection of all outlets in required locations, including but not limited to; all bathrooms, all kitchen counter top outlets, wet bar locations, all exterior outlets, in garage, etc. This condition is a recognized safety hazard and is in need of repair.

One or more outlets in the following locations were not protected:

- Kitchen counter
- Kitchen island
- Bathrooms
- Garage  Exterior
- Wet bar  Laundry sink
- Pool area  Spa / hot tub
- Other:

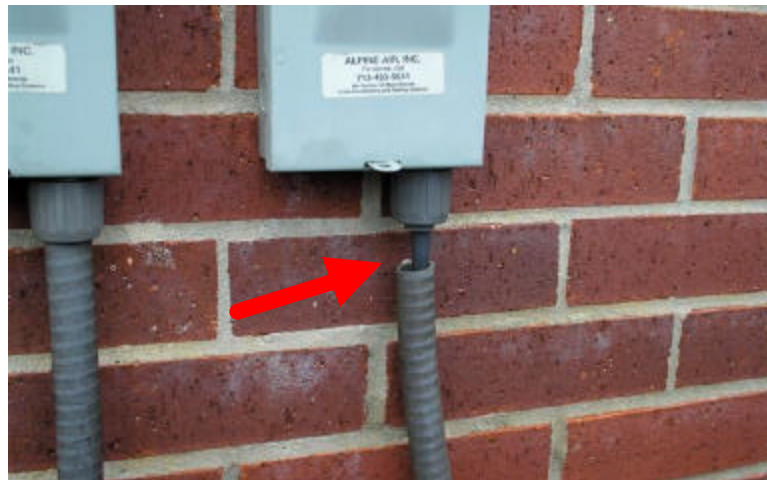
Electrical line supplying power to A/C unit outside is not fully enclosed in protective conduit below A/C disconnect box.

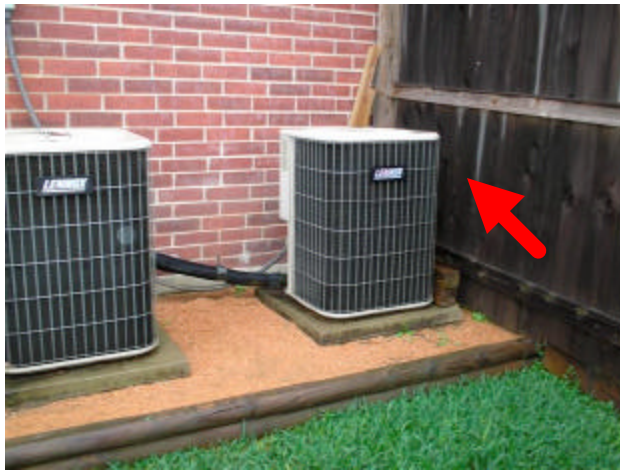
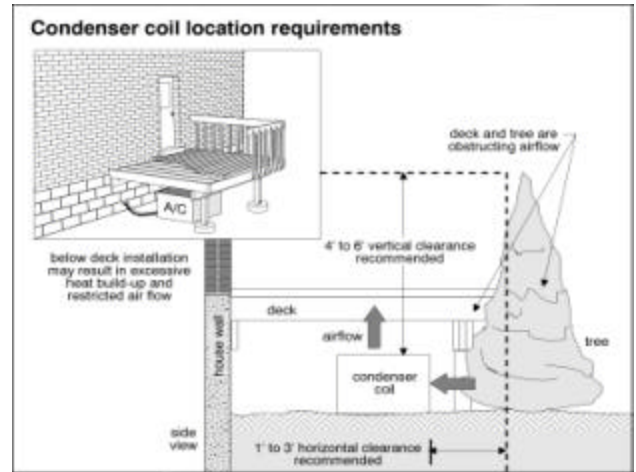
*Buyers note; Keep walls/fences/decks a minimum of 2 feet away from sides of A/C unit and a minimum of 4 feet over unit to allow proper air flow across coils and/or proper access to unit for servicing*

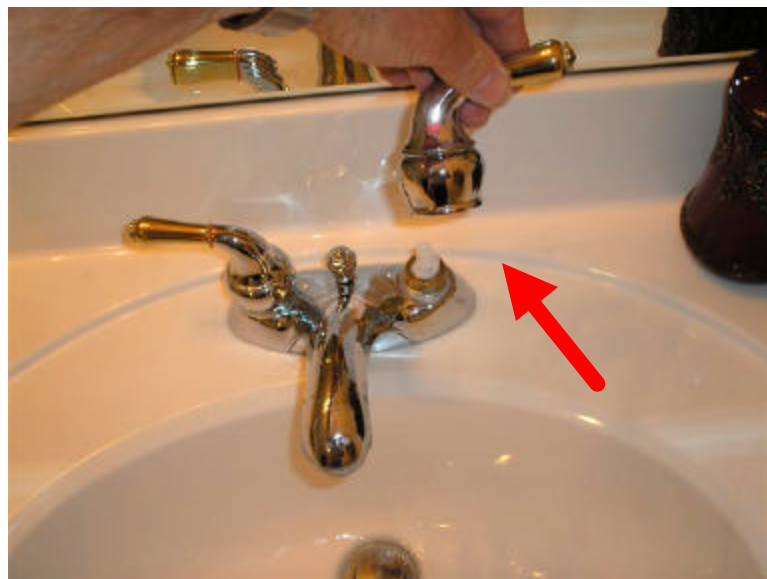
*Handle is loose / not secure; master bath south sink cold water.*

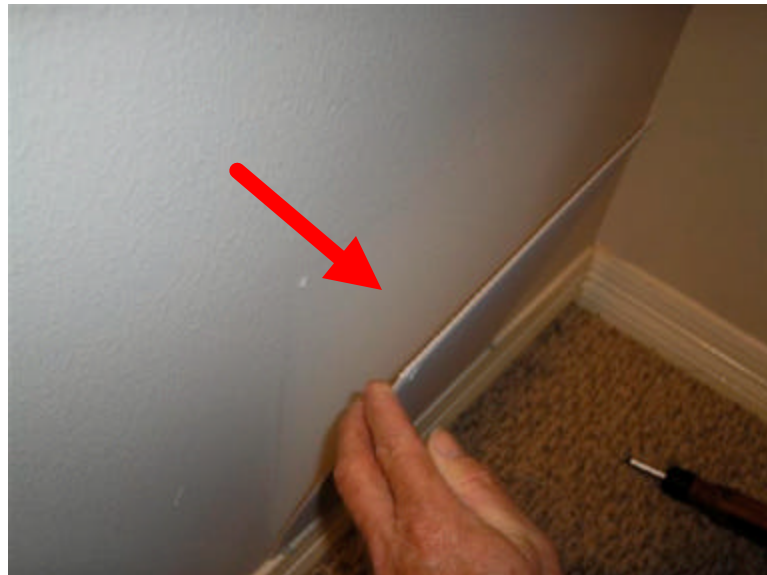
The sheetrock has not been removed behind the 2<sup>nd</sup> floor guest bath plumbing access / inspection panels behind the tub(s). Recommend removal of sheetrock.

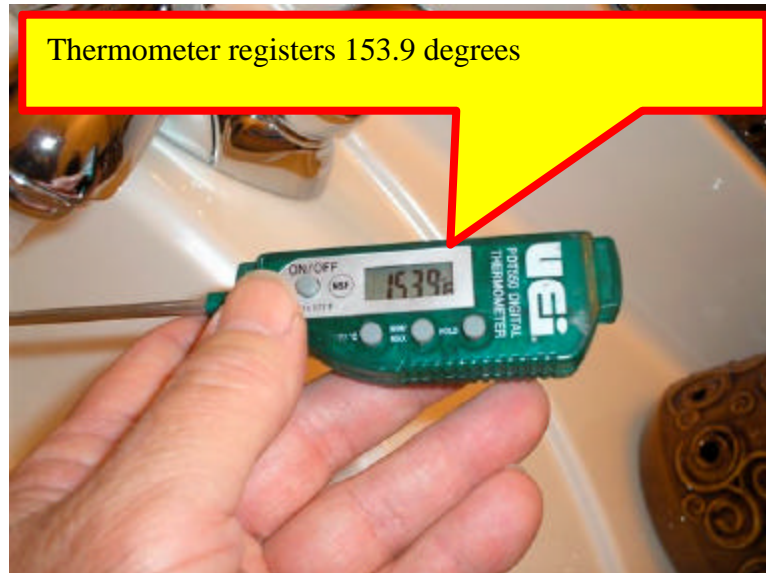
Water temperature is too hot, scalding hazard, temperature measured above 140 degrees.

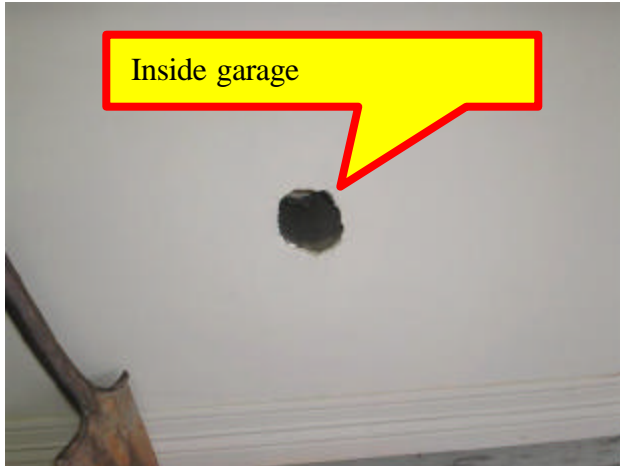
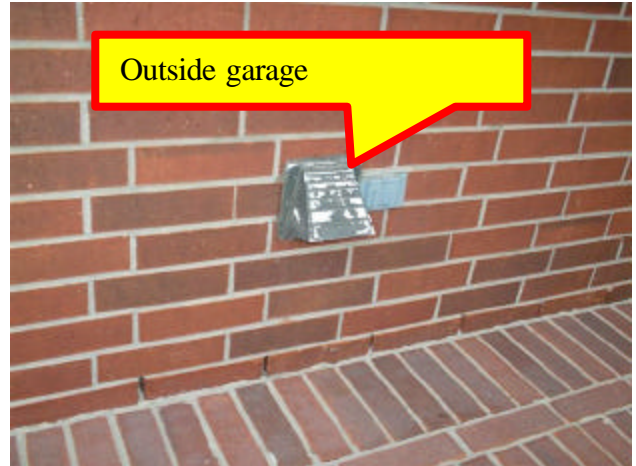
*Buyer's Note: Observed a dryer type vent installed in south wall of garage for unknown reason.*
