### **2002 Humble Home Inspection Report**

# ***PROPERTY INSPECTION REPORT***

**Concerning:** 2002 Home, Humble, Texas 77338  
(Address or Other Identification of Inspected Property)

March 9, 2009  
(Date)

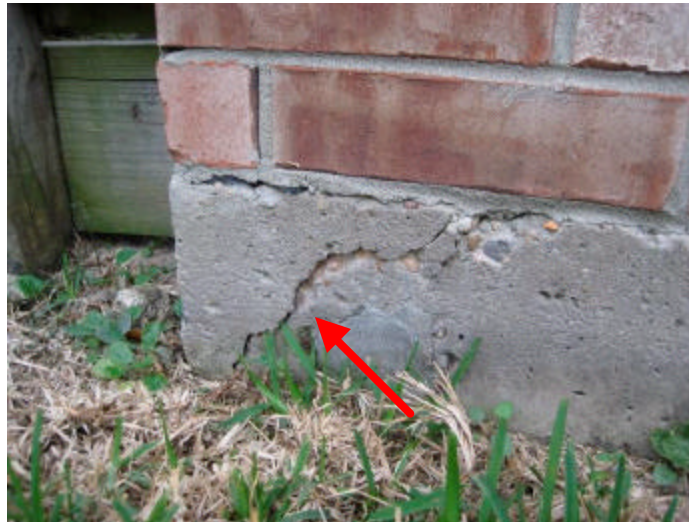
*Spalling (i.e., corner pops) at one or more corner(s), Corner spalling is common to slab foundations and does not affect the structural integrity of the foundation.*

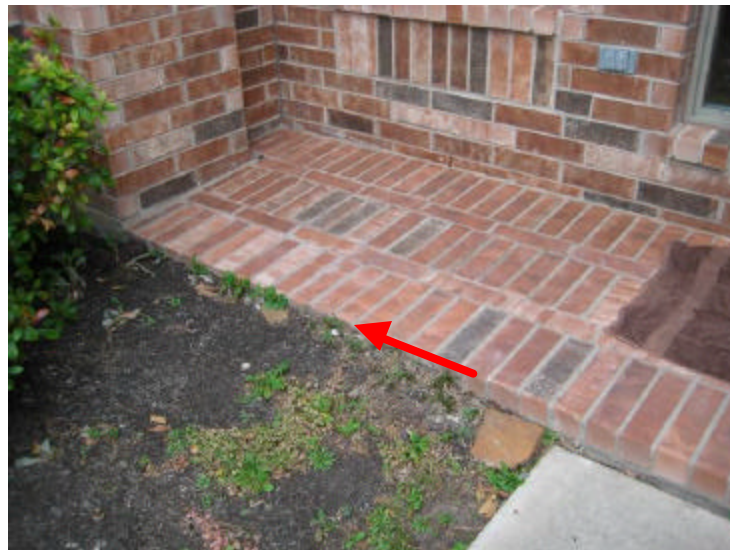
*Buyer's note; ensure flower bed soil does not rise above joint between concrete and brick pavers of exterior patios, wood destroying insects have been known to gain entry between pavers and concrete patio and migrate to house.*

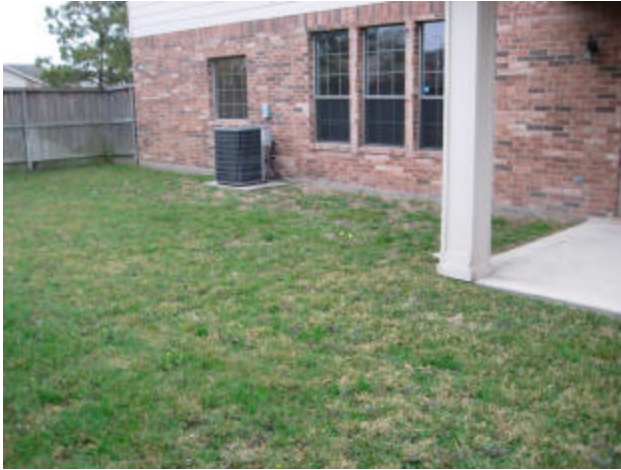
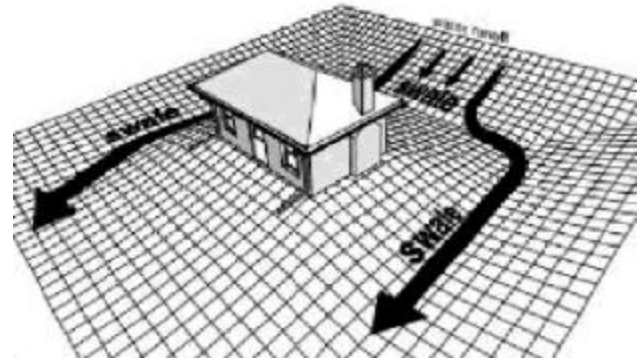
Drainage swale is not continuous, at sides The drainage swale must be kept clear and continuously sloped in order to drain water properly

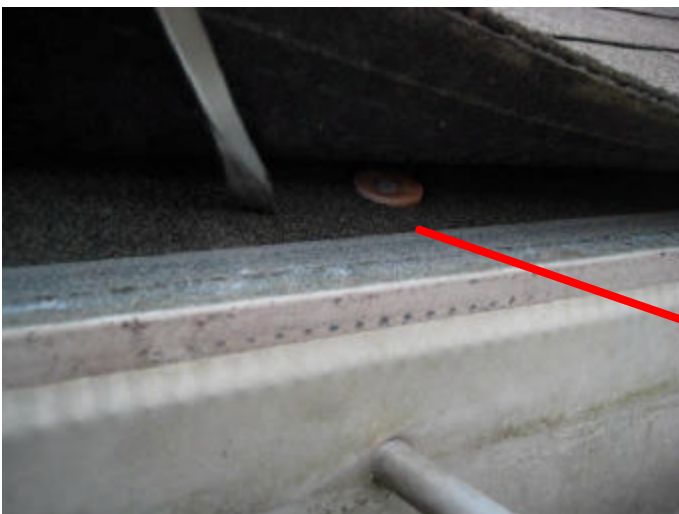
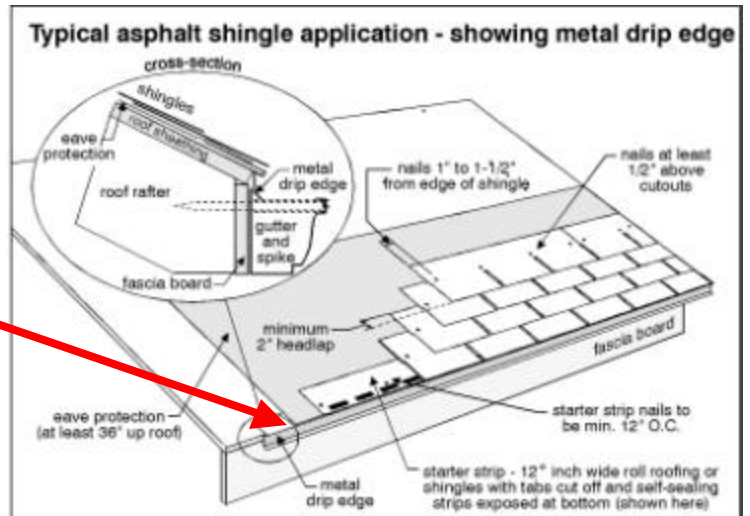
The felt paper observed to be improperly installed under the drip edge. Felt paper should be laying over the metal drip edge to avoid possible moisture from getting trapped and damaging the fascia boards.

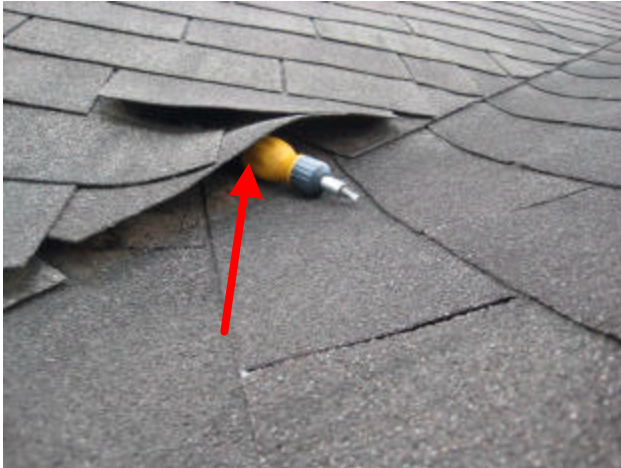
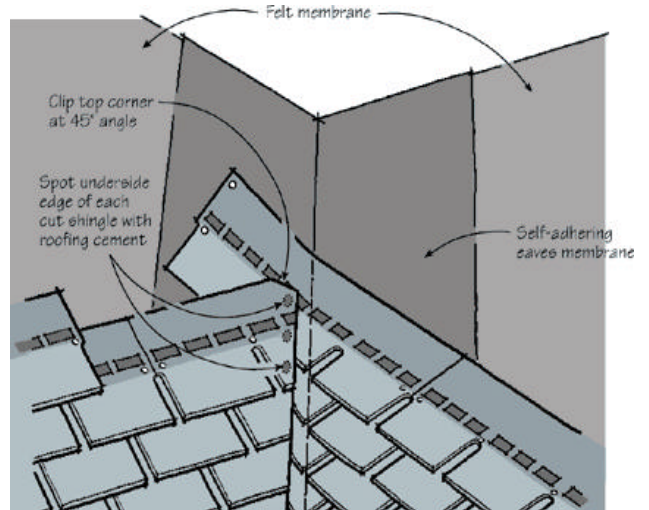
Valley shingles improper. In a closed valley, embed valley shingles in roofing cement.

Always clip the top corner of the valley shingles at a 45-degree angle. This prevents debris from getting caught in the shingles and accumulating in the valley, and it also directs water toward the valley centerline. For extra protection, install a self-adhering eaves membrane under valleys.

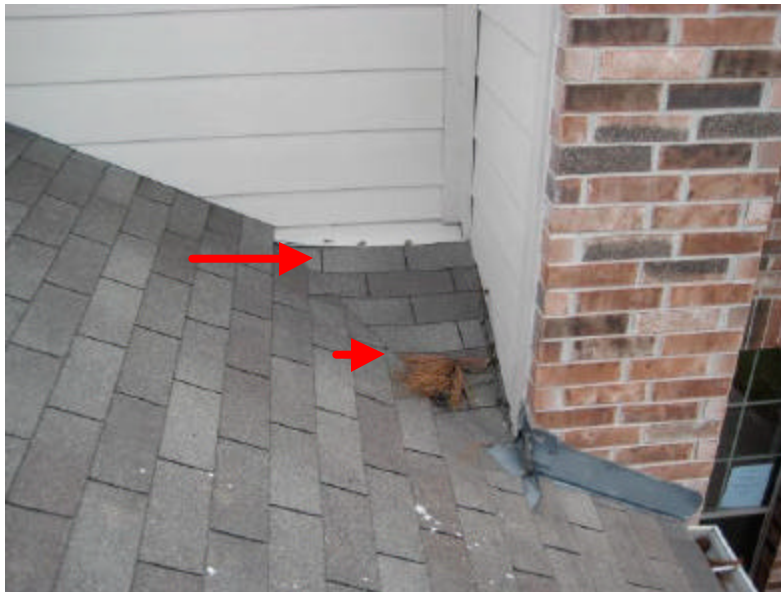
*Observed a “dead valley” roof configuration on roof top. This area is a potential source of debris buildup / water penetration and care should be taken to keep this area free of debris to facilitate rain water run off.*

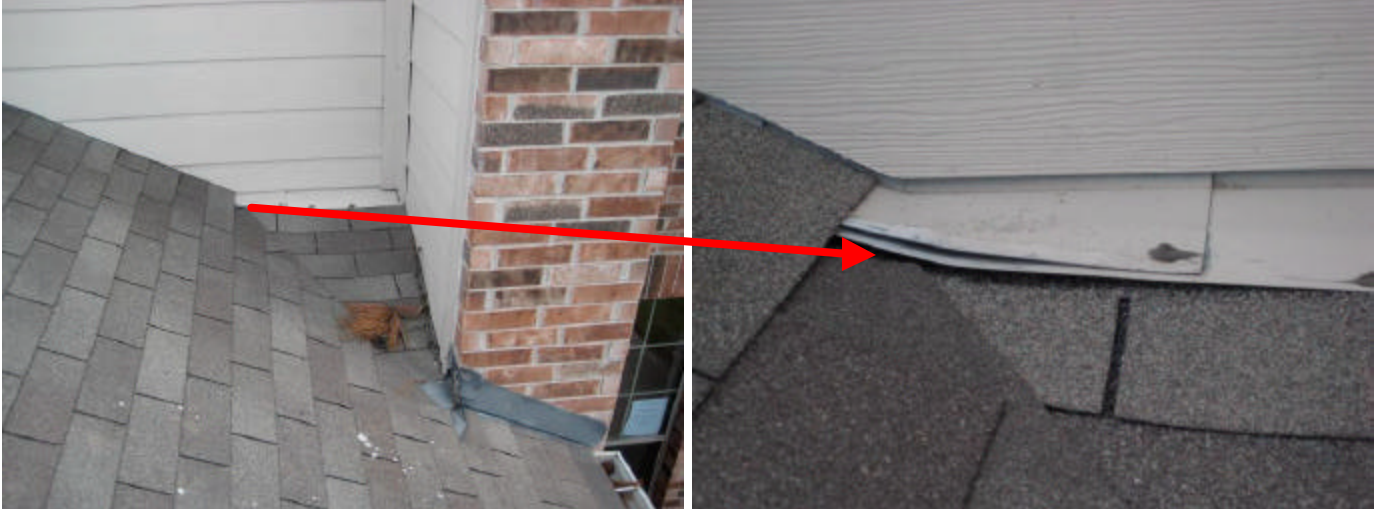
Lower side of flashing is not sealed down, wind driven rains can cause water penetration at the sidewall flashing over the garage. Evidence of water penetration observed in the garage directly over this area.

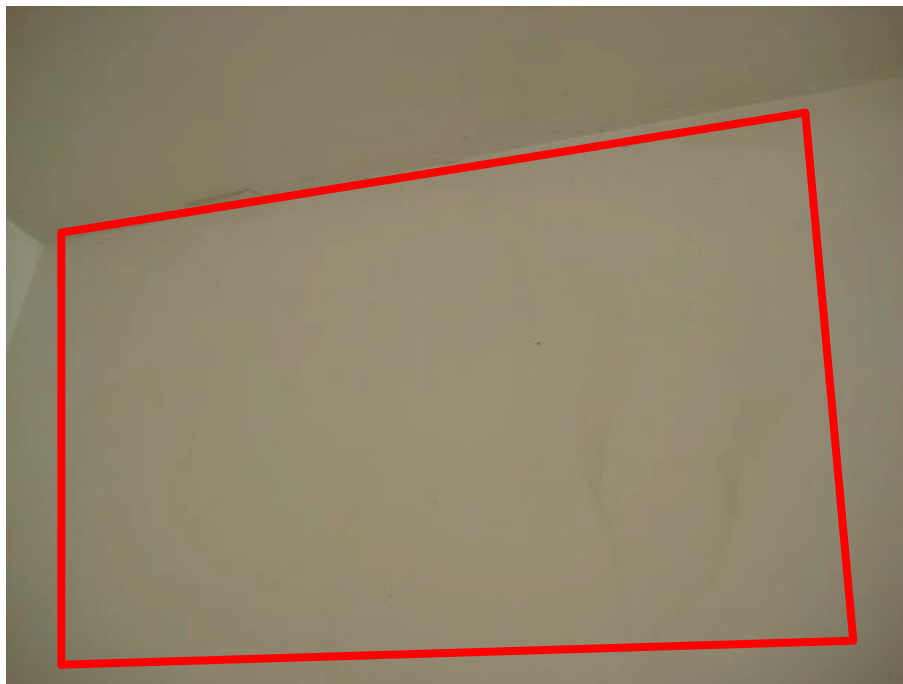
YES !!, Evidence of water intrusion observed in the garage directly under the dead valley area. The cause and remedy needs to be investigated and corrected as necessary. See pictures and comments above.

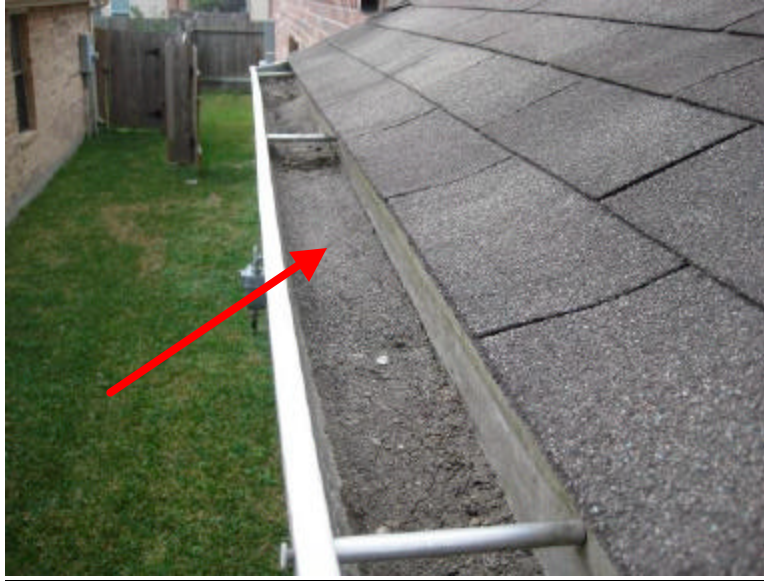
Need general maintenance, Clean out debris / resecure to fascia board / tilt toward drains, seal leaks, etc.

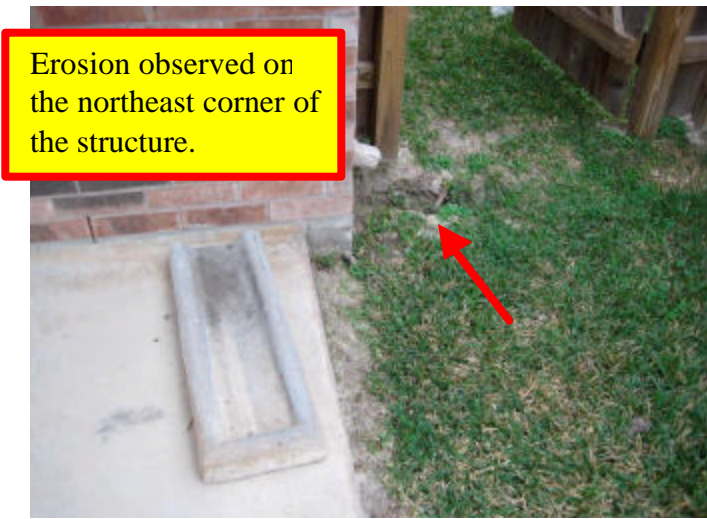
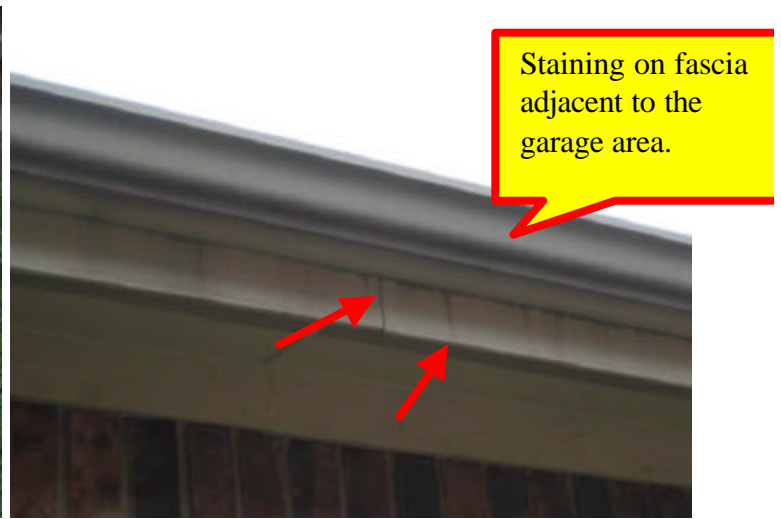
Observed water stains on fascia board on back side of rain gutters; indication water is running down back side of rain gutter which leads to wood rot.

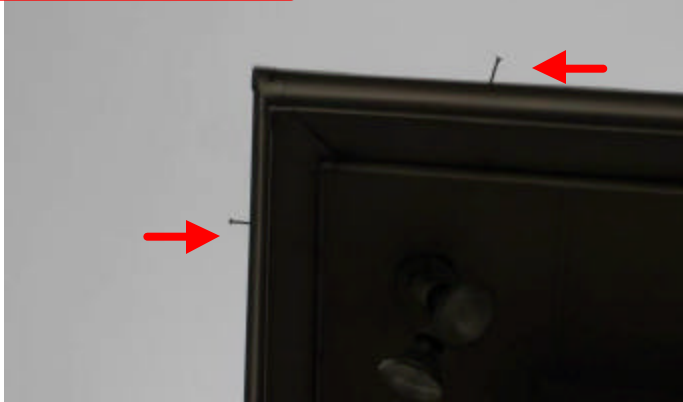
Gutter fasteners observed to be pulling loose in various locations.

Fasteners pulling loose.

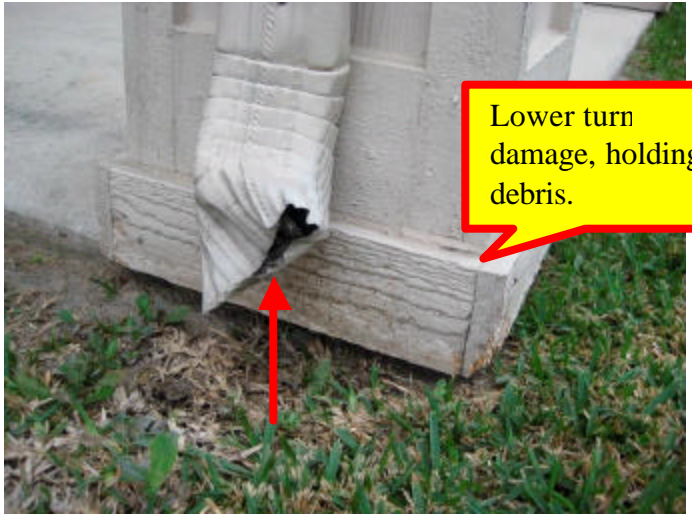
Downspout lower turn observed to be damage and full of debris on the east side of the structure.

Lower turn damage, holding debris.

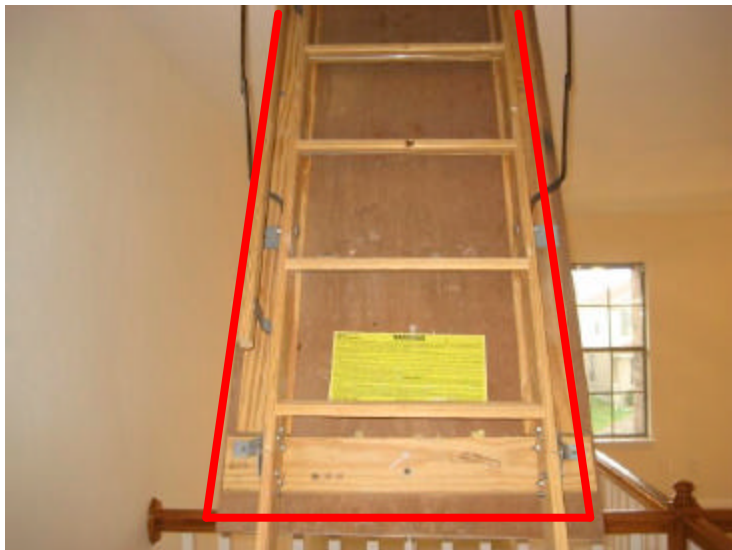
*Stairway to attic is not sealed, recommend client consider weather stripping to seal gaps and prevent loss of conditioned air to attic as well as insulating stairway if not done already.*

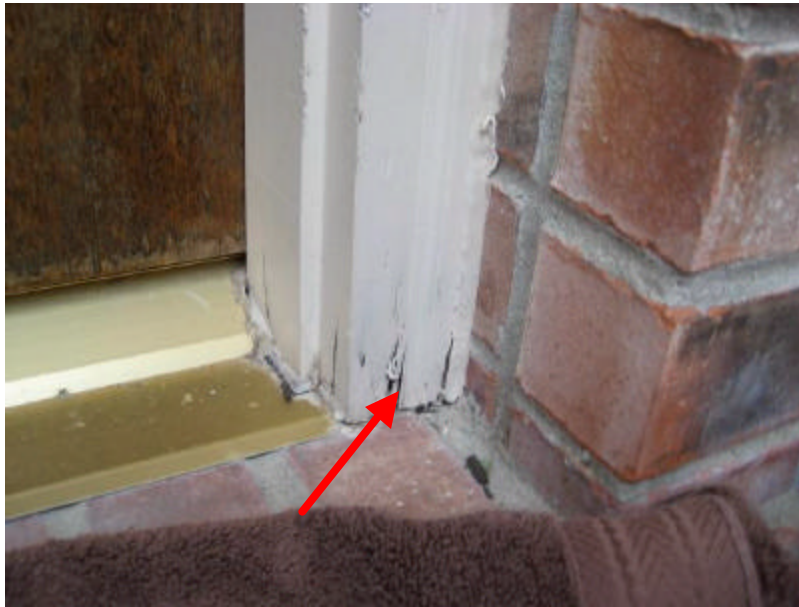
Wood rot observed on areas of house / garage.

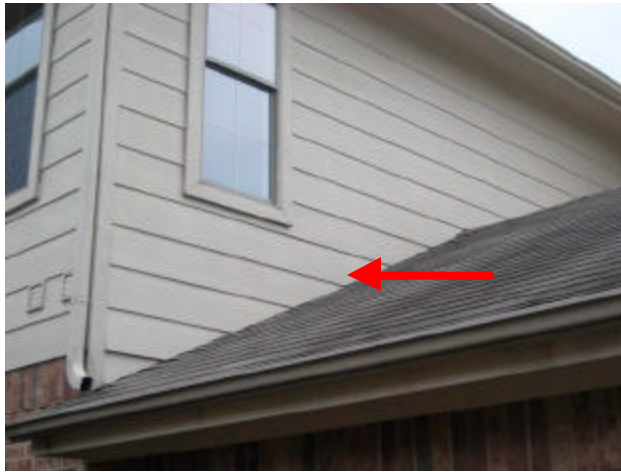
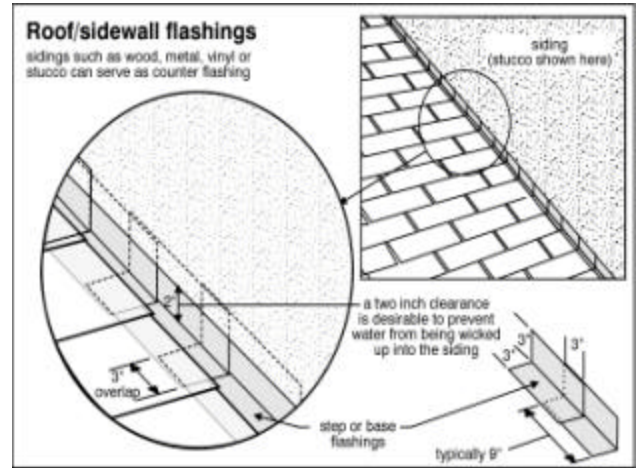
Most wood siding installation requirements specifically state “ Leave 2” clearance between roofing and bottom edge of siding to prevent wood rot. Did not observe the normal 2” clearance from roof surface

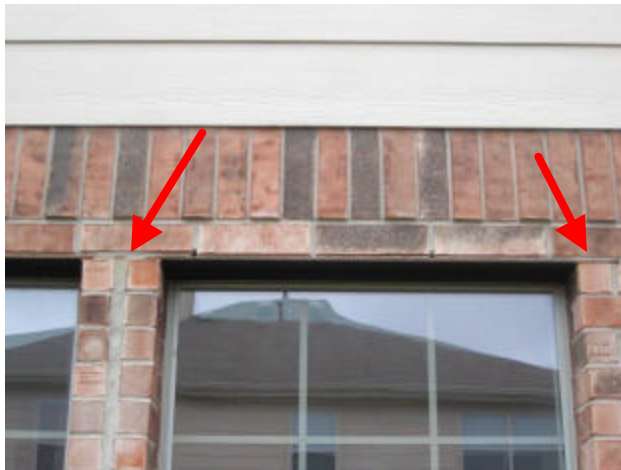
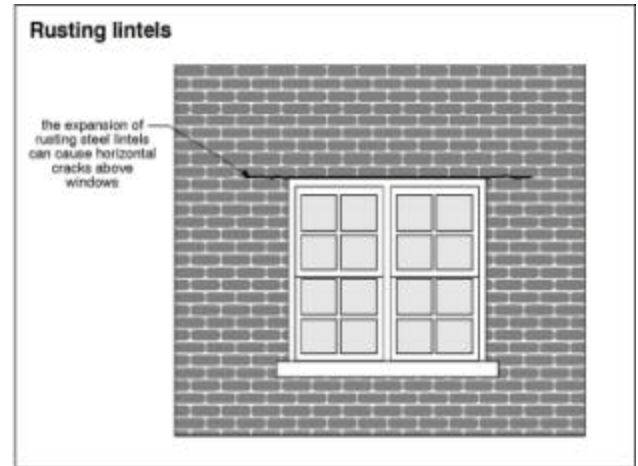
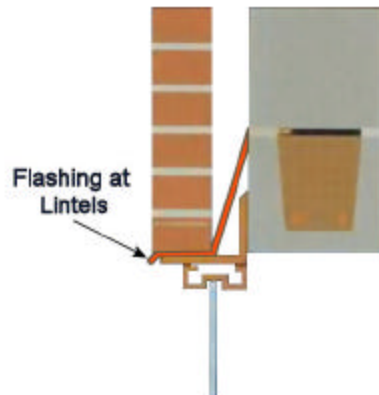
Metal lintel(s) over window/door openings are not flashed as required by current building standards. Ref: IRC 2003 Section R703.7.5 Stone and Masonry Veneer | Flashing.

Metal lintel(s) over window/door openings are not painted.

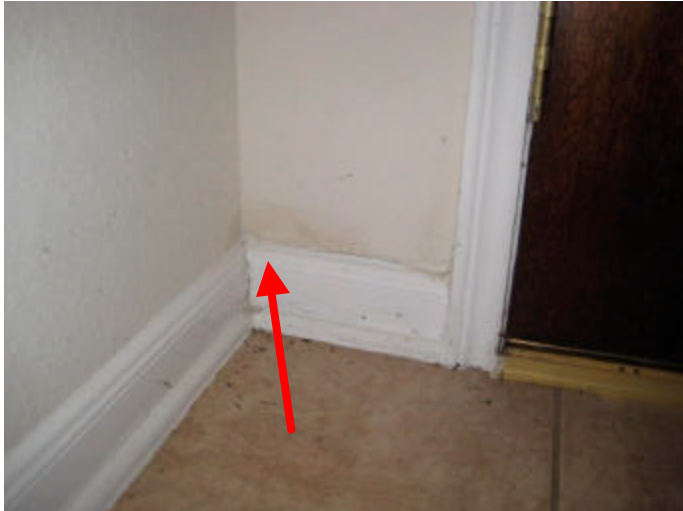
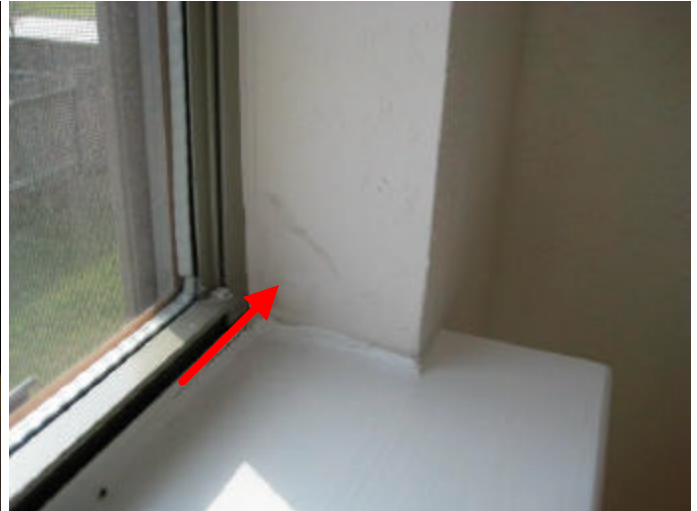
YES !!, Evidence of water intrusion observed adjacent to the front door, and upstairs north east bedroom at the window. These areas should be closely monitored and repaired if necessary.

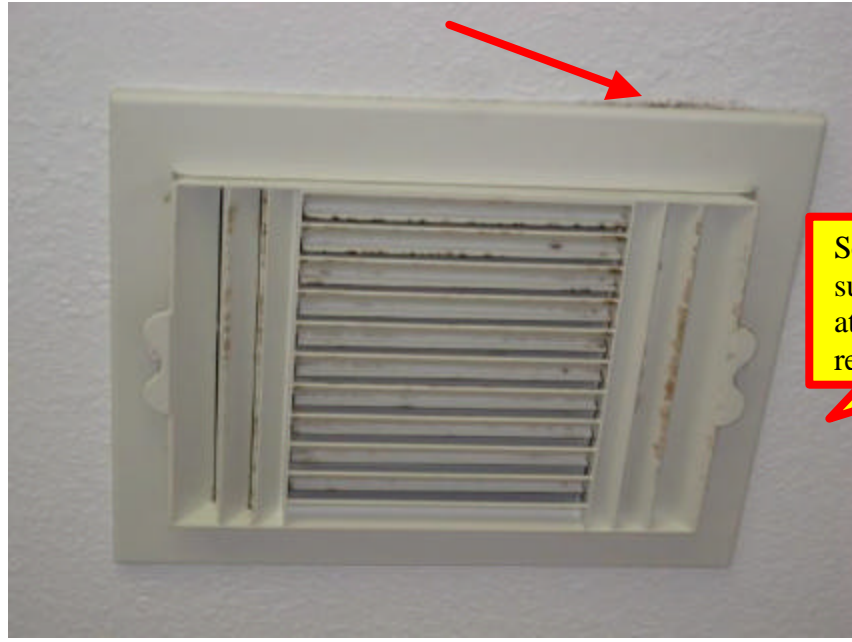
Water stains observed on ceiling near air duct, indication of possible damage insulation on metal duct allowing warm attic air to condense on cold sheet metal and drip onto sheetrock; master bedroom.

Observed possible mold / black stuff ( master near register ) which may be a concern due to increased awareness of environmental issues associated with molds. Recommend removal of all sheetrock containing visible mold growth plus an additional 2 feet surrounding area. *This company does not inspect for and is not qualified to render opinions on any type on environmental or other bio-hazards. If this is a concern or potential concern, Fox Inspections recommends contacting a qualified professional of your choice for further information / investigation.*

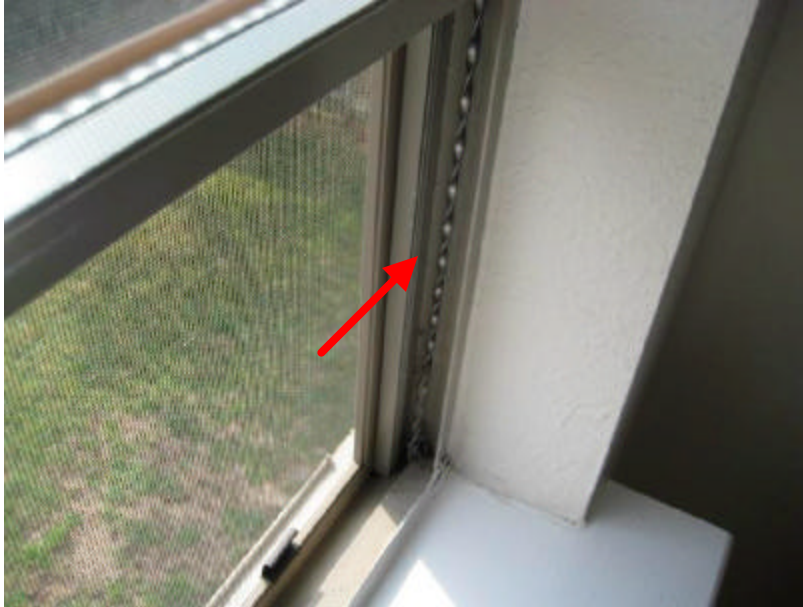
One or more window spring(s) were observed to be sprung/broken/detached. The window in the back middle bedroom will not stay in the open position due to the damage window guides. Springs broken in the northeast, and east middle bedrooms.

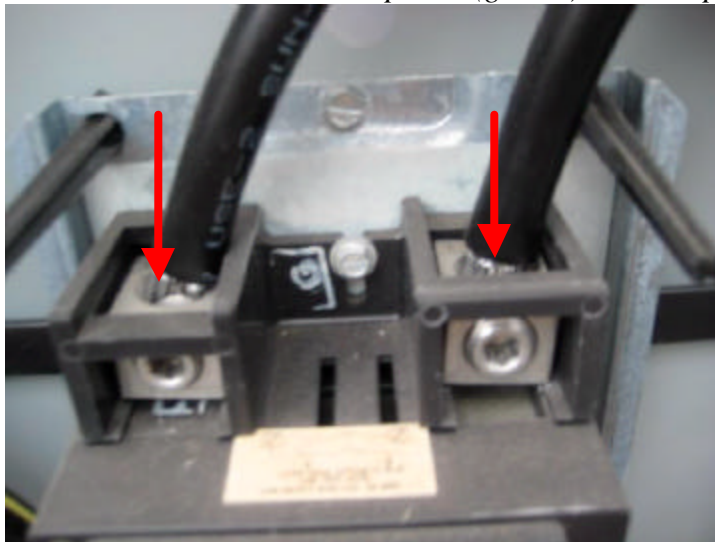
*Did not observe anti-oxidant compound (grease) on the exposed aluminum feeder wiring.*

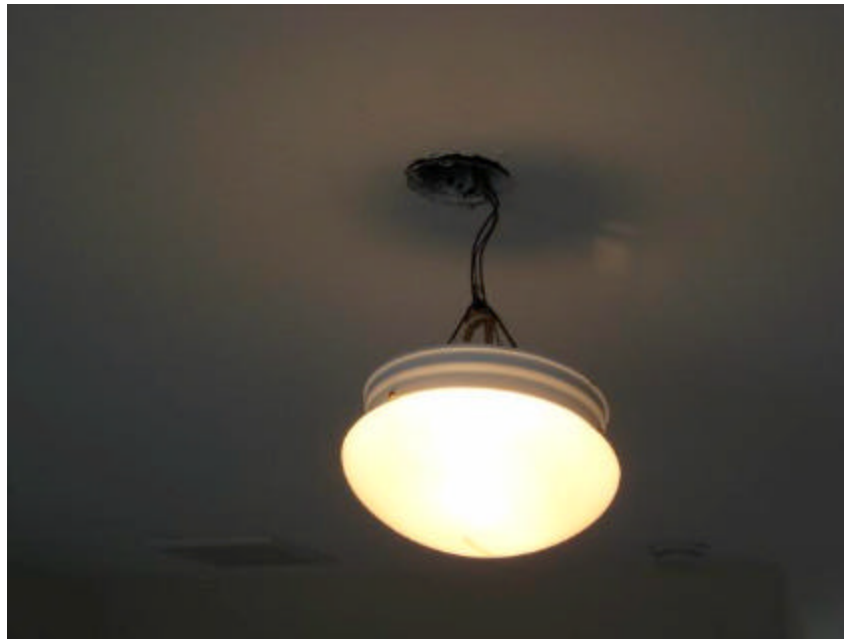
Light not secured, living area above the master bedroom.

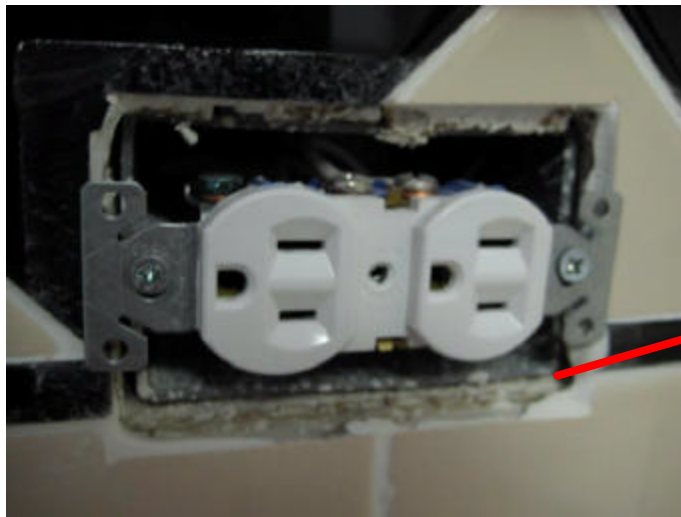
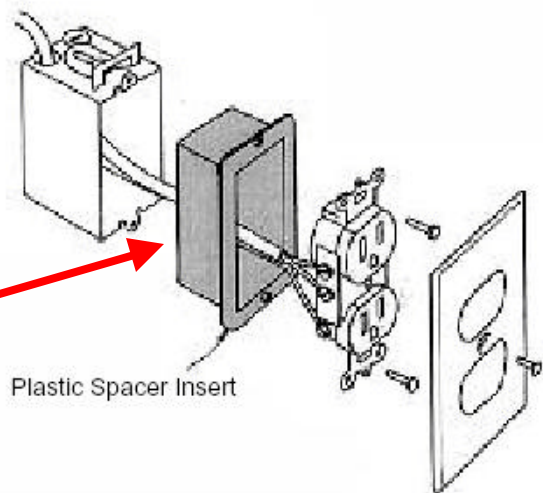
Space between face plate and edge of electrical junction box exceeds ¼ inch allowable by code. Missing required spacer ( spark ring) on all kitchen / bath counter top outlets and switches with tile back splash. Reference NEC 370-20 & IRC E3806.5. In walls of concrete, tile or other noncombustible material, cabinets (outlet & switch boxes) and panel boards shall be installed so that the front edge of the cabinet will not set back of the finished surface more than 0.25 inch.

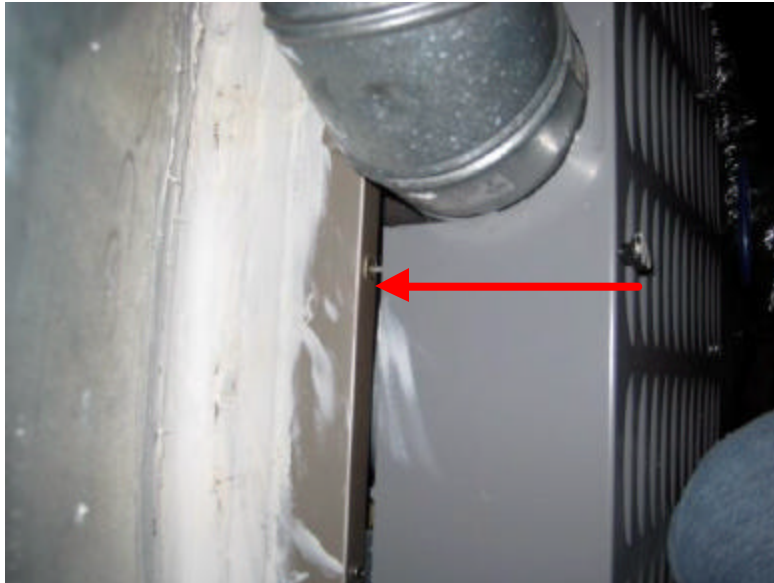
The burner cover fasteners was not long enough to properly secure the burner cover.

Cover is currently loose and needs to be secured.

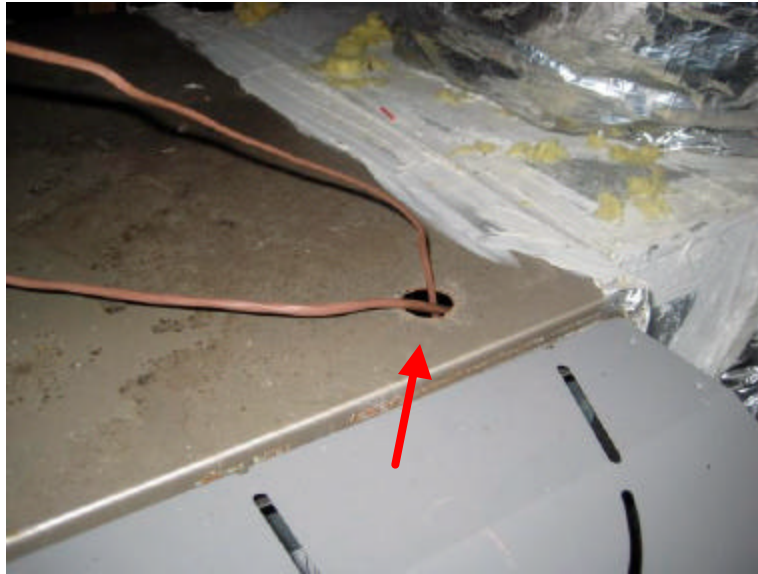
Thermostat wiring not secured to attic unit(s), missing small fitting that secures wiring to cabinet to prevent pulling loose by service personnel or homeowner.

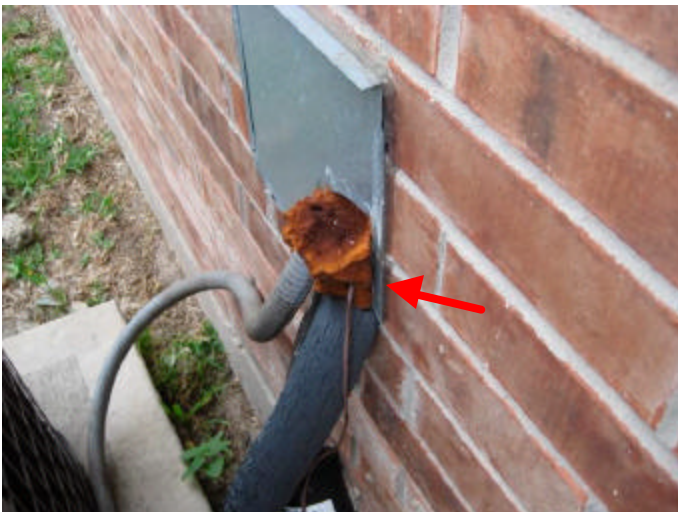
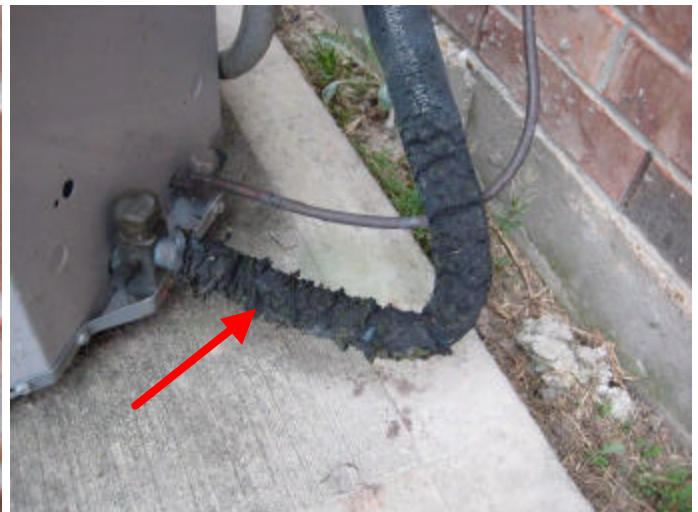
Refrigerant line insulation damage observed at the outside condenser.

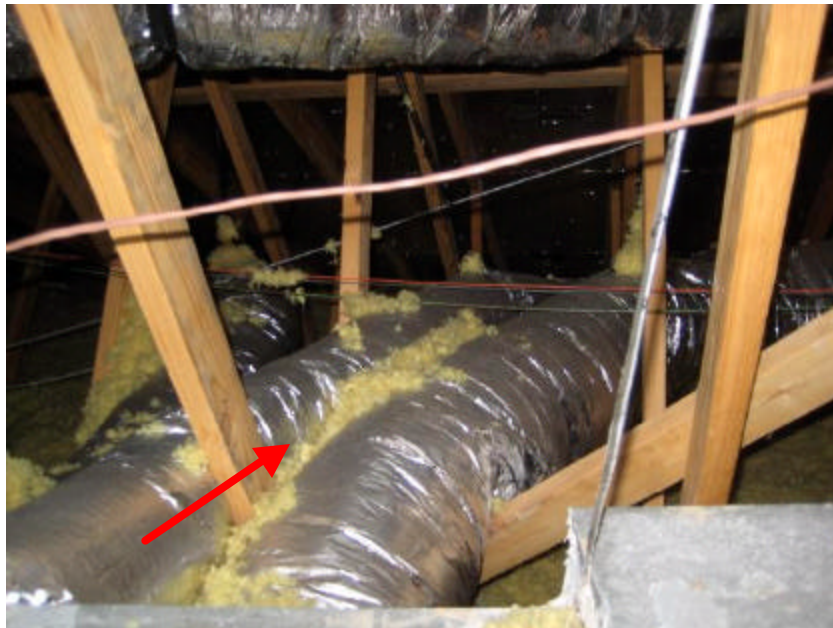
Observed several / multiple areas in attic where flex duct touch and are missing required 1" clearance from other ducts to prevent condensation between ducts that touch. Recommend general maintenance to flex ducts in attic, Re-support where needed, seal/tape minor air leaks, repair torn/damaged vapor seal, etc..

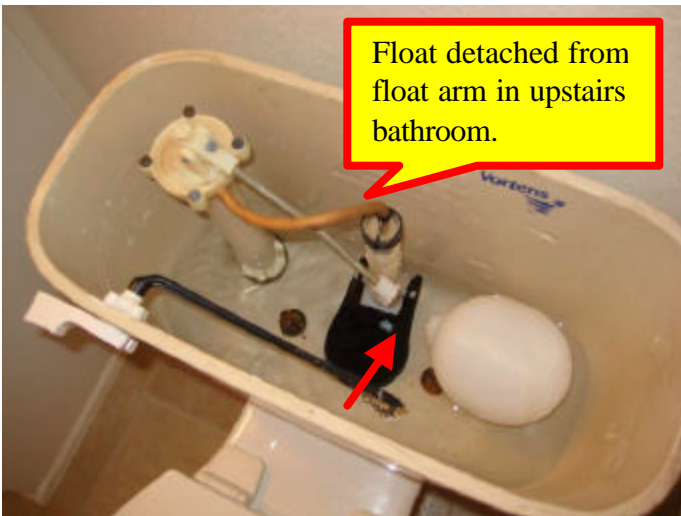
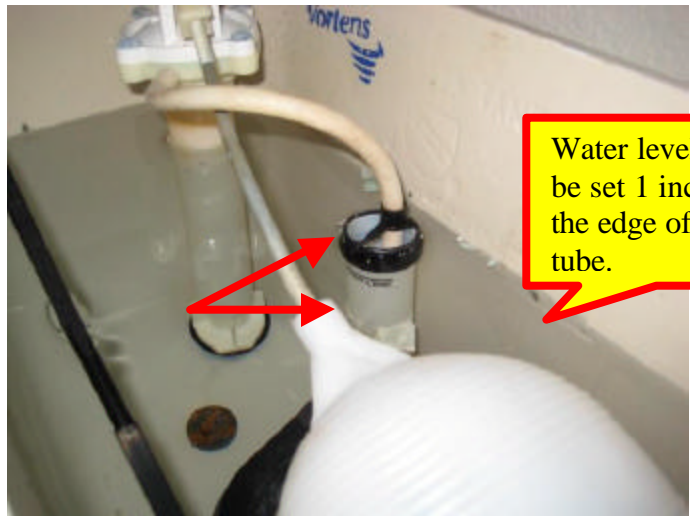
Float device observed to be damage to the upstairs commode.

Tank water level too high; half bathroom.

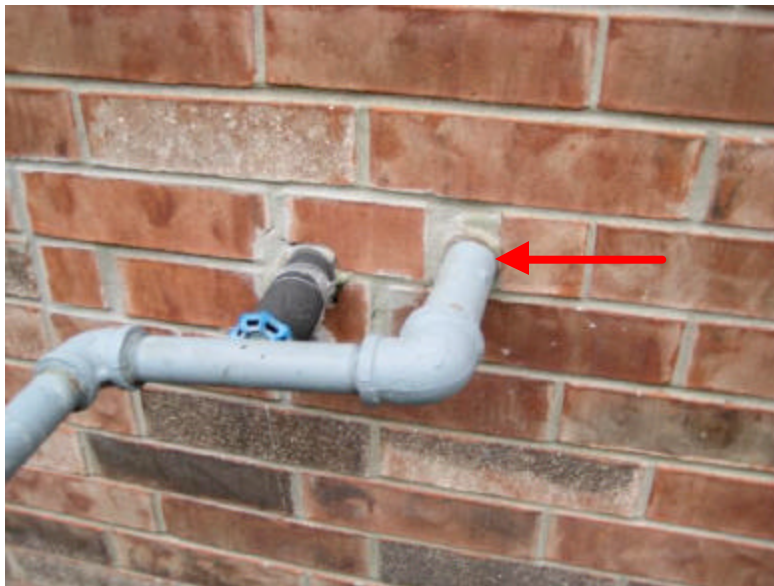
Gas piping not sleeved as it passes thru masonry wall as required by Code [CABO 2608.3] IRC 2603.3.
