1955 Inside 610 Loop

PROPERTY INSPECTION REPORT

Concerning: 1955 Inside 610 Loop, Houston, Texas 77025
(Address or Other Identification of Inspected Property)

March 24, 2009
(Date)

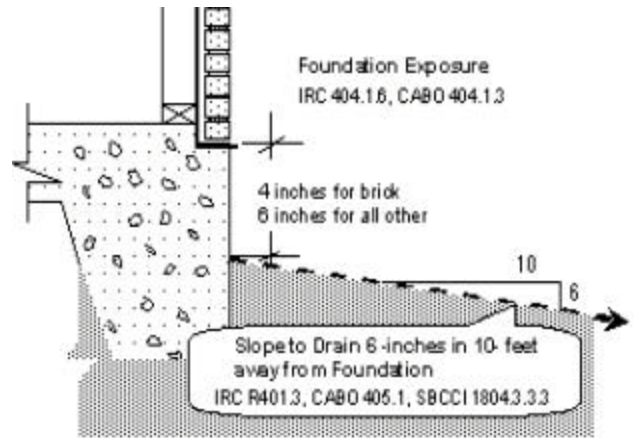
Soil grade and drainage patterns around some areas of house do not appear to properly direct water away from foundation to aid in controlling runoff water and could cause differential movement of the foundation or water penetration during heavy rains.

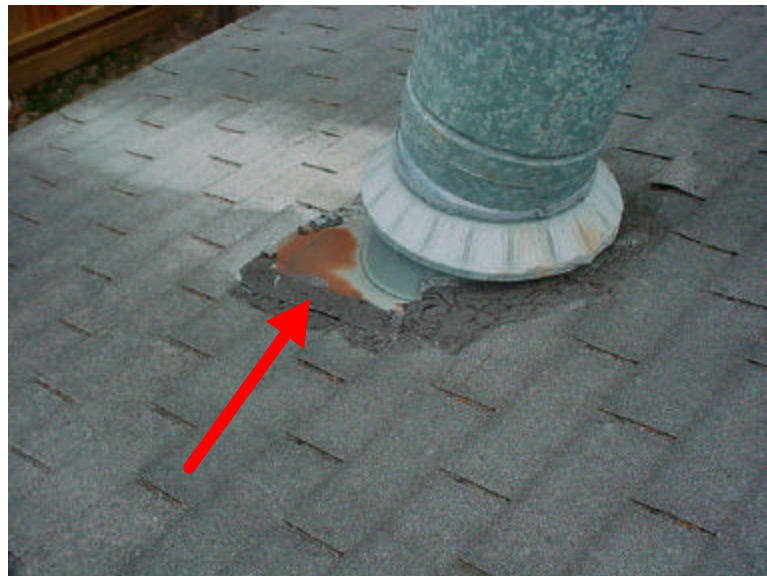
Flashing needs to be sealed / caulked at following location(s); chimney.

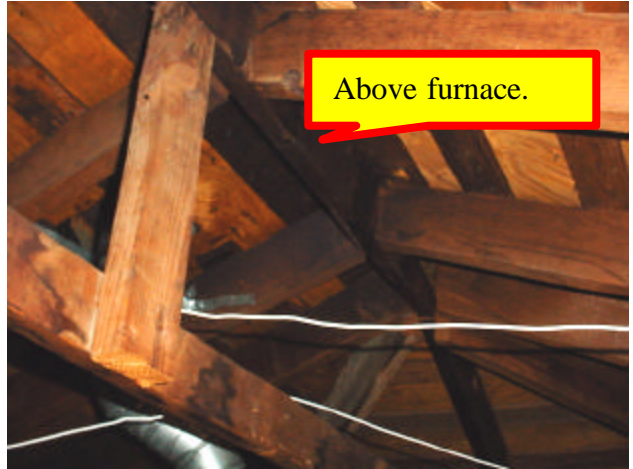
YES!!, in several areas , including but not limited to: above furnace, below east turbine, and in front soffits.

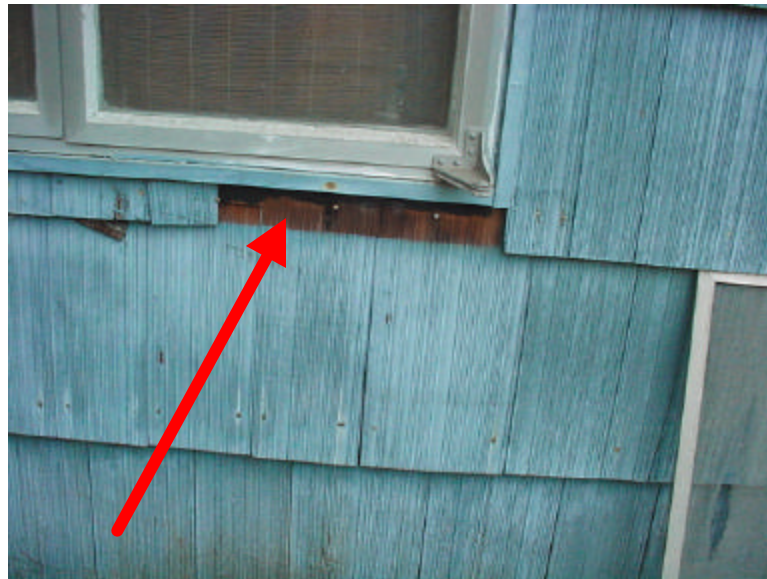
Wood siding observed to be not secured down at one or more areas of house / garage.

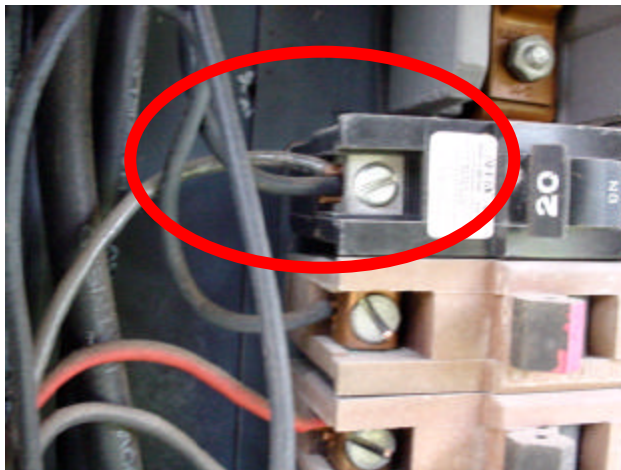
Double ganged breaker(s), [two wires improperly on 1 breaker] observed. "Top left.
