2005 Newer Home Inspection Report

PROPERTY INSPECTION REPORT

Richmond, Texas

March 3, 2009

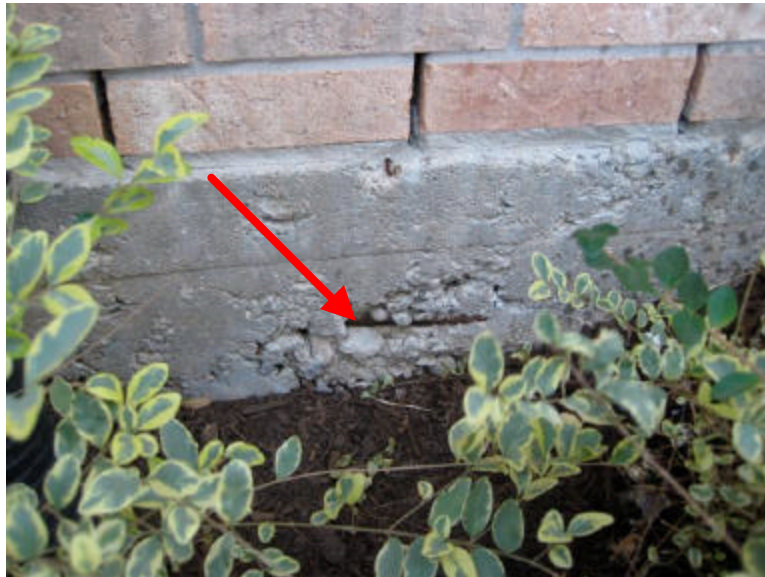
Exposed steel observed at southwest corner needs repair.

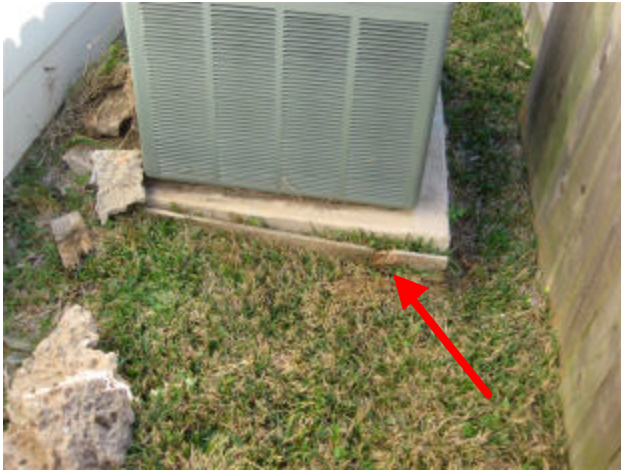
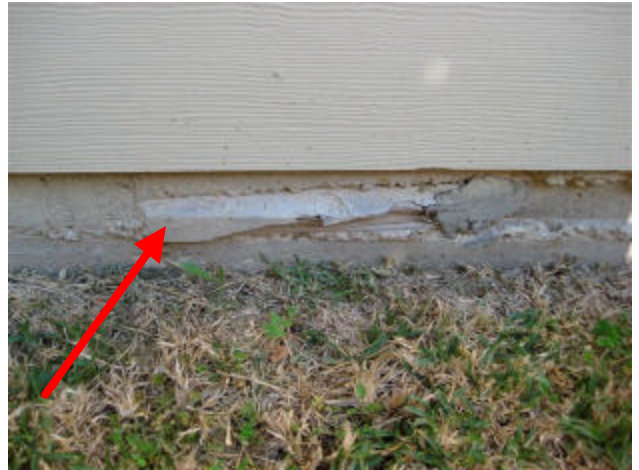
Wood form board(s) around foundation should be removed to reduce chance of wood destroying insect activity.

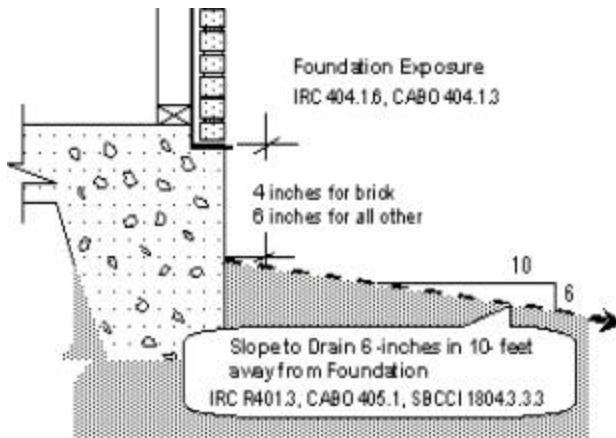
Soil grade and drainage patterns around some areas of house do not appear to properly direct water away from foundation to aid in controlling runoff water and could cause differential movement of the foundation or water penetration during heavy rains.

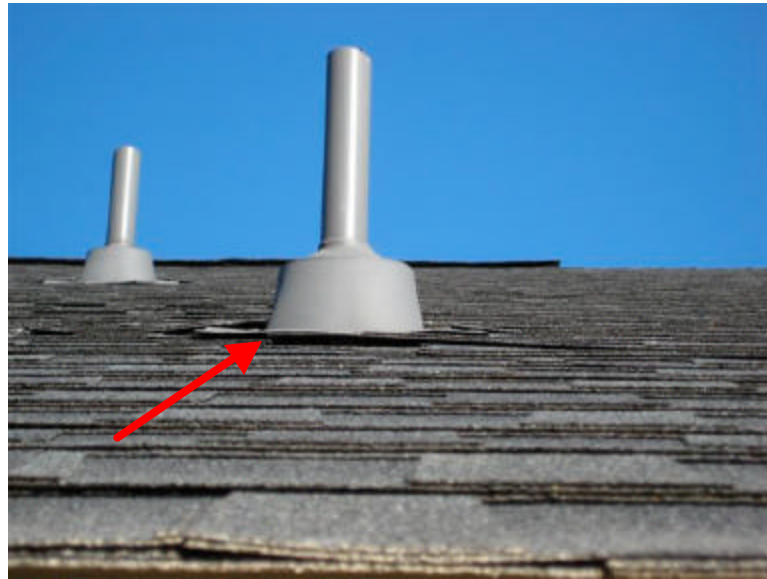
Area of raised shingle tabs from fasteners not secured down properly or nail heads popping up through shingles; south section of roof near satellite dish.

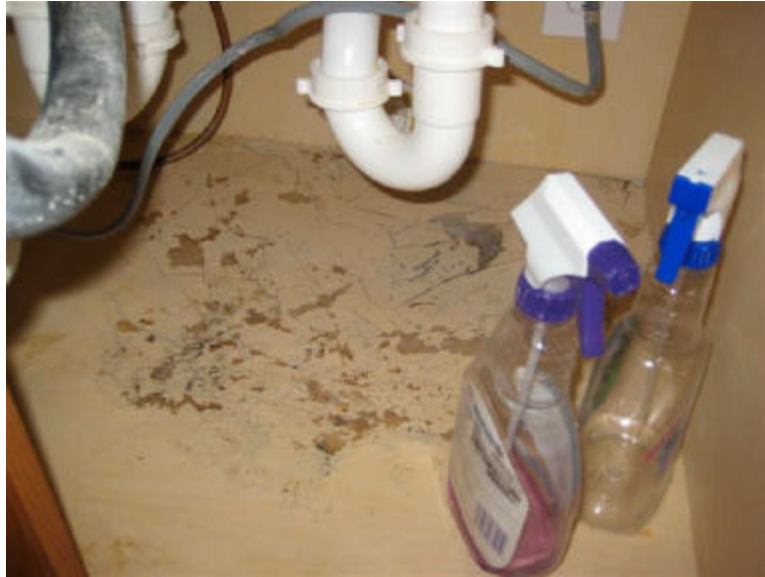
Water damage to base of cabinet below sink.

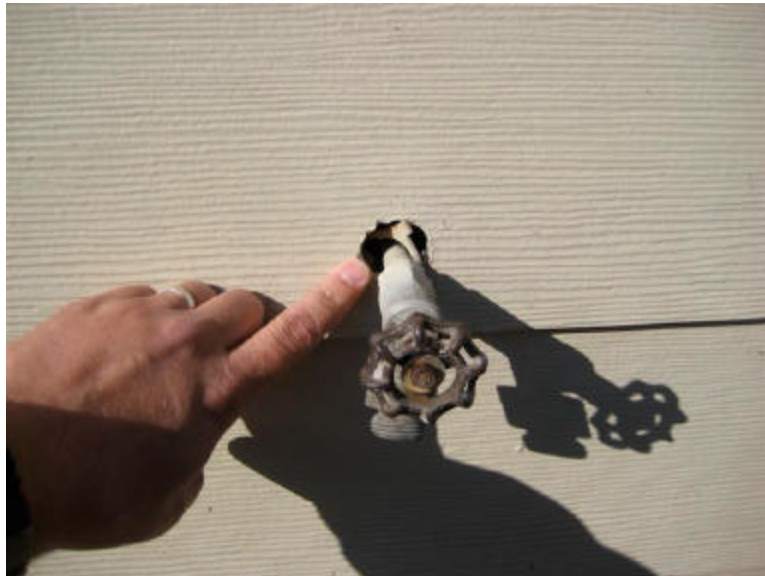
Need sealing / caulking around all holes and exterior siding penetrations on top and both sides, (leave bottom open) to prevent water entry. Including but not limited to dryer, bath and range top vents, light fixtures, etc.

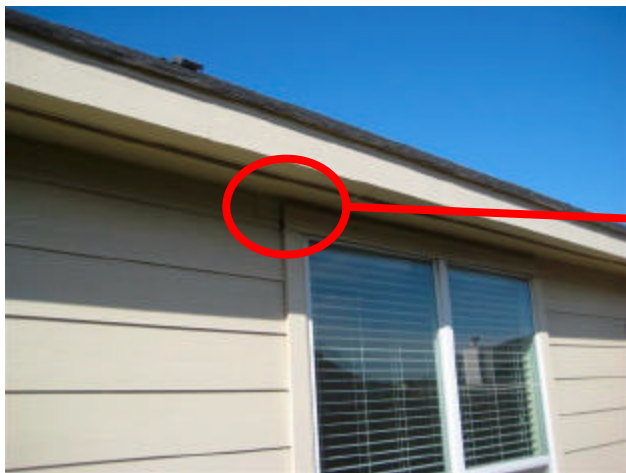
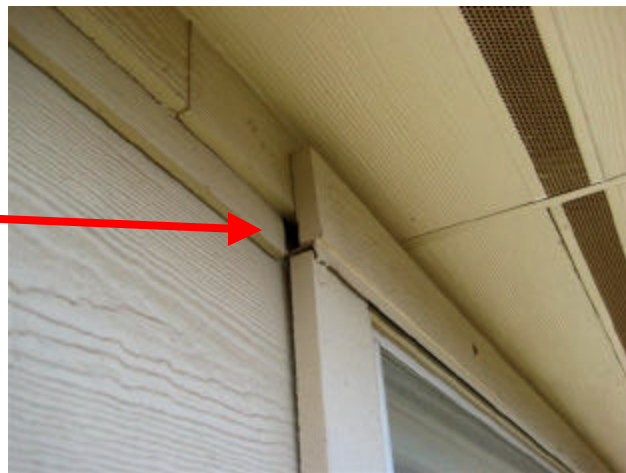
Gap at top of master bedroom window needs to be sealed to prevent water/rodent entry.

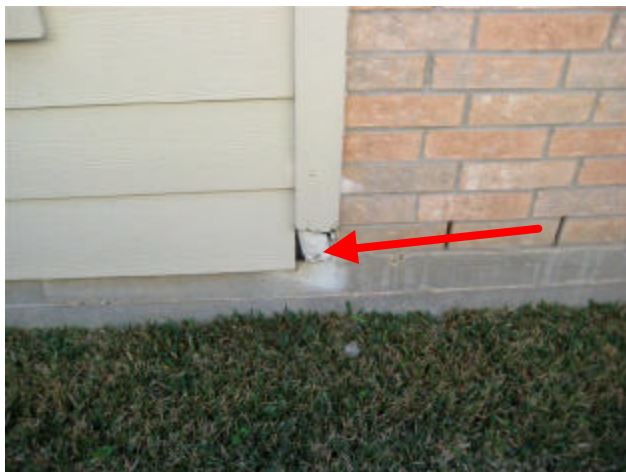
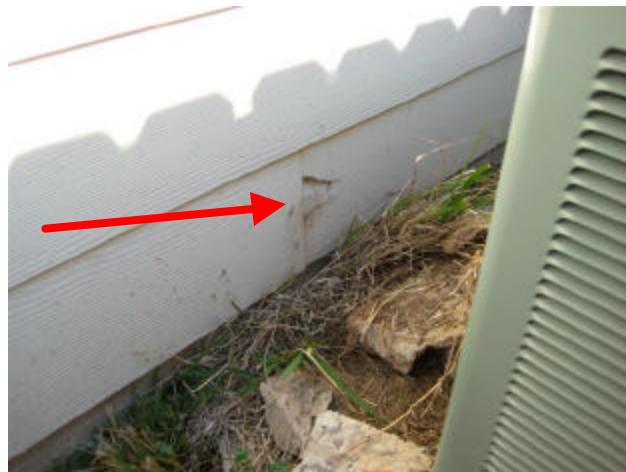
Damaged/missing siding observed on south and north walls.

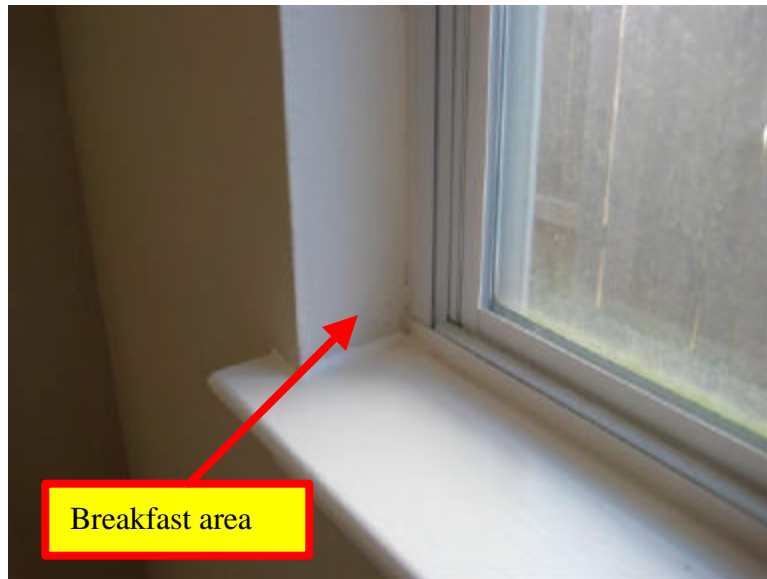
Water stains / damage on interior of one or more window jambs.

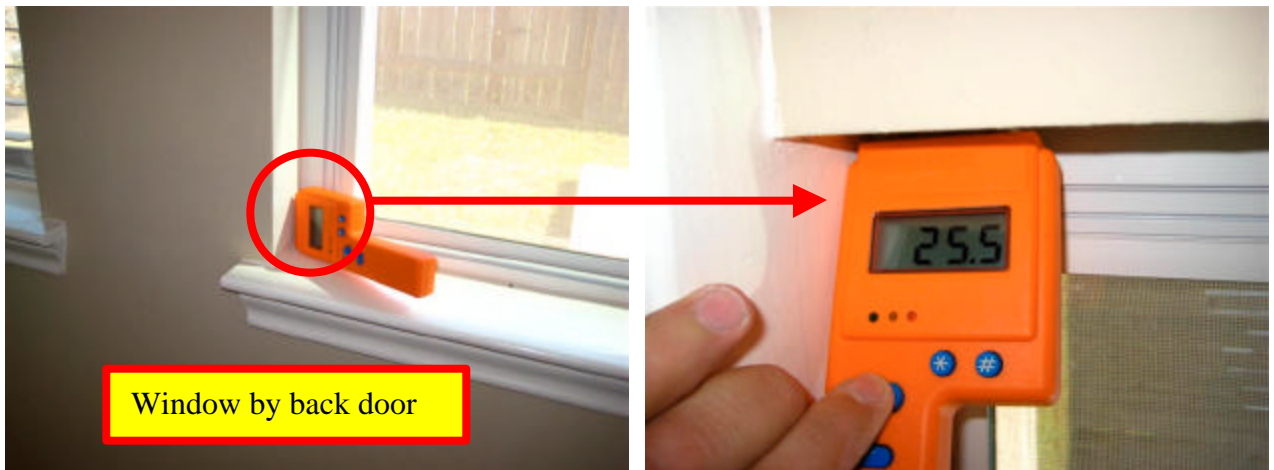
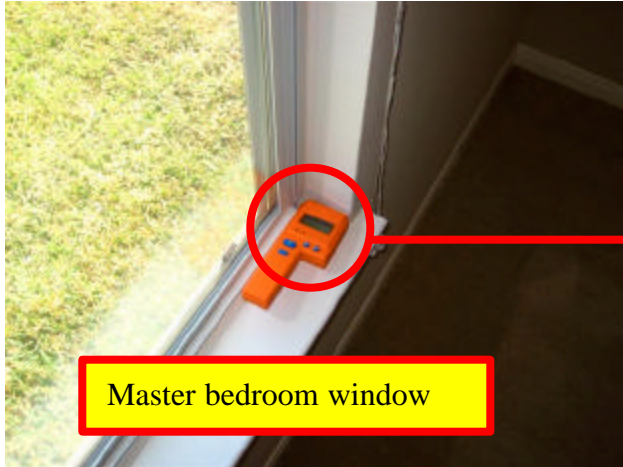
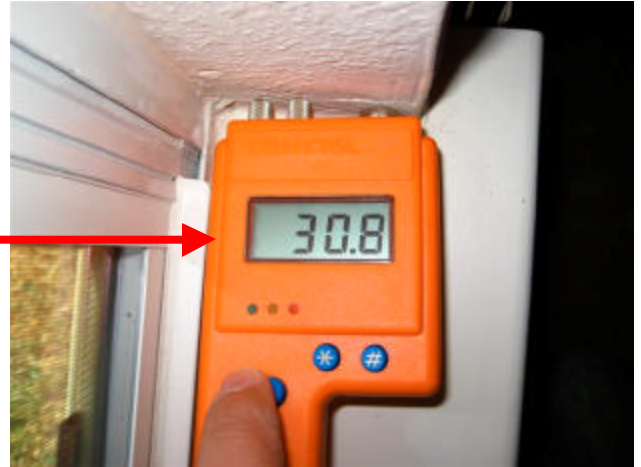
Possible water penetration observed; elevated moisture readings were observed at window jamb near back door and at master bedroom. House has recently been repainted. Inquire with seller if sheetrock repairs have been performed in these areas.

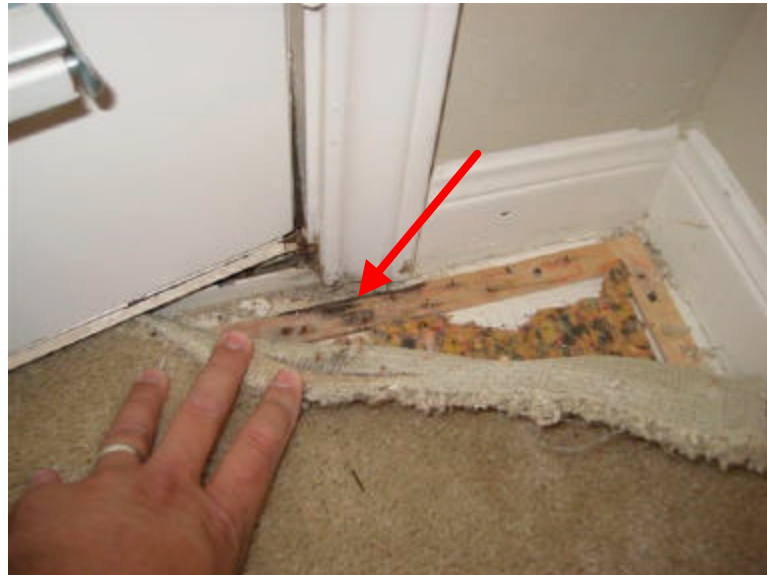
YES!!, Evidence of water penetration observed at back door. Carpet tack strip shows signs of water exposure.

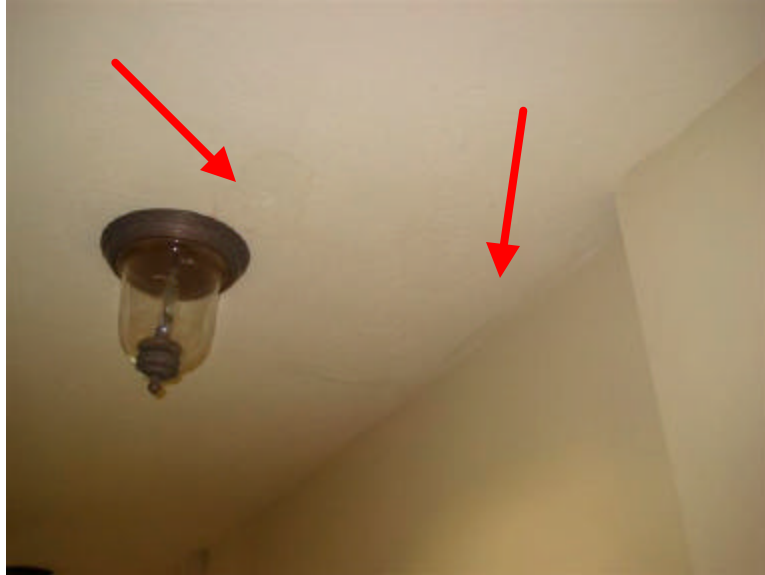
Water stains, damage or repairs observed, moisture detection equipment indicated that stains are not active (wet) at time of inspection; hallway below a/c unit in attic.

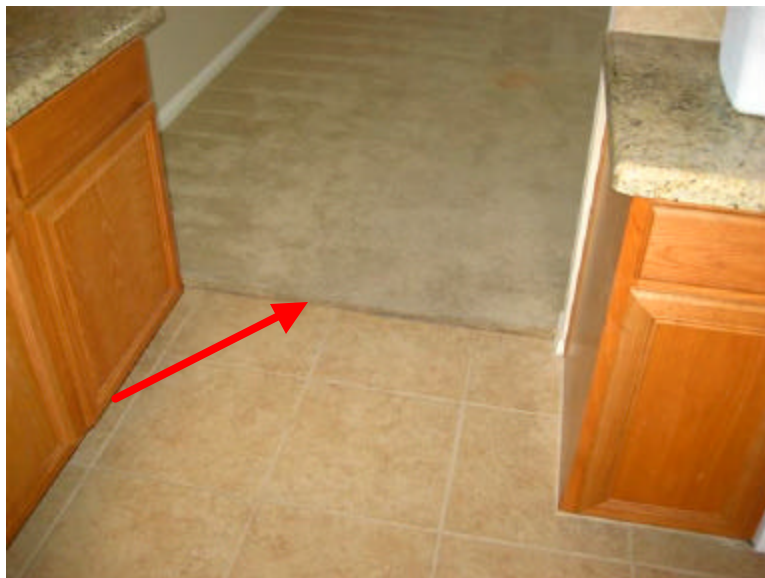
Carpet near kitchen tile is not secured well.

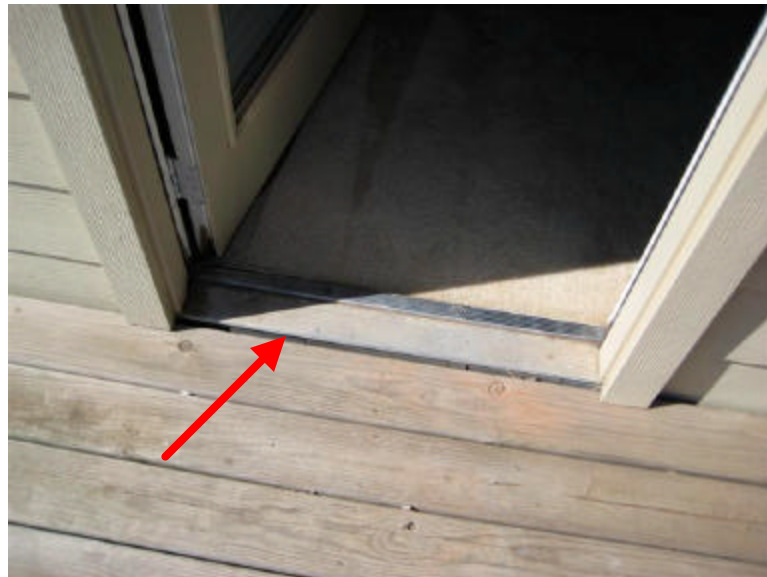
Improper threshold used on exterior door (back door) without roof overhang protection from wind driven rains will probably result in water damage from intermittent water entry. Recommend replacement with metal type threshold with rain water channels that directs water back to exterior.

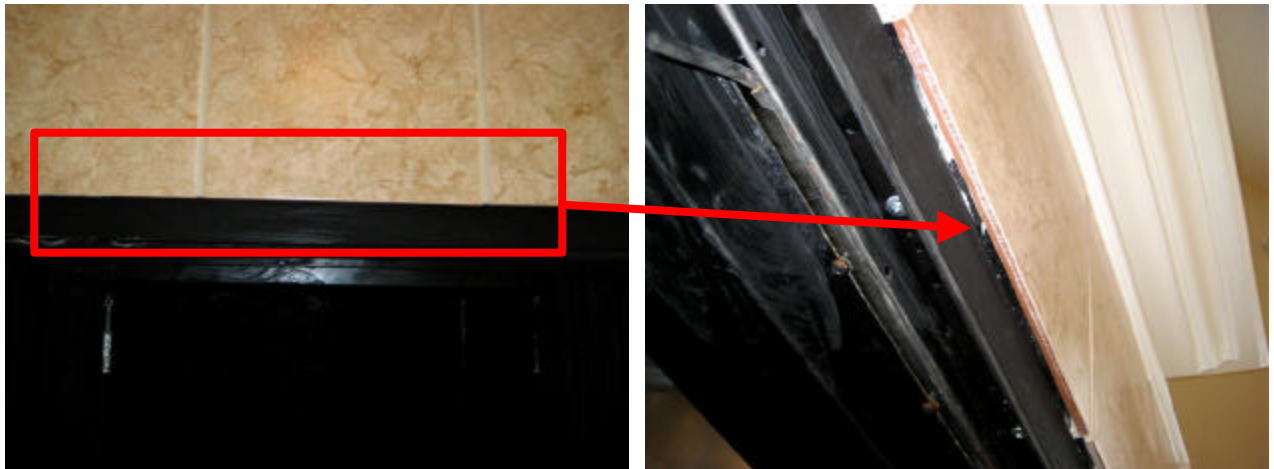
Tile needs to be grouted on front of fireplace to prevent sparks/embers and super heated gas from getting behind tile work.

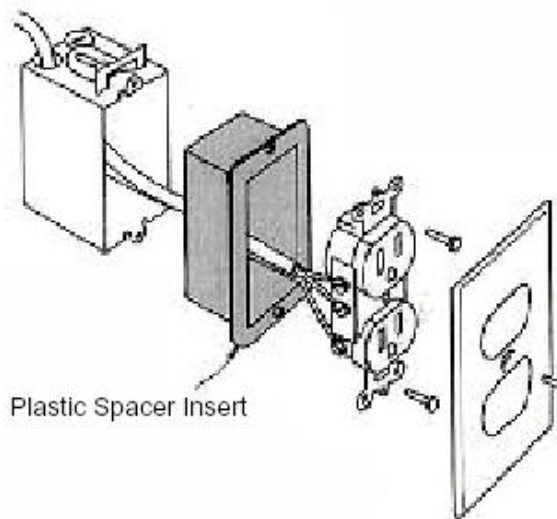
Space between face plate and edge of electrical junction box exceeds ¼ inch allowable by code. Missing required spacer (spark ring) on all kitchen counter top outlets and switches with tile back splash. Reference NEC 370-20 & IRC E3806.5. In walls of concrete, tile or other noncombustible material, cabinets (outlet & switch boxes) and panel boards shall be installed so that the front edge of the cabinet will not set back of the finished surface more than 0.25 inch.

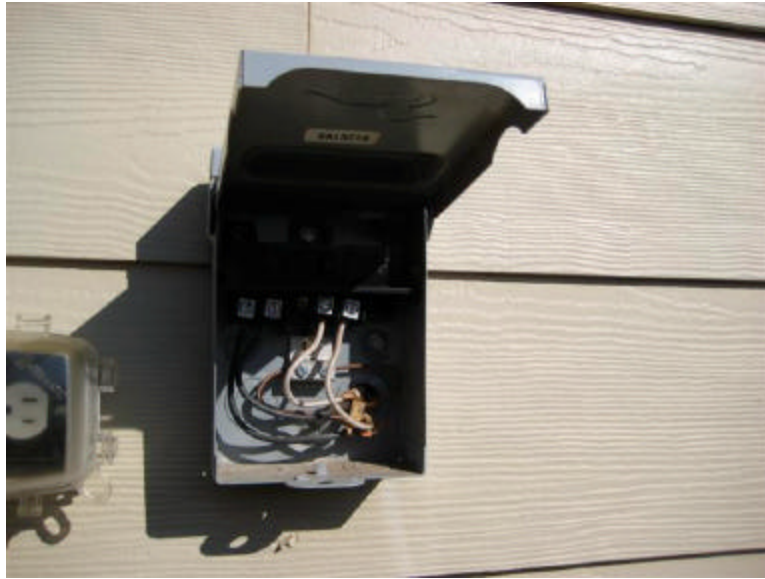
A/C unit electrical disconnect wiring reversed, line / load connections are backwards.
Live electrical wiring to wrong side of electrical disconnect when power turned off at disconnect will result in shock hazard, repair.

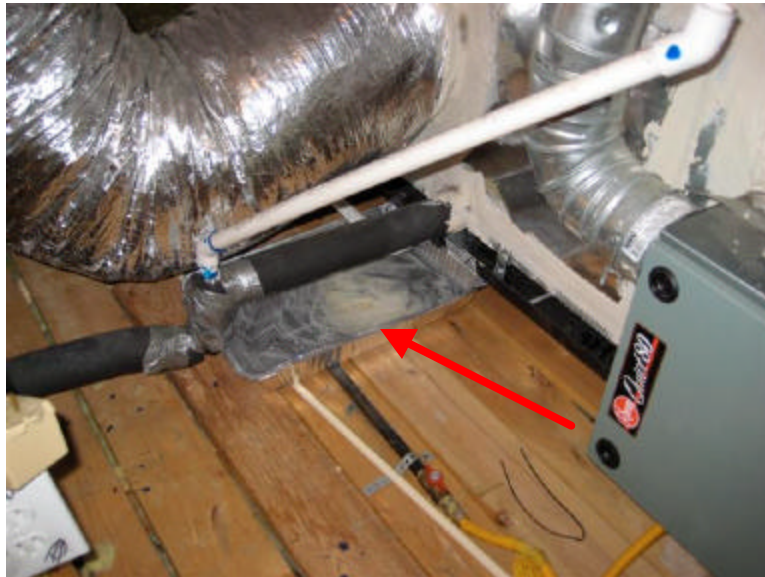
Cooking pan observed below primary and secondary drain line on unit. Recommend inquiry of seller. Water stains observed on ceiling below this area.

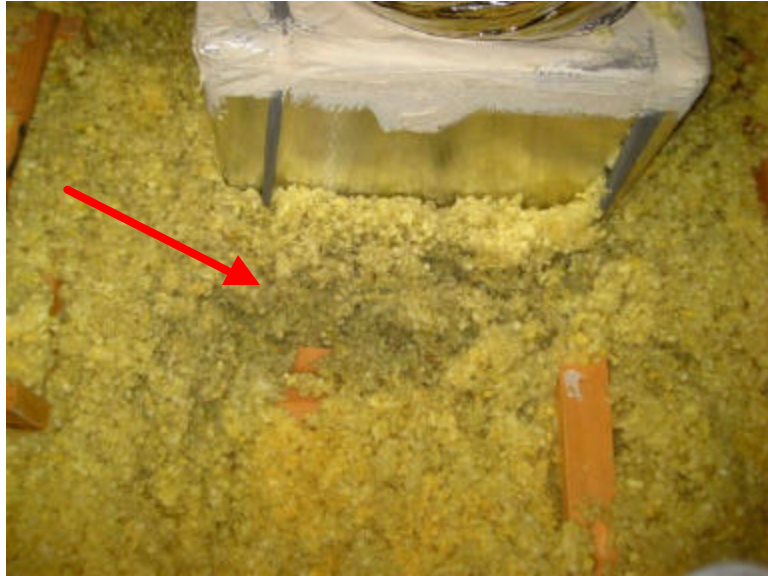
Discolored attic insulation around attic return air chase indicates attic air is drawn in where return air duct is attached to ceiling sheetrock in attic. Needs sealing around perimeter of return air chase to prevent sucking attic air and insulation into system.

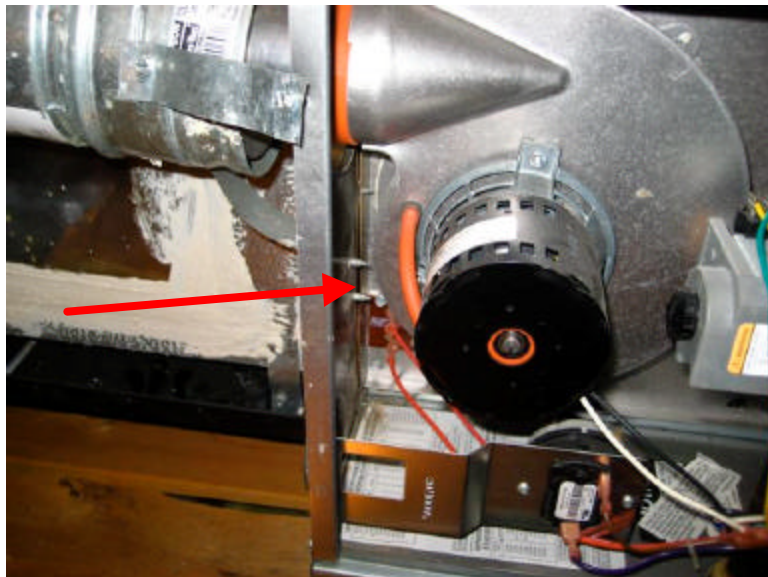
Excessive air loss at defective manufacture construction joint / seam of heater.

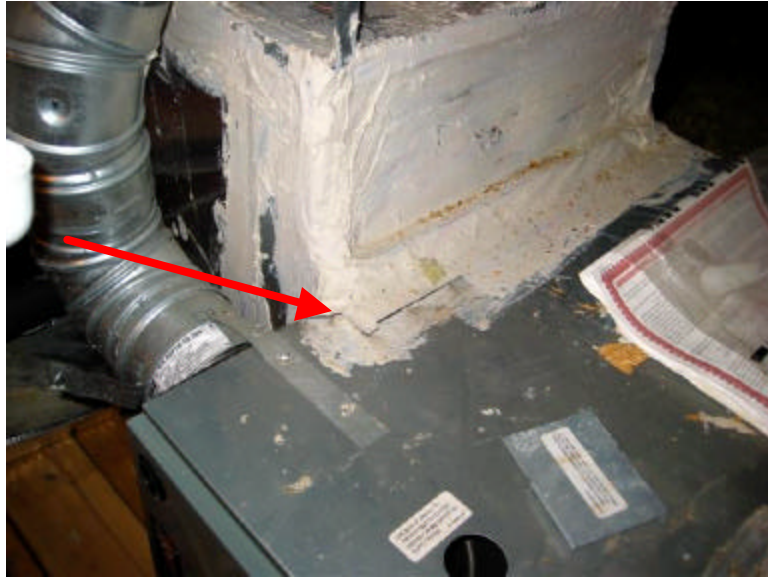
Excessive air loss around transition between heater and evaporator coil; loose taped joint.

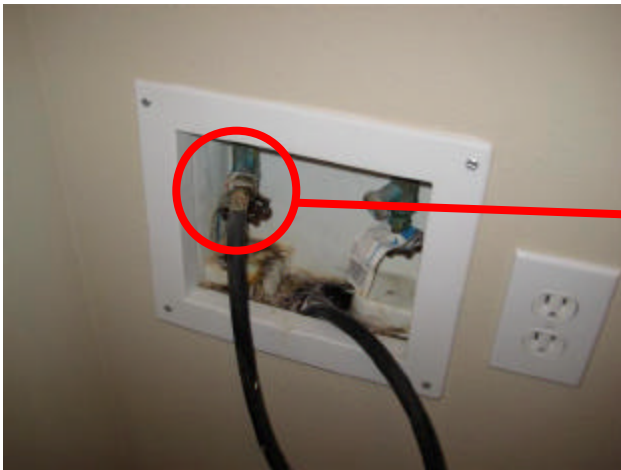
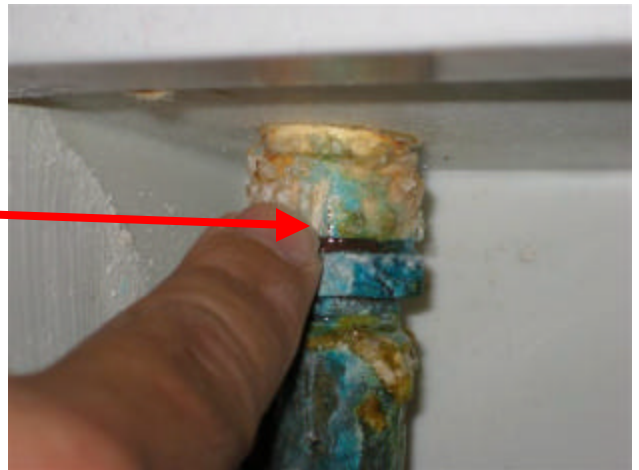
Active water leaks observed at clothes washer supply line on the left side. Fitting has a hairline crack.

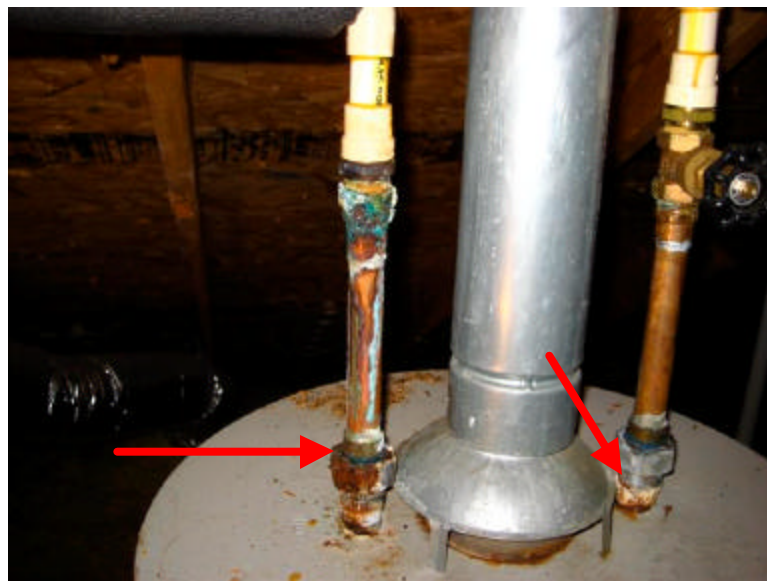
Corrosion and active water leak observed at shut off valve and/or connections on top of water heater.

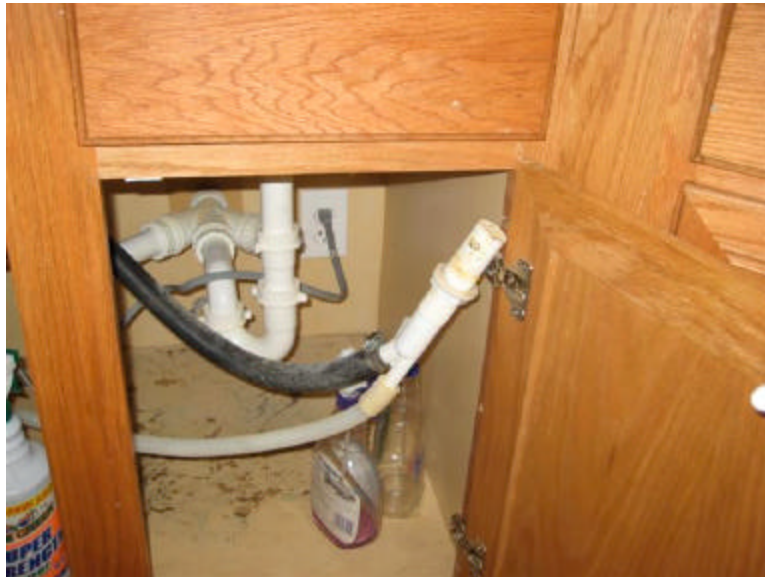
Air gap device has not been installed properly (has been removed from counter and replaced with spray wand). Device may be clogged; leaks water when dishwasher drains.

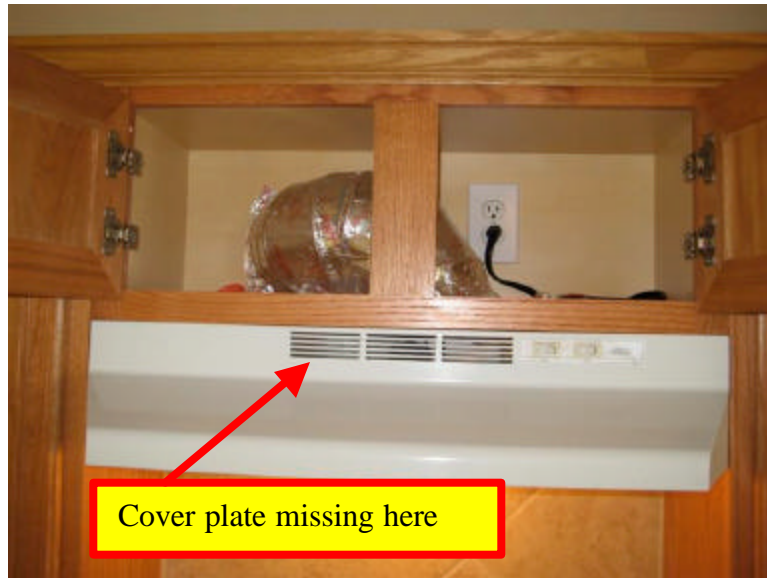
Unit blows air back into house (is set up to exhaust to the exterior). Missing vent cover piece that re-directs air to the exterior.
