1967 Timbergrove Manor Home Inspection Report

PROPERTY INSPECTION REPORT

Concerning: 1967 Timbergrove Manor, Houston, Tx. 77008
(Address or Other Identification of Inspected Property)

March 4, 2009
(Date)

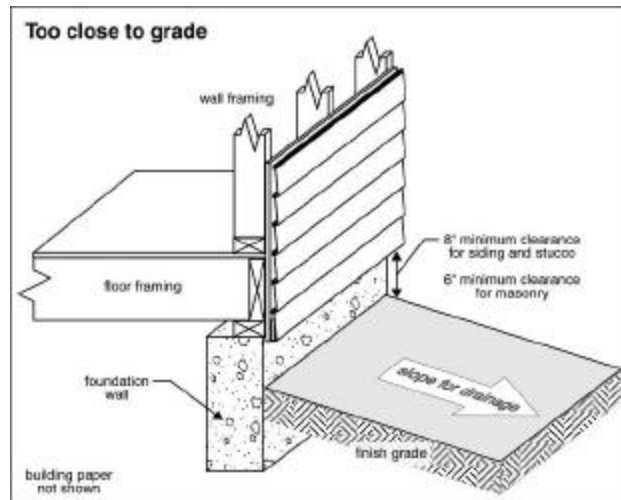
Soil level too high around areas with brick siding at multiple areas around house.

Common industry practice requires a clearance of at least 4 inches from bottom of brick veneer to soil. High soil level near brick siding promotes wood rot and is considered a conducive condition to termite activity and water penetration.

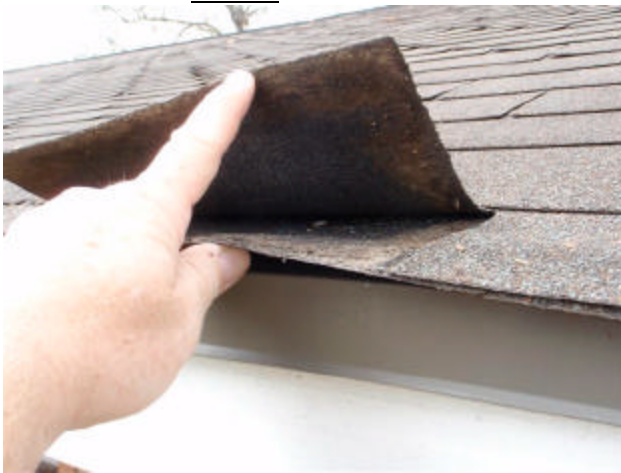
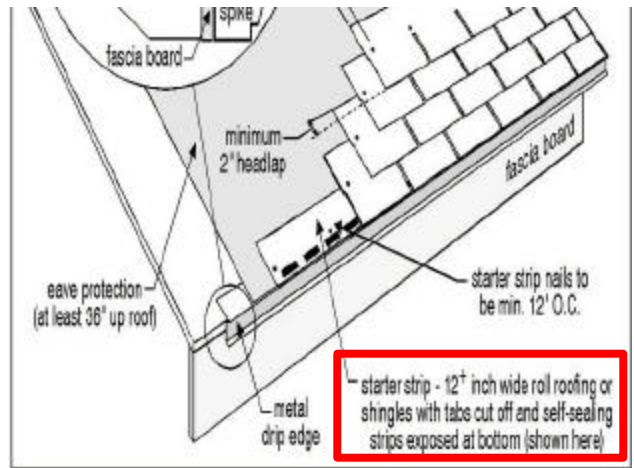
Improper installation of shingle starter course, not installed per manufacture's installation instructions on every bundle of shingle that instructs glue / sealing tabs to be located near lower edge of roofing. When starter course is not installed properly, high winds can peel roofing off. Reference: shingle bundle wrappers. Recommend addition of roof sealant dabs on lower course to mimic / gain effect of properly installed starter course.

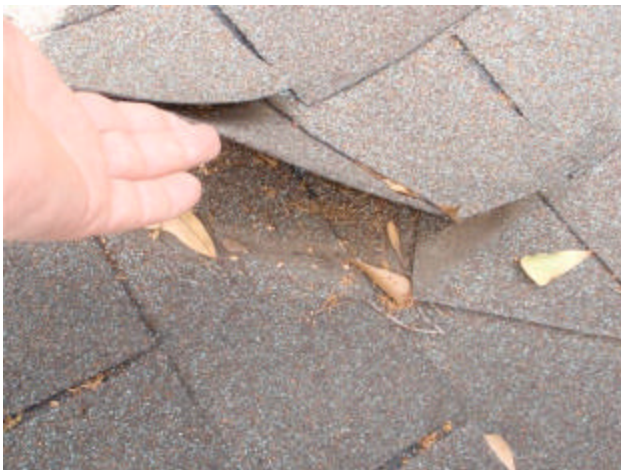
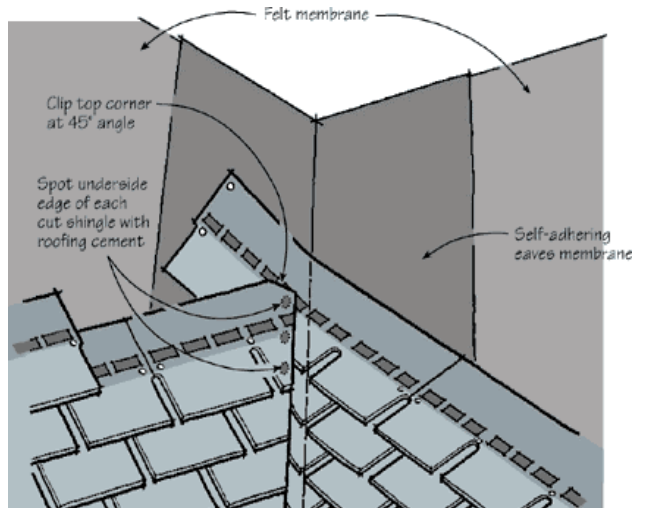
Valley shingles improper. In a closed valley, embed valley shingles in roofing cement.

Always clip the top corner of the valley shingles at a 45-degree angle. This prevents debris from getting caught in the shingles and accumulating in the valley, and it also directs water toward the valley centerline. For extra protection, install a self-adhering eaves membrane under valleys.

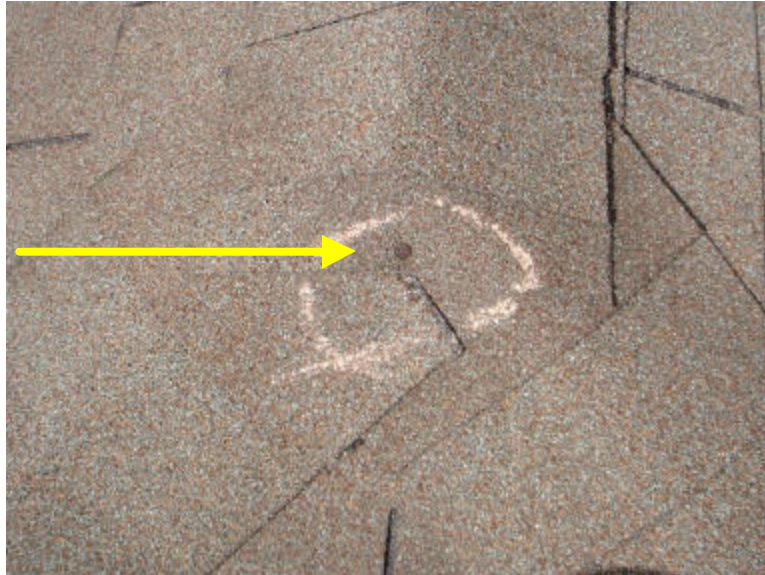
Exposed staples / nail heads / fasteners observed on roof, all exposed fasteners should be sealed to prevent water entry.

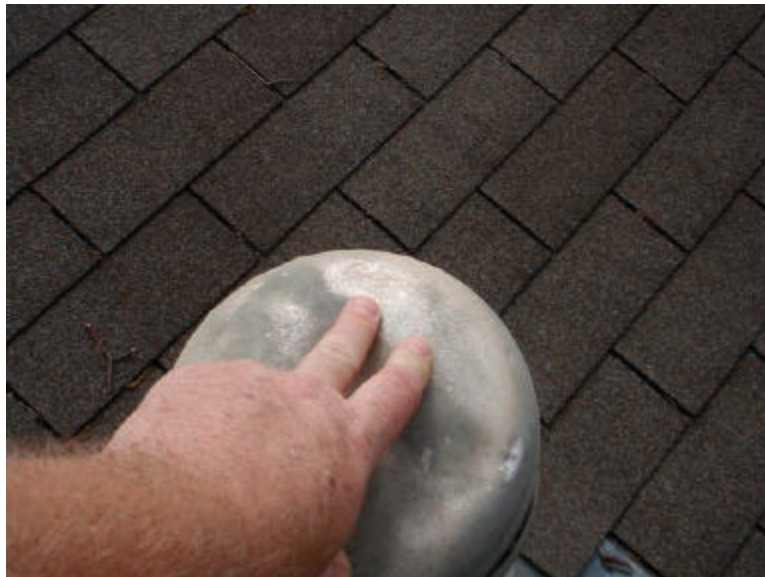
Observed evidence roof may have been subject to hail storm in the past. Recommend inquire seller regarding any/all information (full disclosure) available.

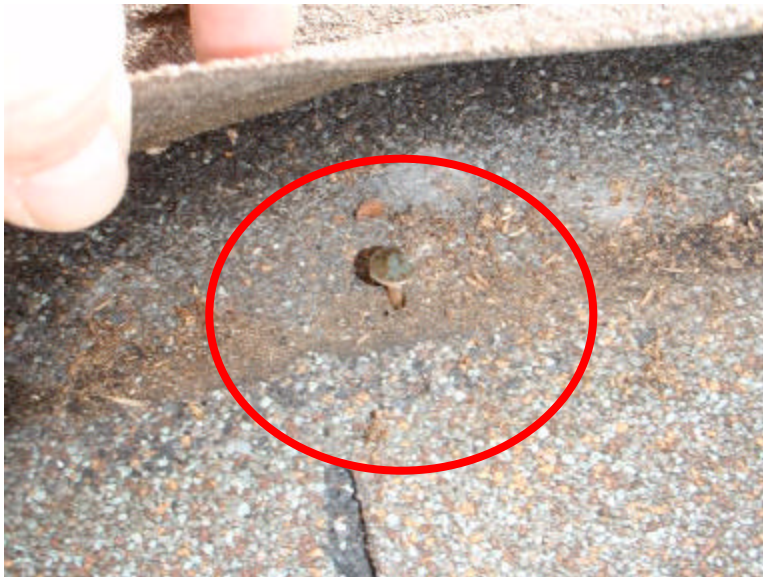
One or more areas of raised shingle tabs from fasteners not secured down properly or nail heads popping up through shingles.

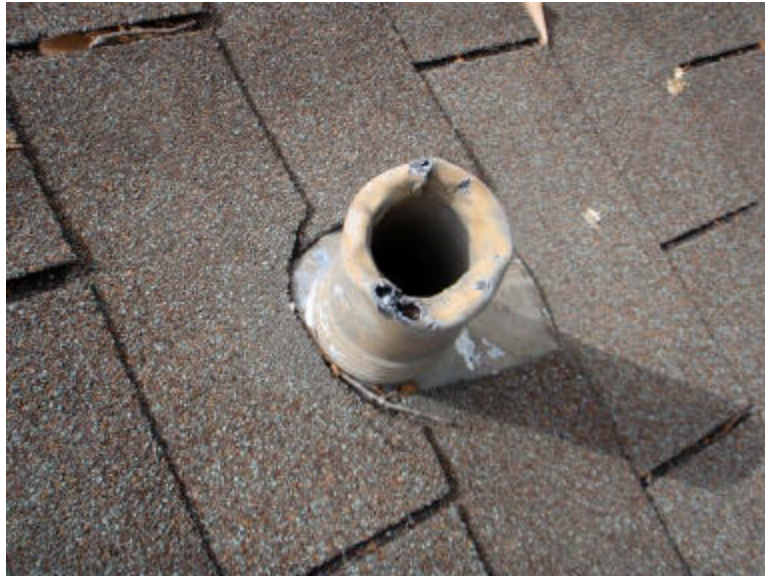
Not all lead flashing of drain waste vents are properly rolled down interior of plumbing vent pipes and/or are damaged by squirrels, may allow some rain water entry.

Possible from damaged areas of flashing on drain waste vents and lack of caulking at storm collar.

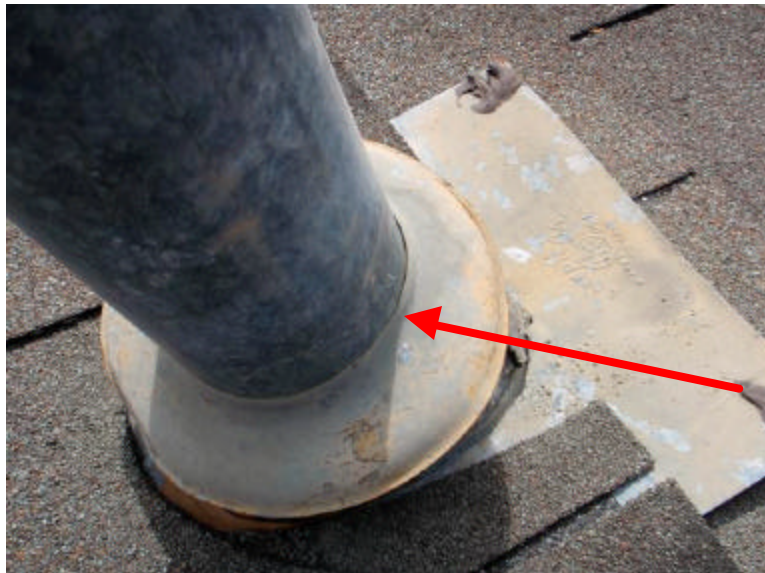
Storm collar needs caulking on all house and water heater vent pipes.

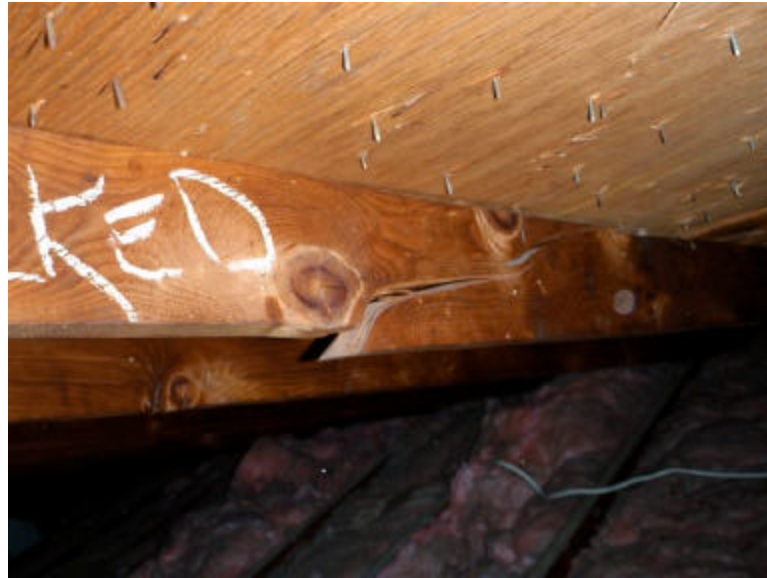
Observed cracked rafter(s) in attic of house/garage have been marked with chalk.

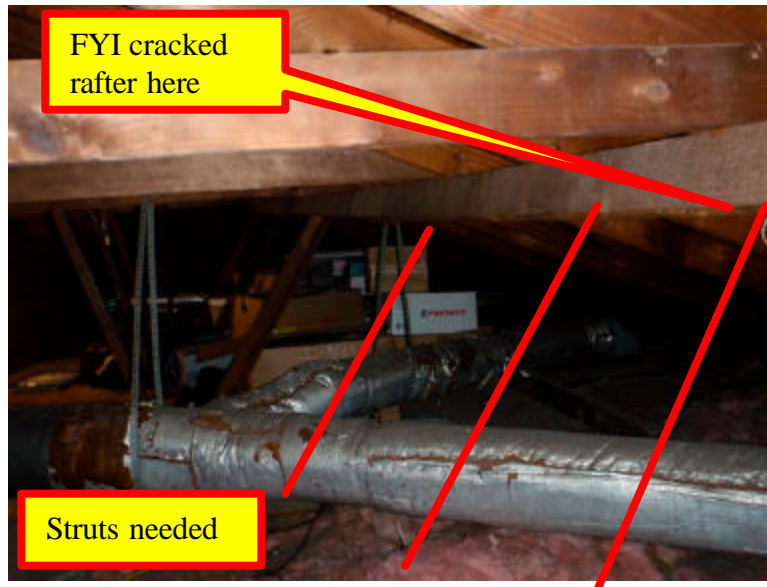
Observed insufficient purlin (roof bracing) supports in attic, needs additional purlin struts at 4 foot centers down to load bearing walls for proper roof support.

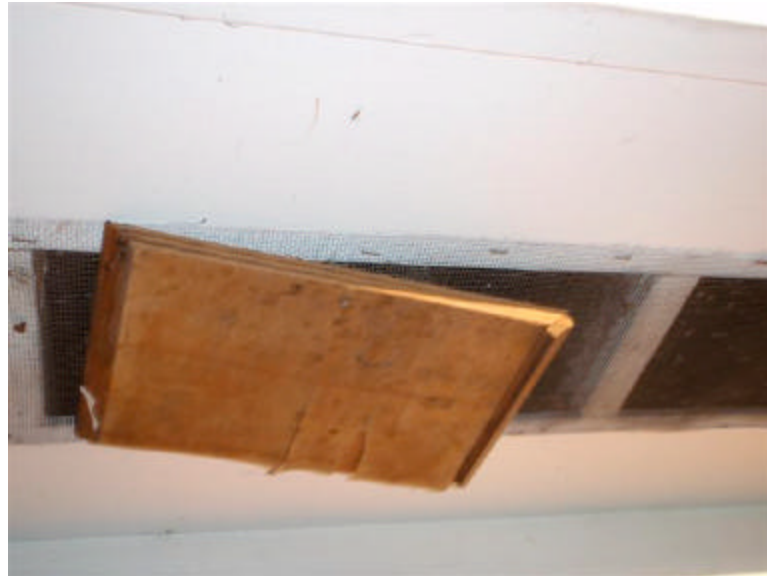
Soffit screening damage observed at one or more locations around house.

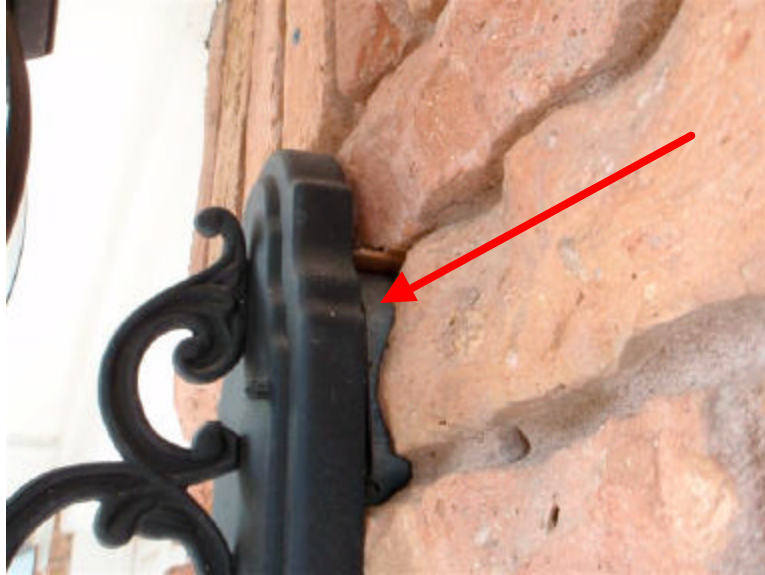
Need sealing / caulking around all holes and exterior siding penetrations on top and both sides, (leave bottom open) to prevent water entry. Including but not limited to dryer, bath and range top vents, light fixtures, etc.

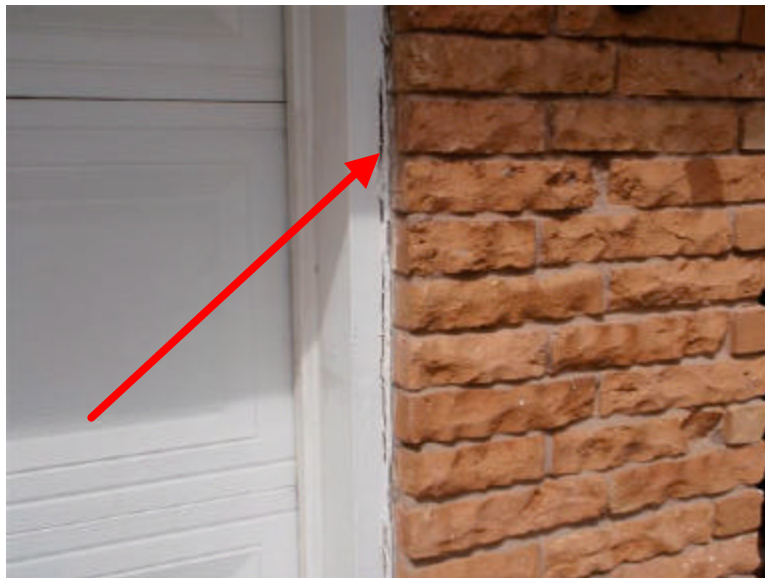
Caulking missing and/or deficient around vertical trim boards may allow wind driven rain entry.

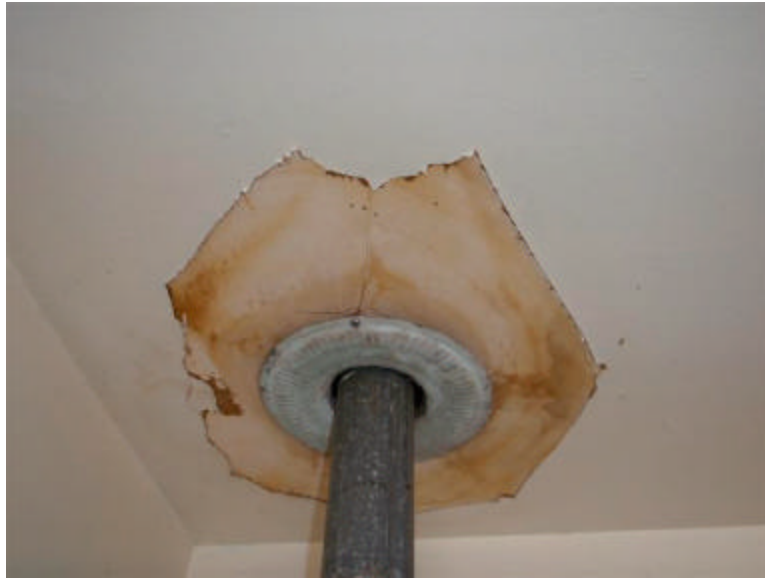
Water stains / damage or repairs observed; at water heater vent.

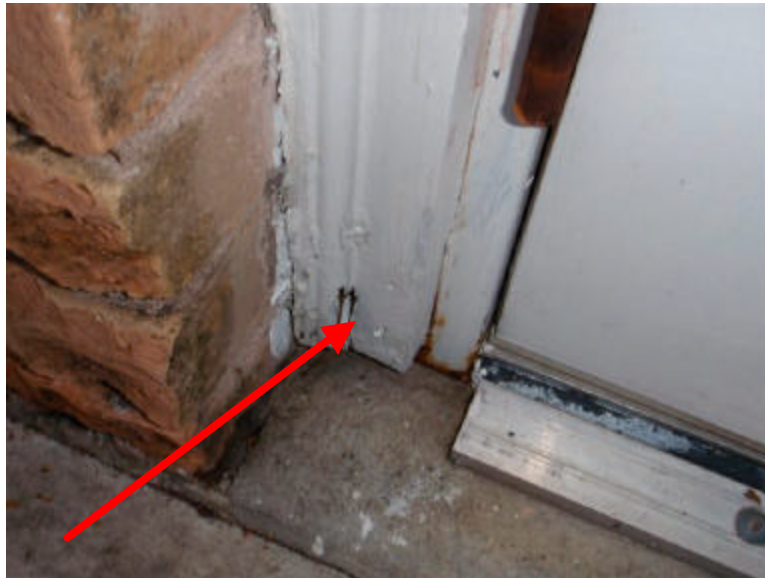
Wood rot of lower door and/or jamb; side entry to garage.

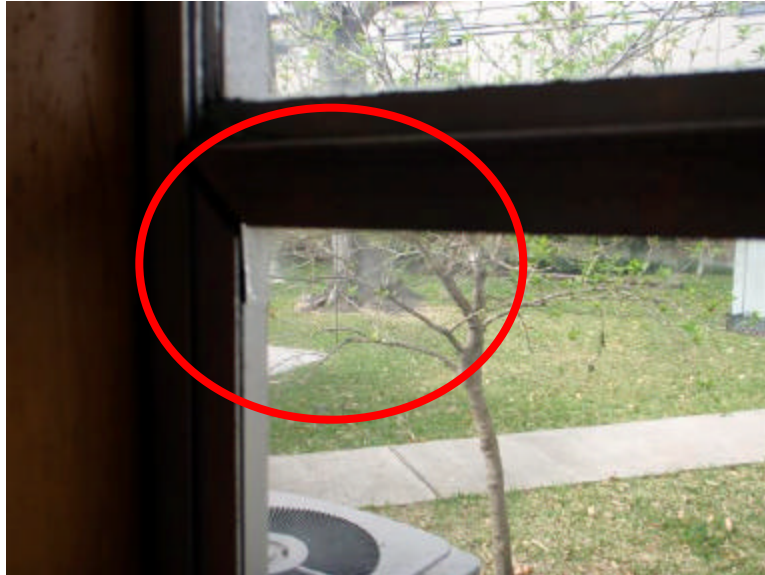
One or more windows had cracked / broken glass pane(s). bathroom.

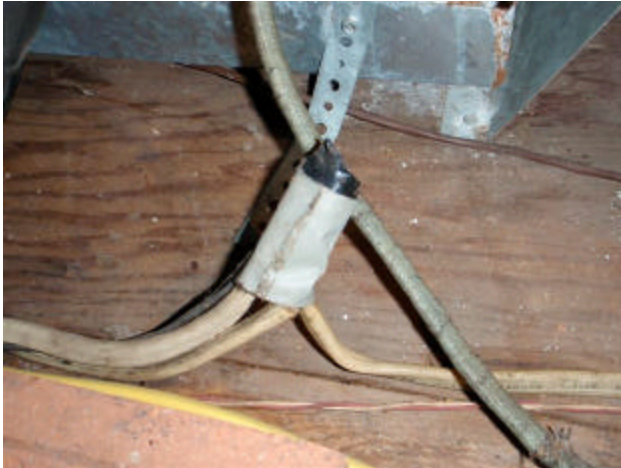
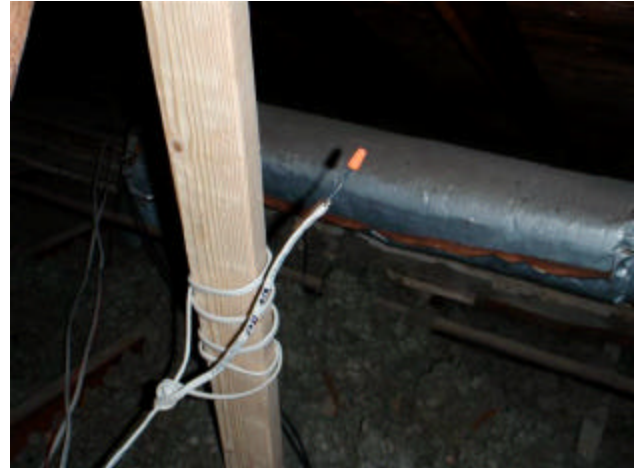
Wire connections are not enclosed in proper electrical junction box(s), or electrical junction box(s) do not have covers in place, including but not limited to the following location; attic.

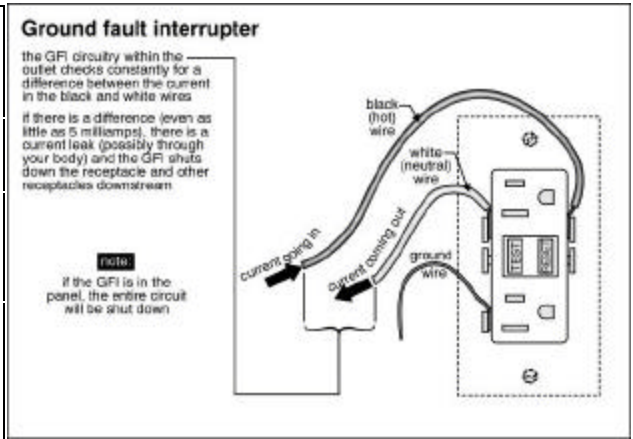
Did not observe GFCI protection of all outlets in required locations, including but not limited to; all bathrooms, all kitchen counter top outlets, wet bar locations, all exterior outlets, in garage, etc. This condition is a recognized safety hazard and is in need of repair.

- One or more outlets in the following locations were not protected:
- Kitchen counter
 - Kitchen island
 - Bathrooms
 - Garage Exterior
 - Wet bar Laundry sink
 - Pool area Spa / hot tub
 - Other:

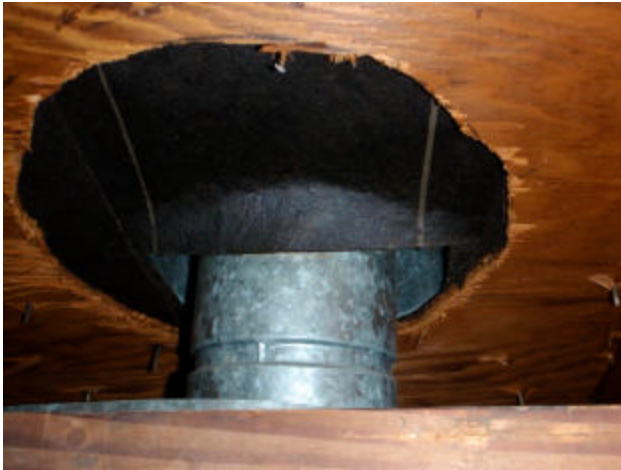
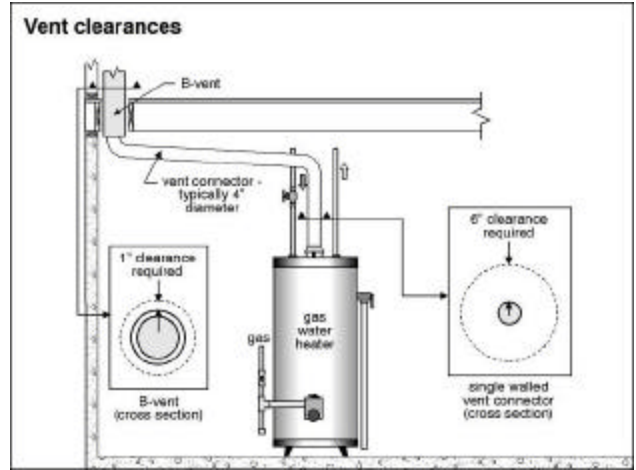
Exhaust vent pipe is in contact with combustible material, [tar/felt paper]. Current industry standards (code) require 1" clearance for double wall vent pipe.

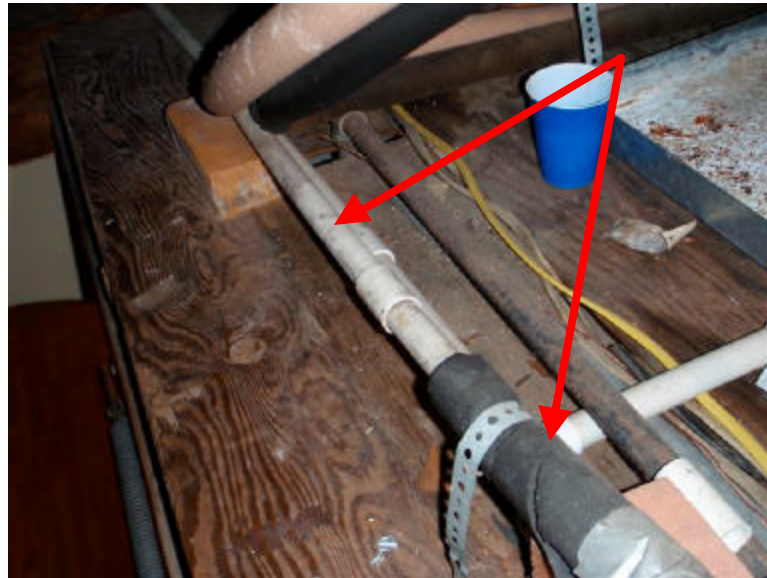
Primary drain line should insulated along entire length in attic to prevent warm attic air condensing on cool drain line and dripping condensation.

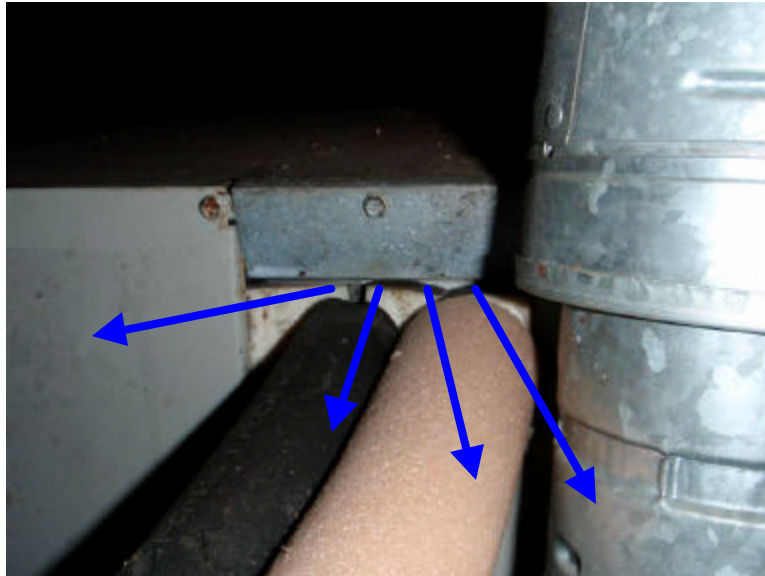
Excessive air loss at coil around drain and Freon line connections.

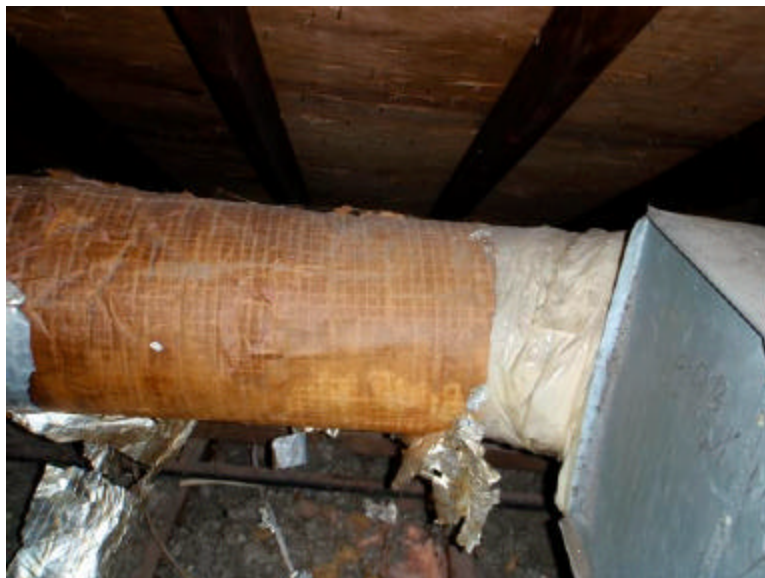
Some insulation missing and/or damaged on metal ducts in attic. Exposed metal ducts can sweat condensation, drip onto ceiling and cause moisture / water damage.

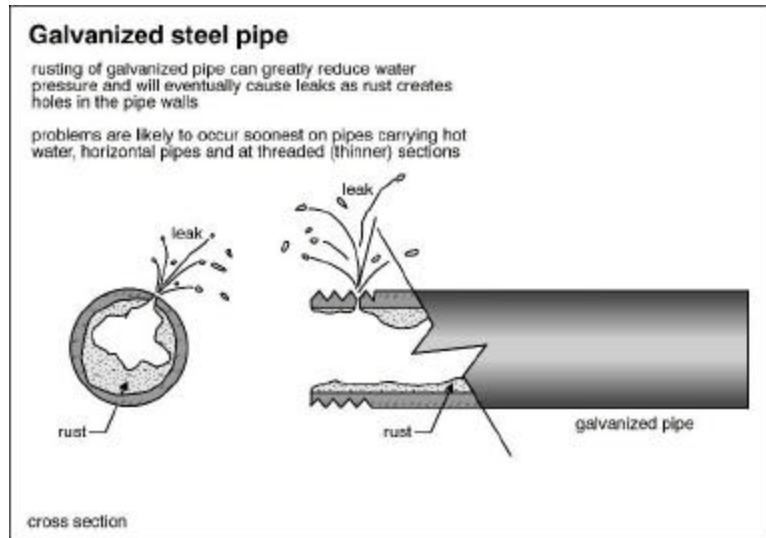
Water supply piping observed to be predominantly galvanized

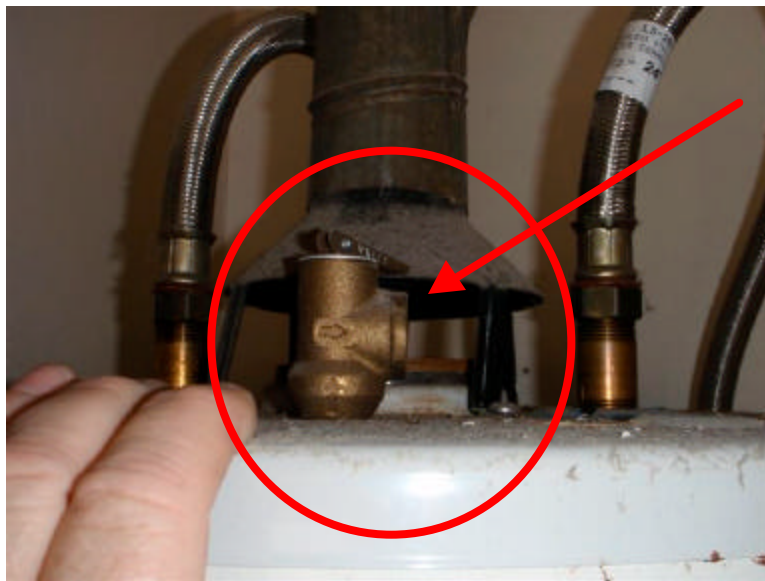
Drain line is not present. This condition is considered a recognized safety hazard

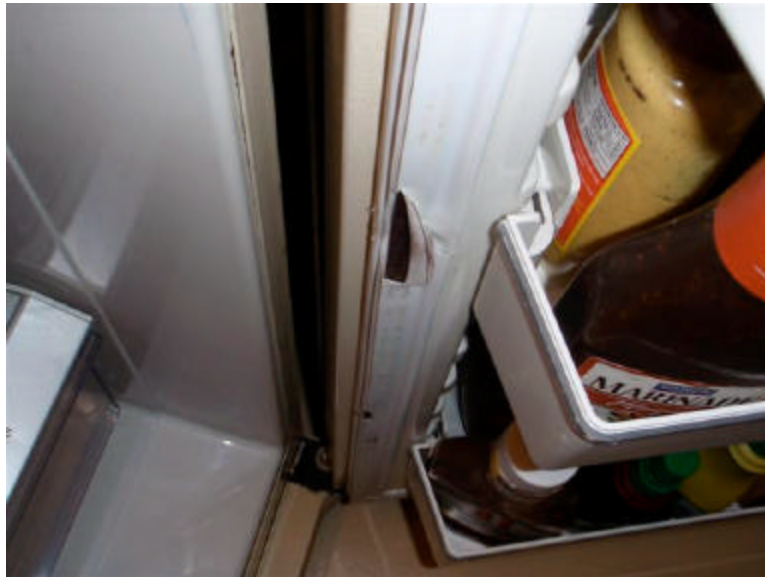
Door seal / gasket is worn / damaged.
