FIG Services LLC d/b/a FOX INSPECTION GROUP  
Forensic Inspection Report # 090302aw  
11227 Endicott Lane Houston, TX 77035  
(Office) 713.723-3330 (Email) [office@foxinspectiongroup.com](mailto:office@foxinspectiongroup.com)

**Concerning:** Northwest Freeway Houston, Texas 77040

This is a Thermal / Infrared Inspection on a Commercial Roof System

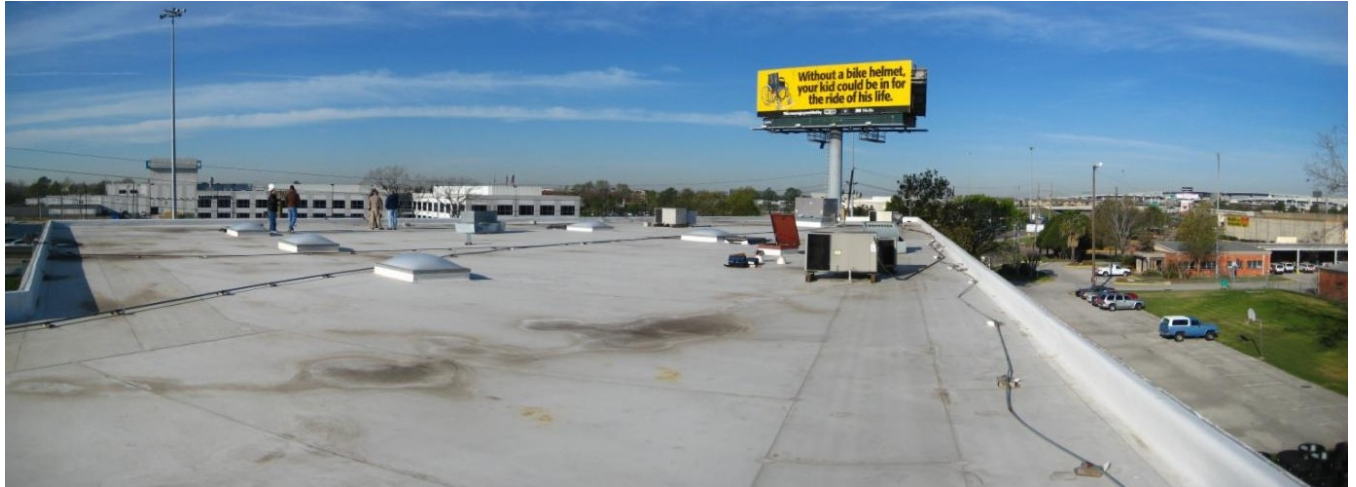
Wide angle picture of subject roof top

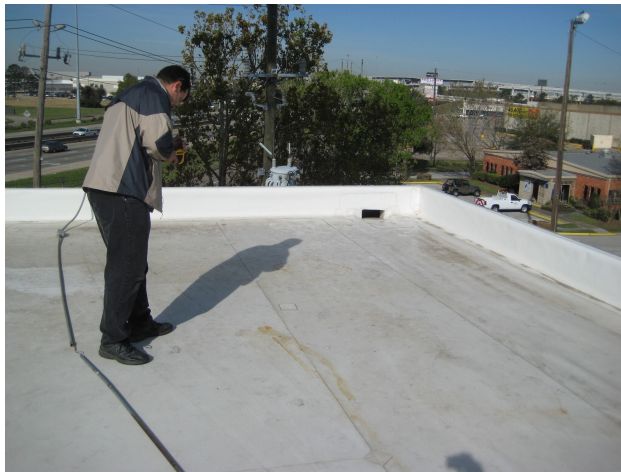
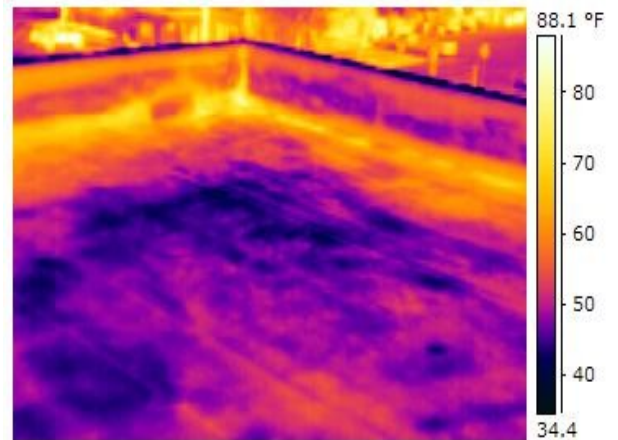
1. Thermal camera indicated multiple anomalies on the roof surface. Suspect areas were marked with orange paint.
2. Sections of roof were opened up by Civil Concepts at random areas and indicated moisture below the roof surface and/or powdered/soft concrete decking in some areas.

Photos were taken of thermal anomalies observed during the inspection. Darker areas indicate the possible presence of moisture.

1. Recommend further invasive testing on the sections of roof that have been marked with orange paint to confirm presence of moisture and condition of roof and deck materials.

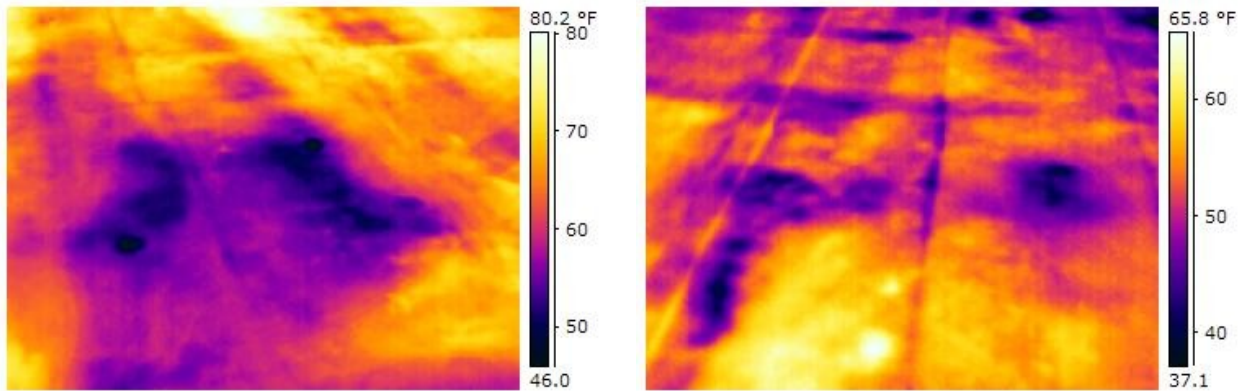
Large section of roof that was opened up near skylight. Membrane below top layer was rippled/wavy.
