**2008 New Construction Tanglewood Area**

# ***PROPERTY INSPECTION REPORT***

**Concerning:** 2008 New Construction Tanglewood Area, Houston, Texas  
77057  
(Address or Other Identification of Inspected Property)

March 10, 2009  
(Date)

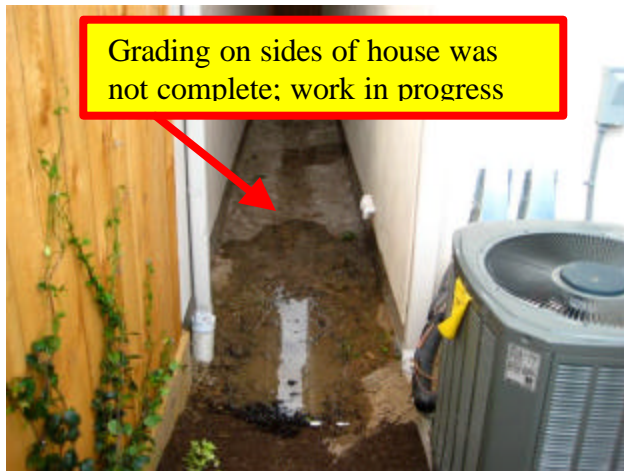
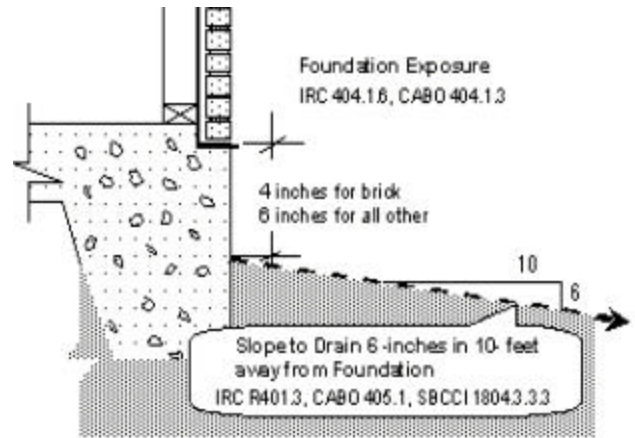
Soil grade and drainage patterns around some areas of house do not appear to properly direct water away from foundation to aid in controlling runoff water and could cause differential movement of the foundation or water penetration during heavy rains.

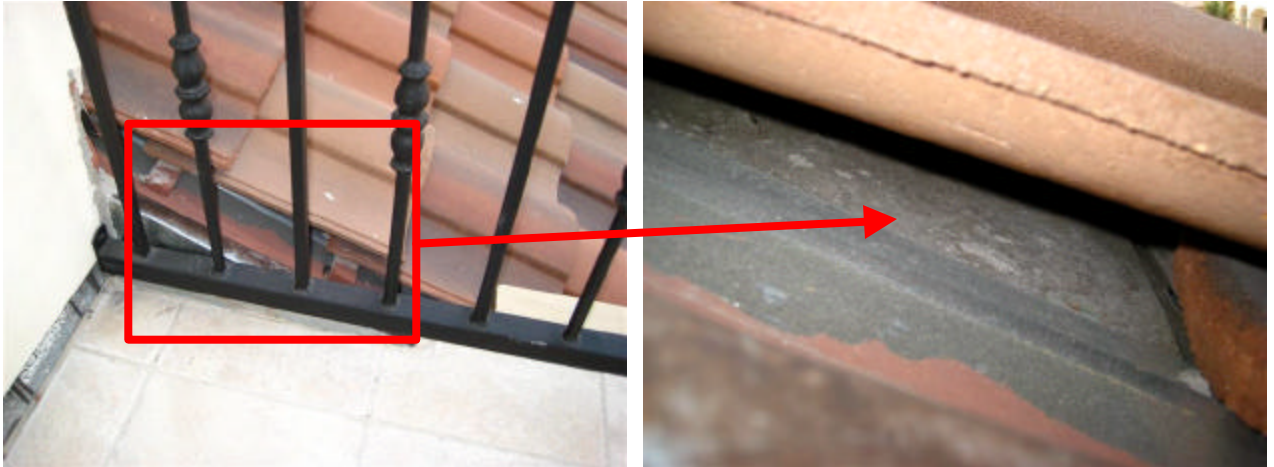
Edge of tile roof has not been terminated properly at 2<sup>nd</sup> floor balcony; tiles/flashing missing. Tar paper visible inside large opening.

Possible from section of roof at 2<sup>nd</sup> floor balcony that has not been terminated properly.

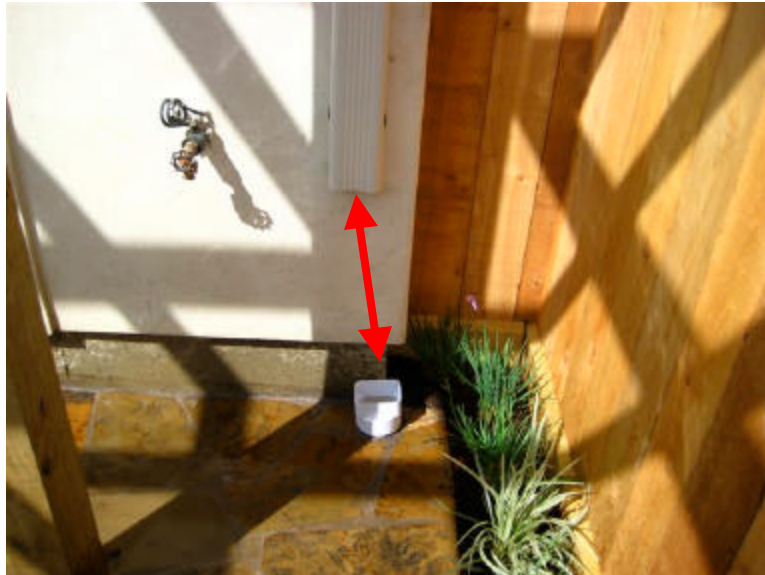
Downspout needs to be connected to drain at southeast corner.

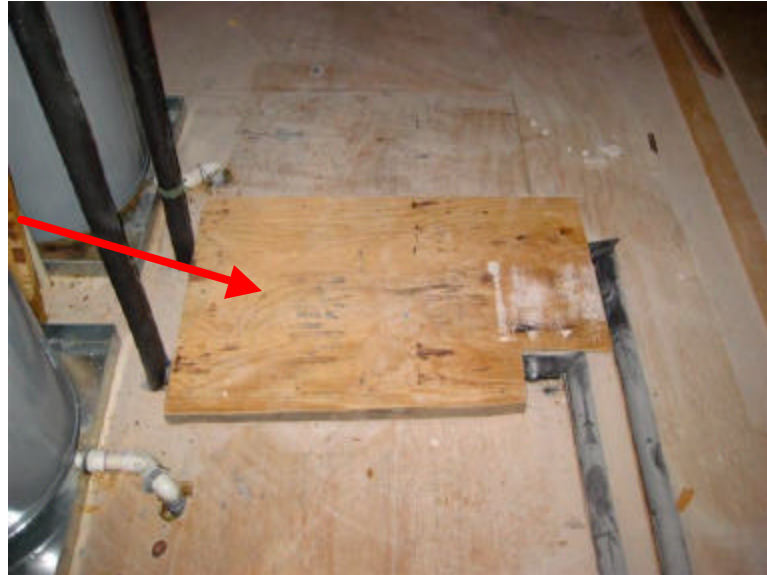
Platform over water heater lines needs additional support below; decking is weak.

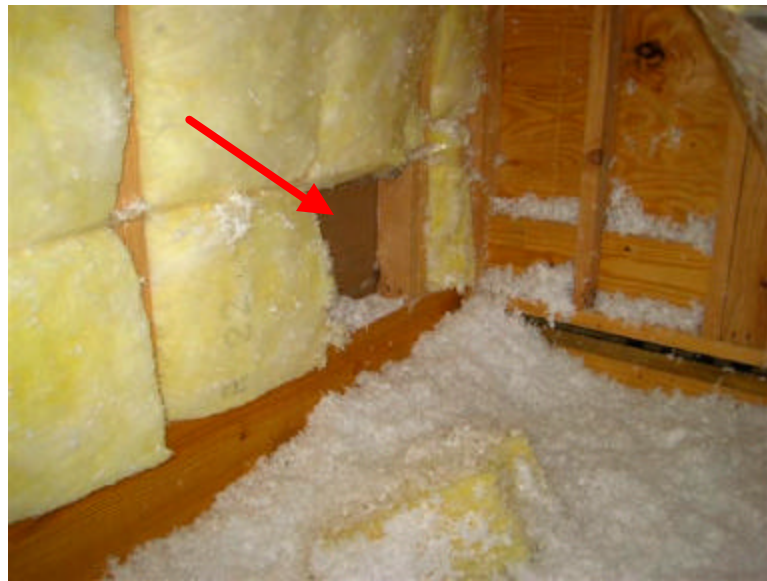
Vertical section of insulation has fallen down off interior wall in far section of attic.

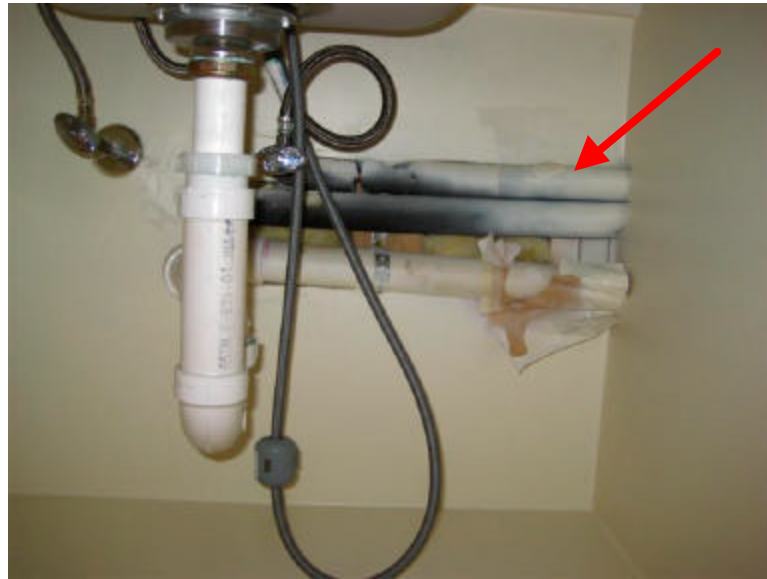
Hole in wall where plumbing lines pass through wall, below laundry room sink.

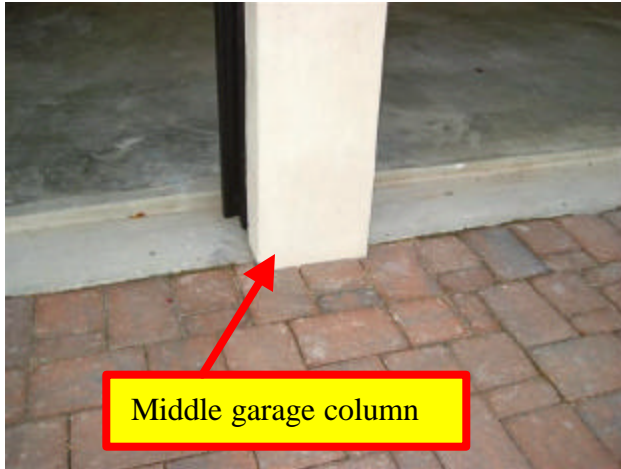
Inadequate space and / or missing weep screed at base of stucco. "Corrosion-resistant weep screed or plastic weep screed, with a minimum vertical attachment flange of 3 1/2 inches shall be provided at or below the foundation plate line on exterior stud walls in accordance with ASTM C 926. The weep screed shall be placed a minimum of 4 inches above the earth or 2 inches above paved areas and shall be of a type that will allow trapped water to drain to the exterior of the building." (Ref: IRC 2003 Section R703.6.2.1 Weep screeds).

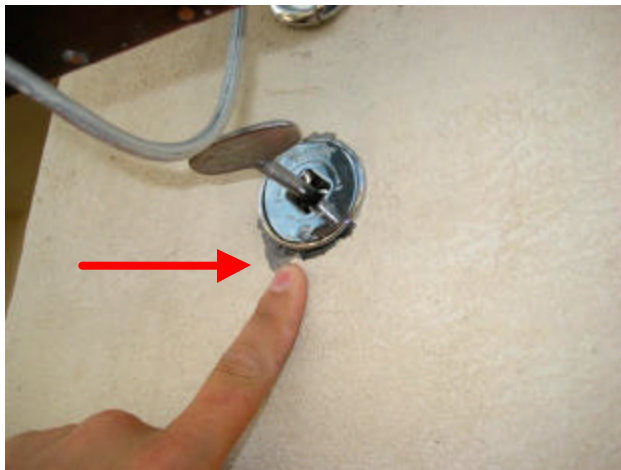
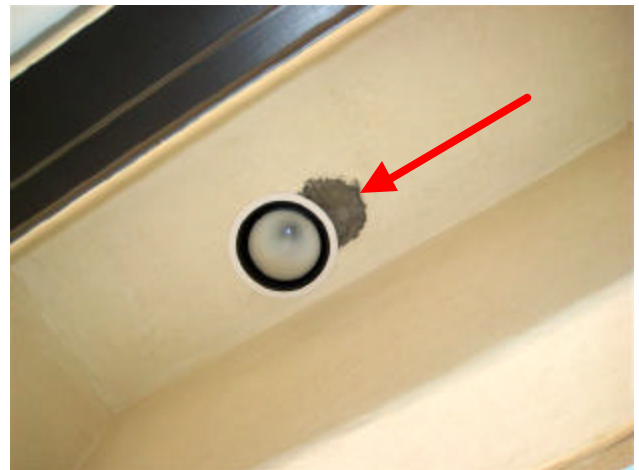
Stucco is in need of repair around gas lantern valve (on front of house) and 2<sup>nd</sup> floor exterior balcony light.

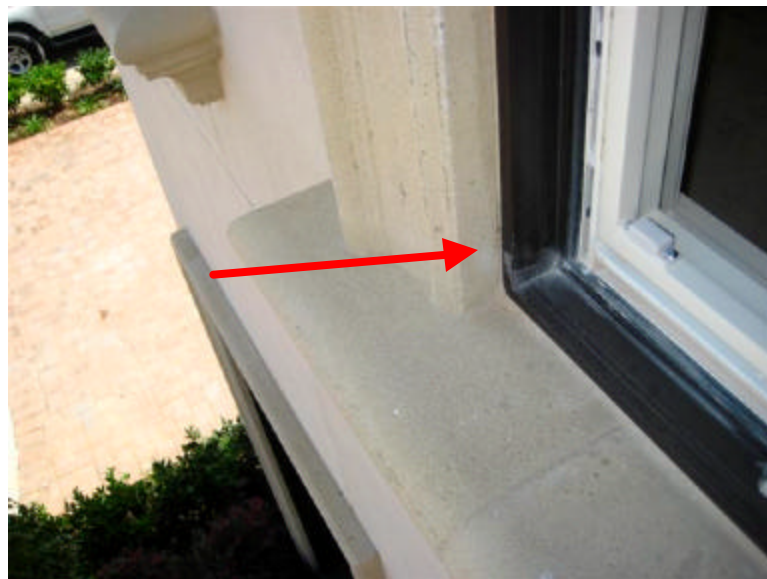
Grout/caulking needed around exterior of left master bedroom window; possible water entry point.

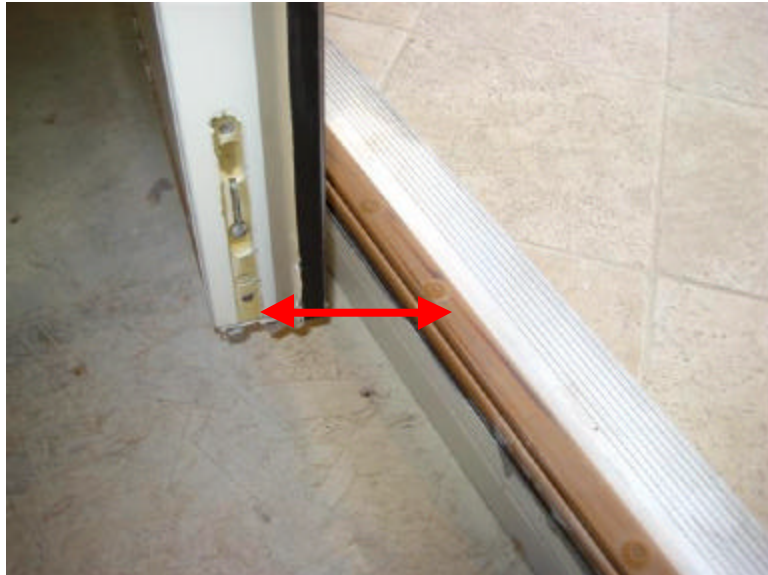
Lower lock receiver hole missing on 3<sup>rd</sup> floor balcony door threshold.

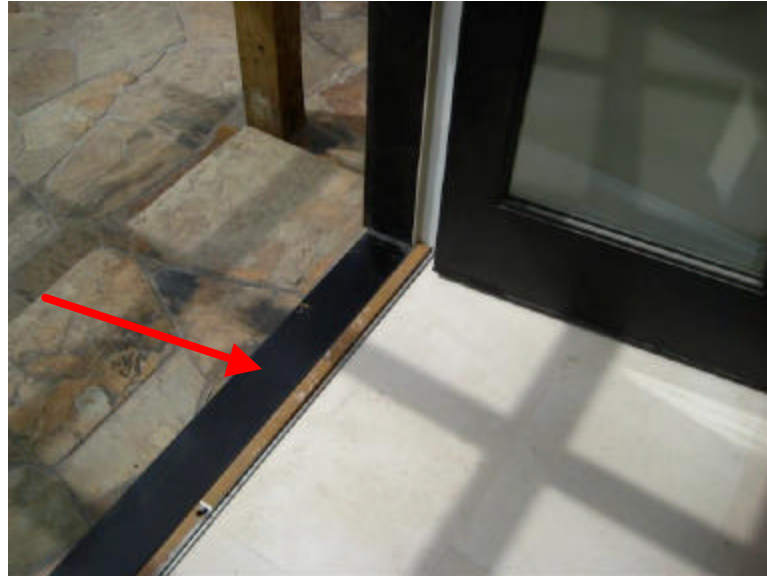
Improper threshold used on exterior doors (back doors) without roof overhang protection from wind driven rains will probably result in water damage from intermittent water entry. Recommend replacement with metal type threshold with rain water channels that directs water back to exterior.

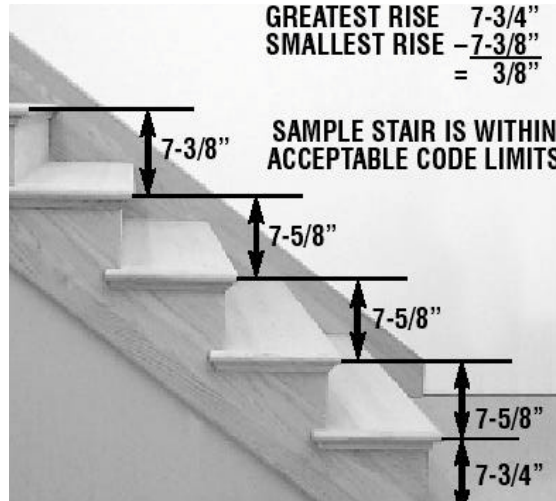
Third floor stairway has tripping hazard , Risers are not same height along the entire height of steps. Stairway does not comply with current industry standard, (code). CABO 314.2 & UBC 1006.3 requires "The greatest riser height within any flight of stairs shall not exceed the smallest by more than 3/8 inch."

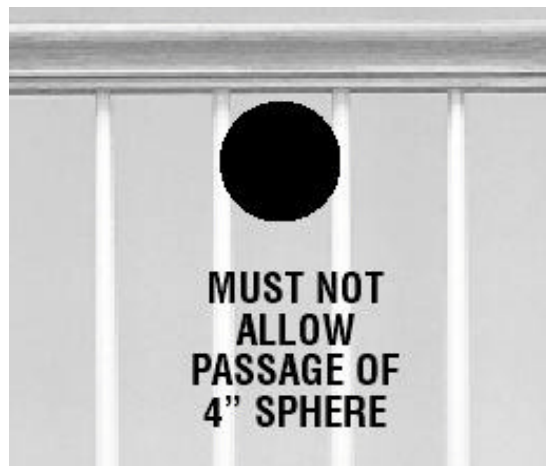
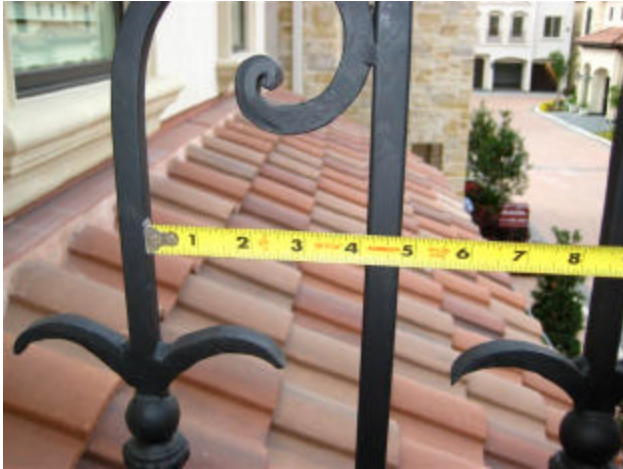
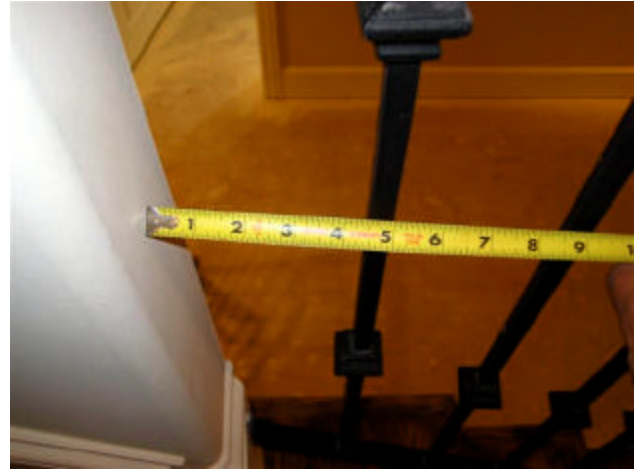
Space between railings does not comply with current industry standard, (code) UBC 421.1.1 & CABO D105.2.1. Requires spacing between intermediate rails do not allow passage of an object four inches in diameter. Recommend covering large openings in stair rails with temporary type nylon netting if small children are present in house to prevent injury. Condition present at interior of house and balcony railings.

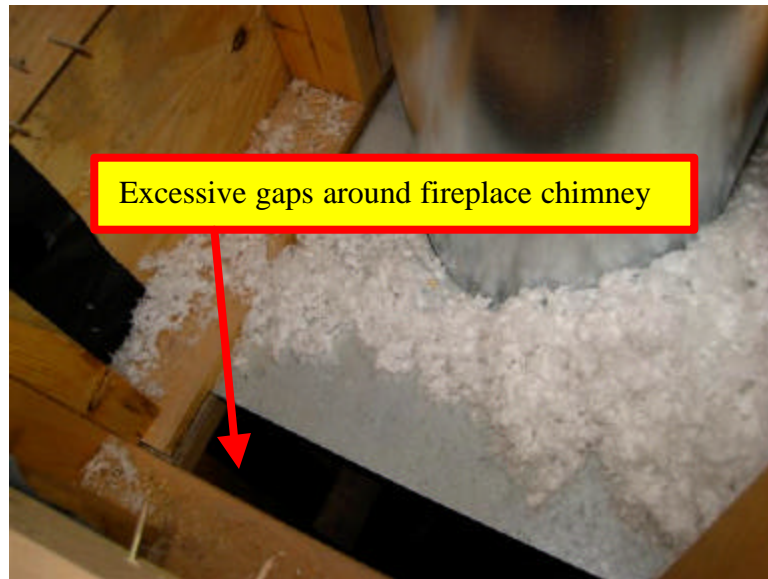
Chimney is not properly fire stopped in attic ; Does not comply with the 1992 CABO One and Two Family Dwelling Code section R-402.7 IRC R1001.16.

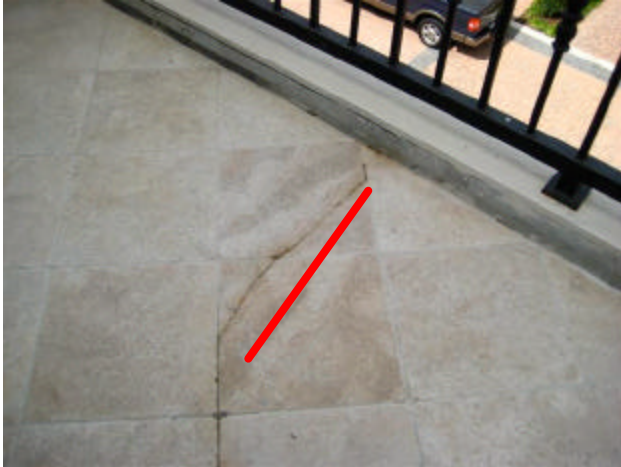
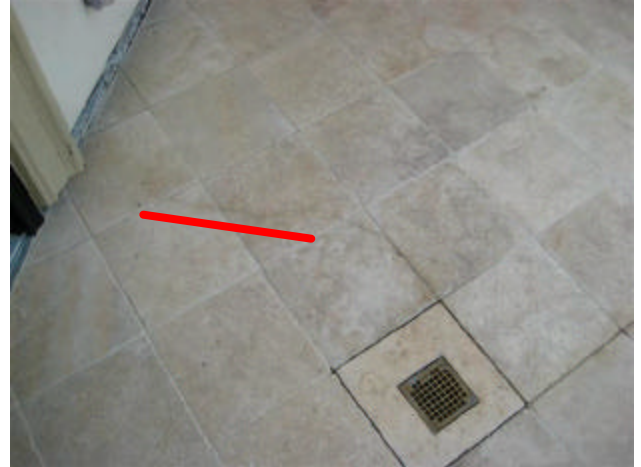
Cracks observed in tile at 3<sup>rd</sup> floor balcony.

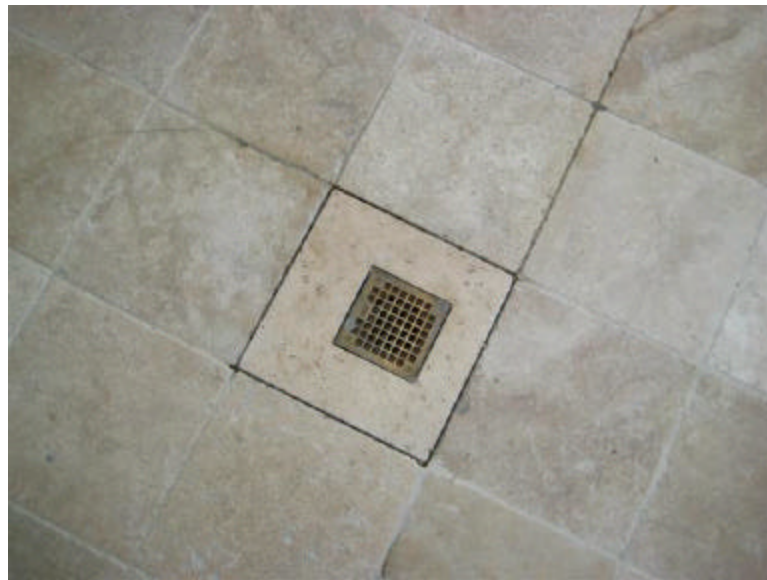
Tile around drain needs to be grouted.

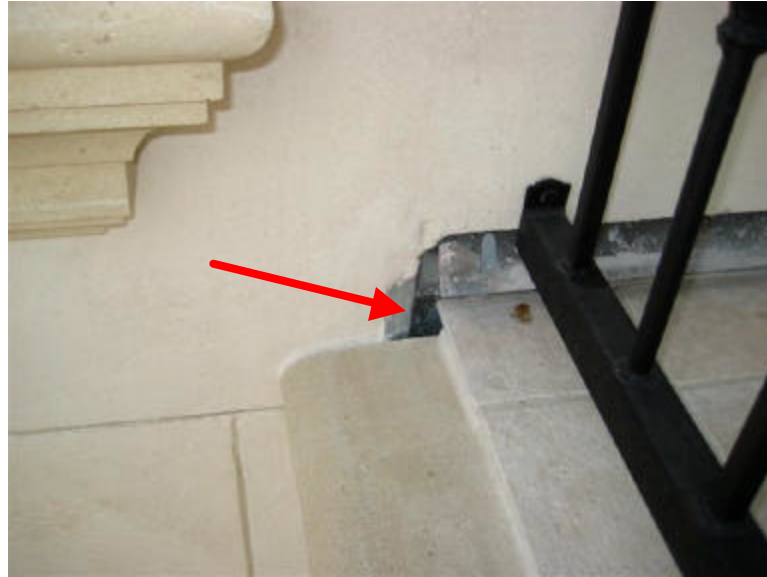
Excessive gap observed around flashing at 2<sup>nd</sup> floor balcony.

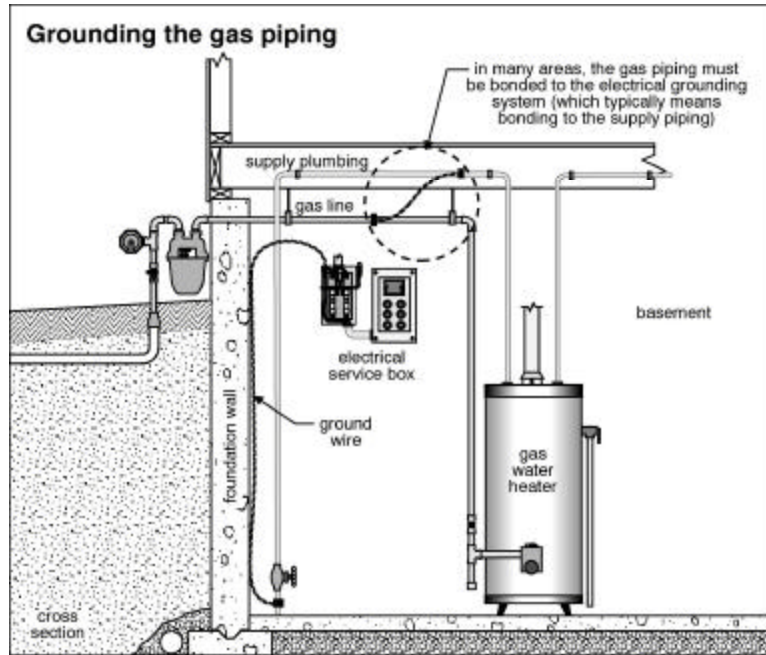
Gas and hot / cold water lines are not properly bonded near water heater. Does not comply with most recent electrical code. NEC 250-80b.

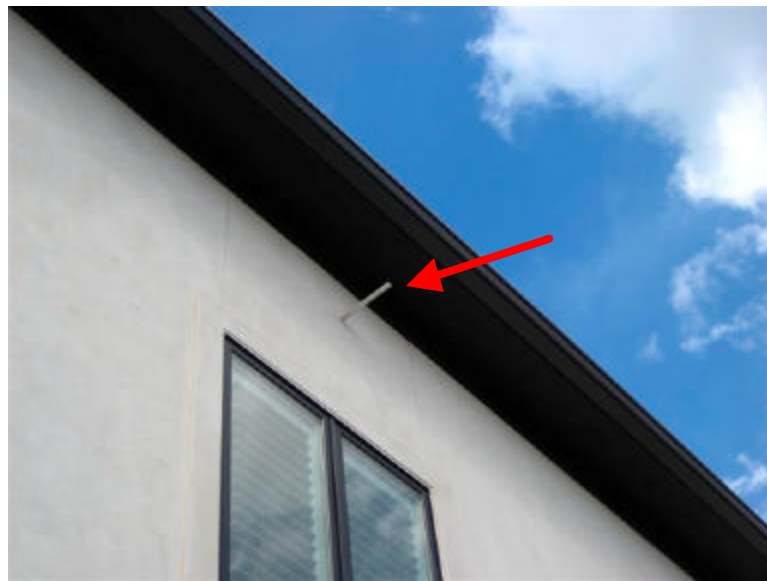
Missing 90 degree elbow fittings on end of emergency drain lines to prevent condensation dripping back onto exterior wall.

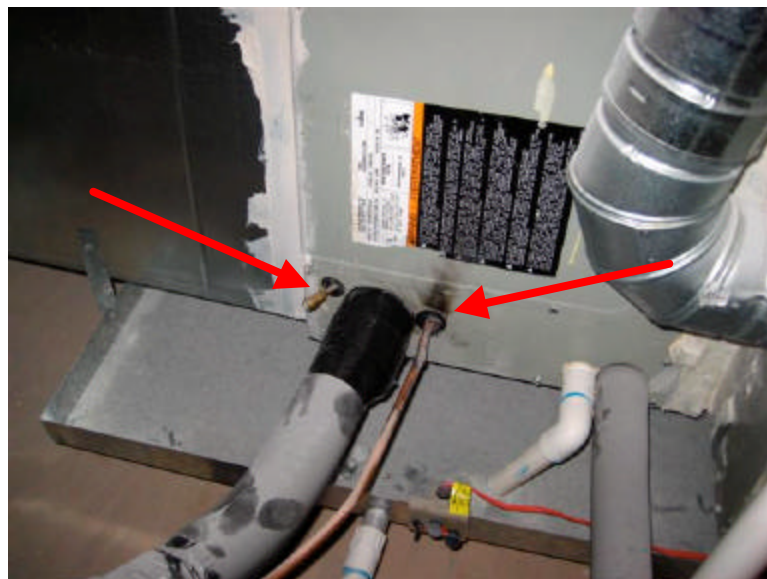
Excessive air loss at coil around drain and Freon line connections; both units.

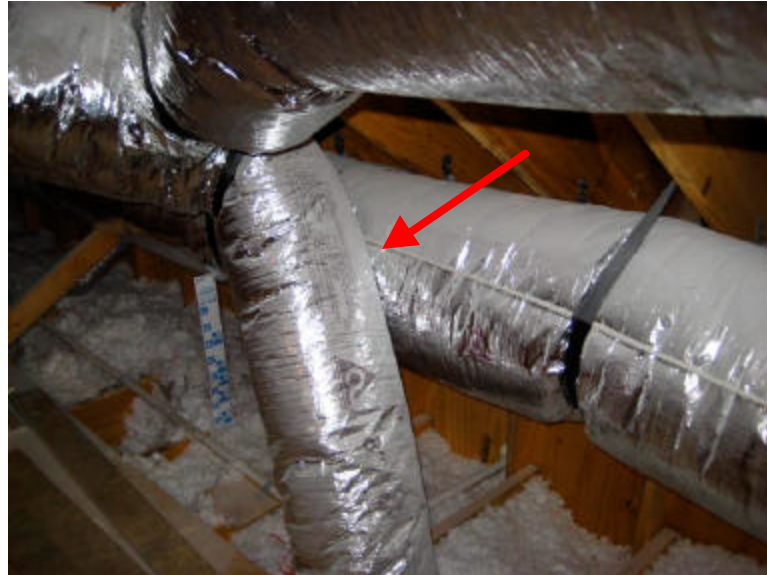
Observed several / multiple areas in attic where flex duct touch and are missing manufacturer required 1" clearance from other ducts to prevent condensation between ducts that touch.

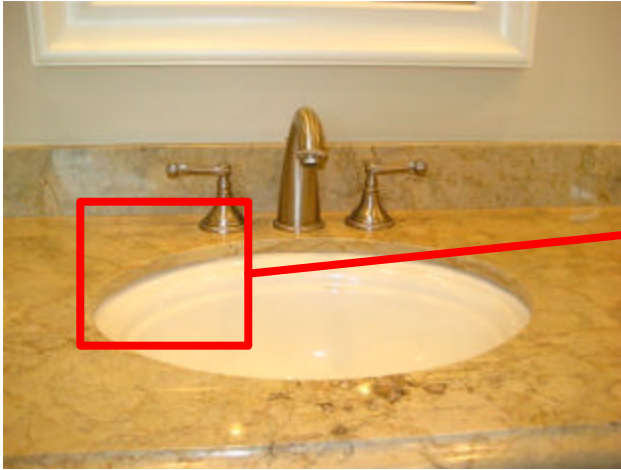
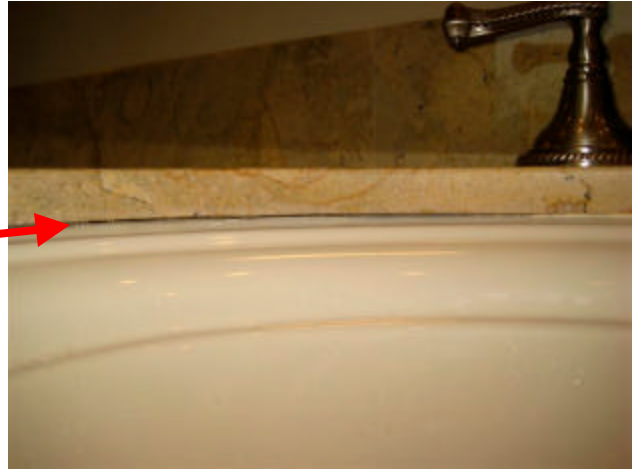
Bath sinks need additional caulking around rim of sink where it meets counter.

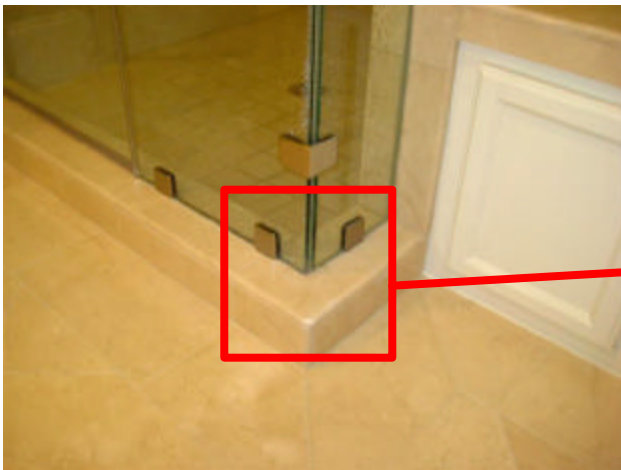
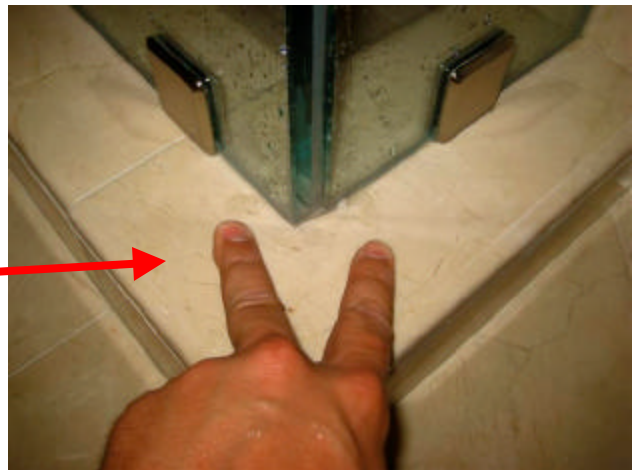
Master bath shower enclosure leaks water.

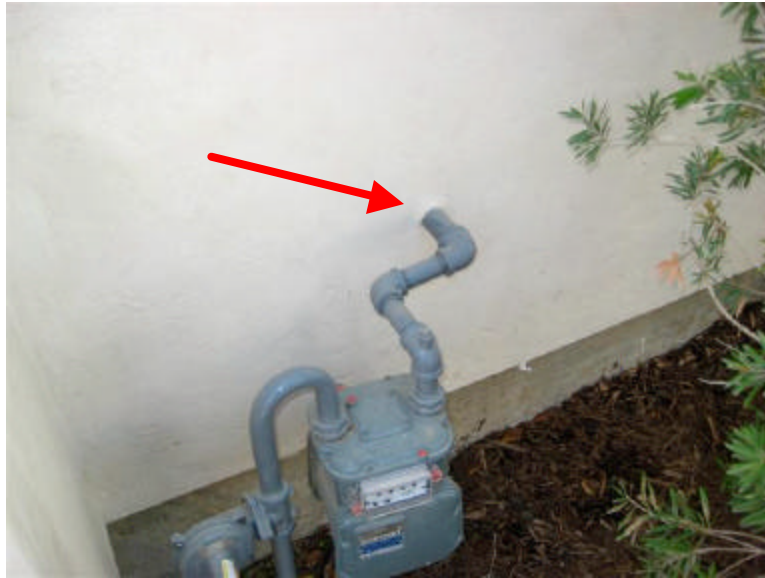
Unable to confirm if gas piping is sleeved where it passes through wall as required by Code [CABO 2608.3] IRC 2603.3.
