1950 Oakforest Home Inspection Report

PROPERTY INSPECTION REPORT

Concerning: 1950 Oak Forest area, Houston, Texas 77018
(Address or Other Identification of Inspected Property)

April 3, 2009
(Date)

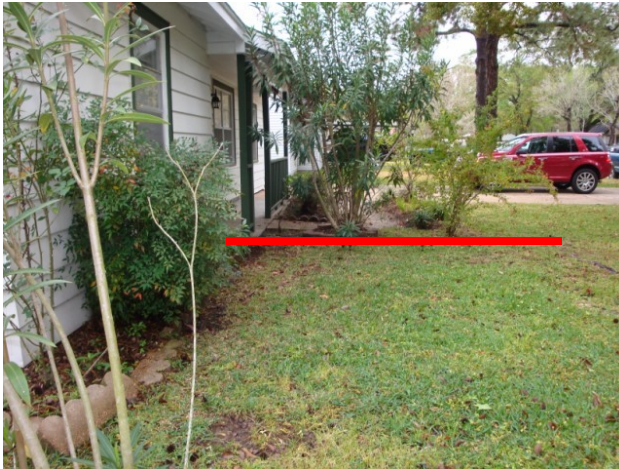
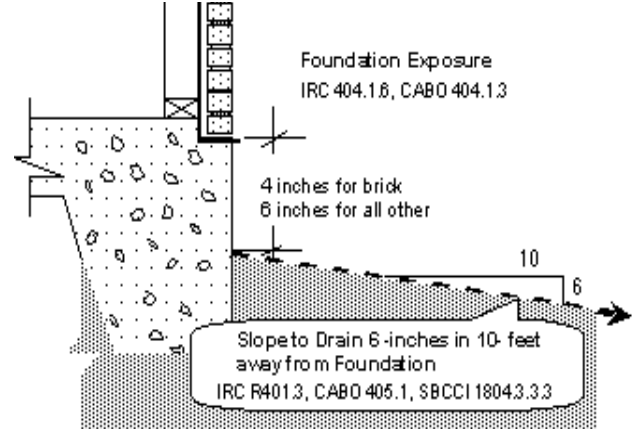
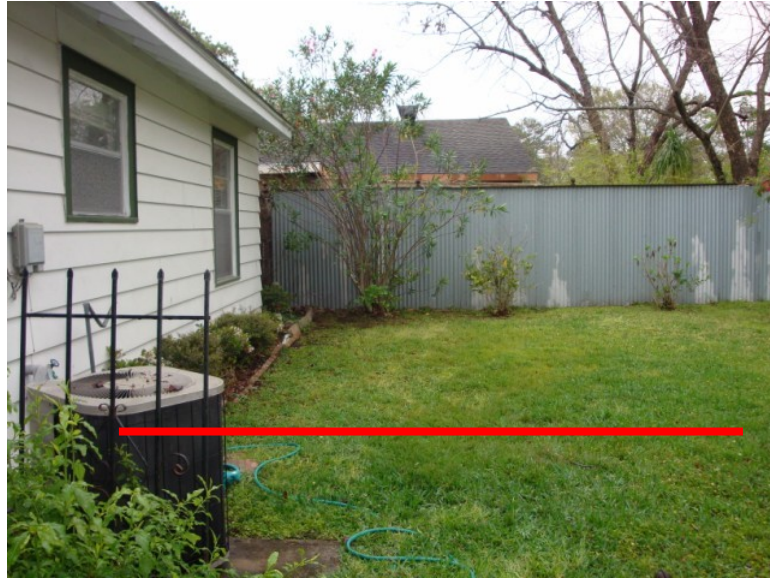
Soil grade and drainage patterns around some areas of house do not appear to properly direct water away from foundation to aid in controlling runoff water and could cause differential movement of the foundation or water penetration during heavy rains.

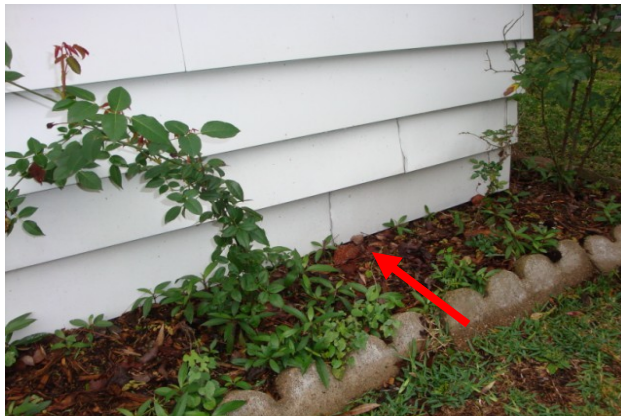
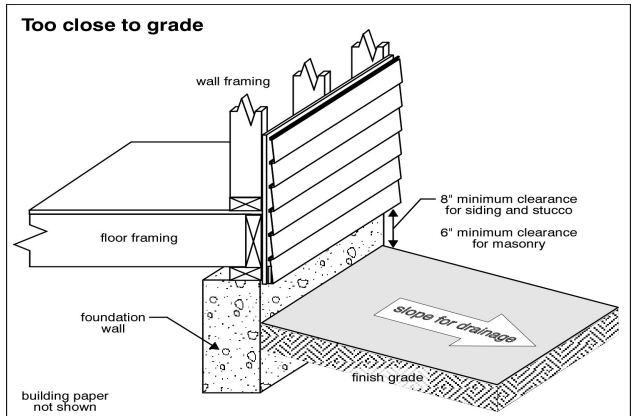
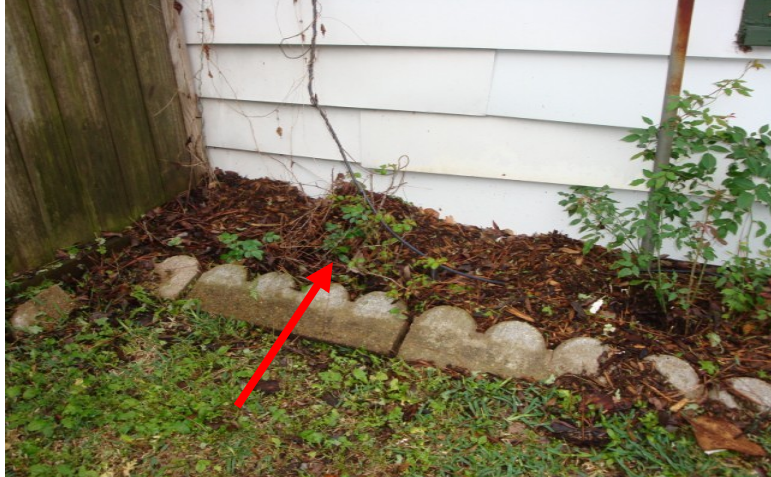
Soil level too high around areas with wood siding. Code and common industry practice requires a clearance of 6-8 inches from bottom of wood veneer to soil. High soil level near wood siding promotes water/termite penetration and wood rot.

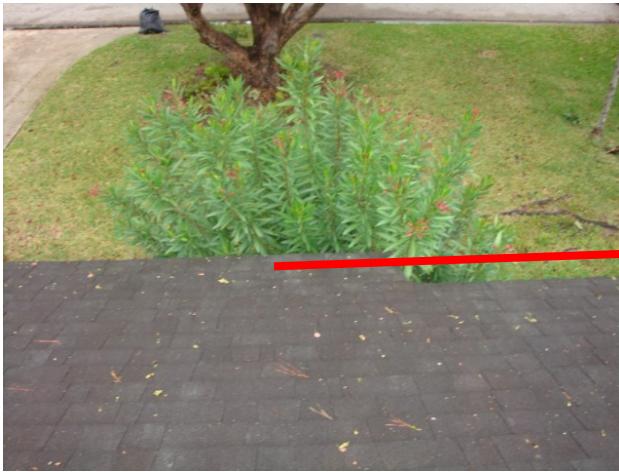
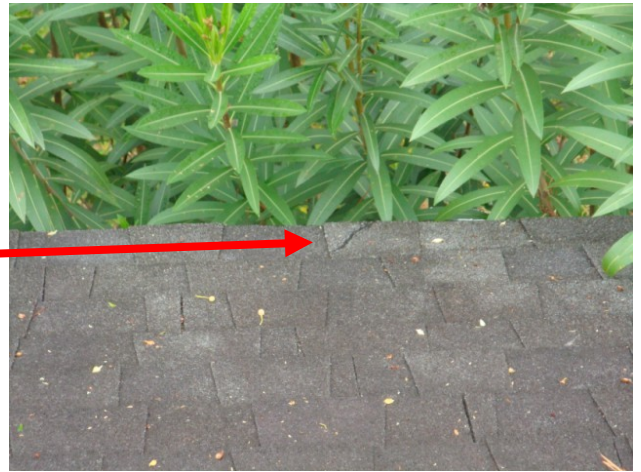
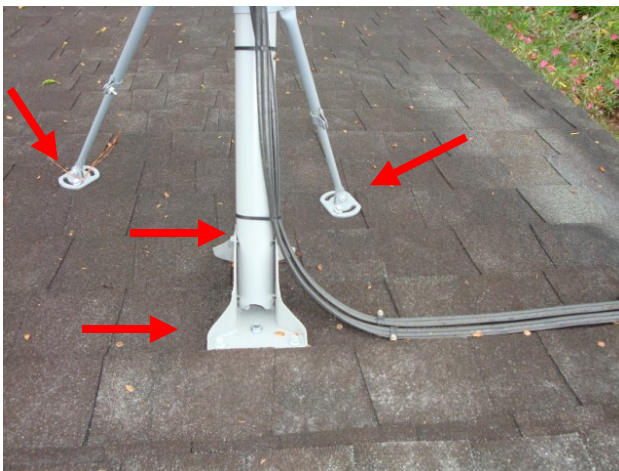
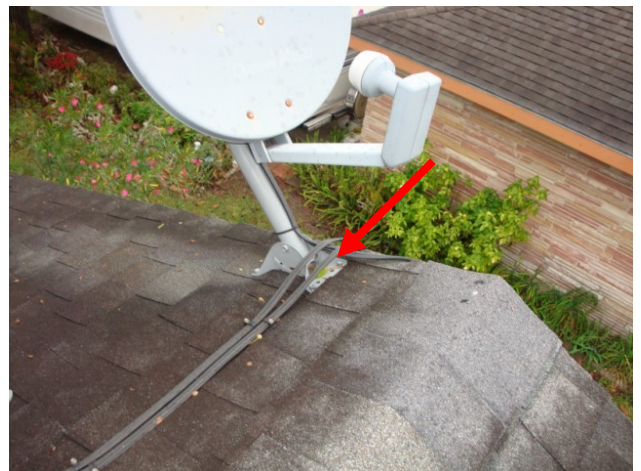
Areas that need immediate attention, are at the front lower area and the multiple satellite/ antenna mounting locations where fasteners have not been caulked.

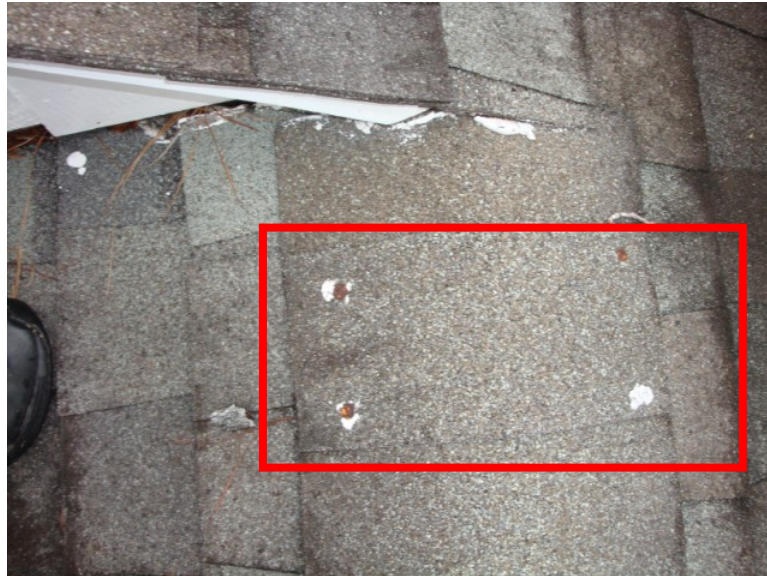
Exposed staples / nail heads / fasteners observed on roof, all exposed fasteners should be sealed to prevent water entry.

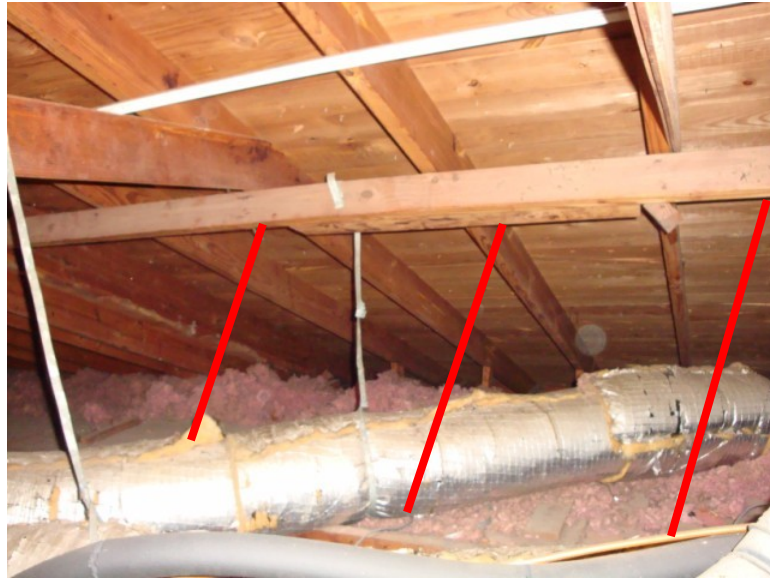
Observed insufficient purlin (roof bracing) supports in attic, needs additional purlin struts at 4 foot centers down to load bearing walls for proper roof support.

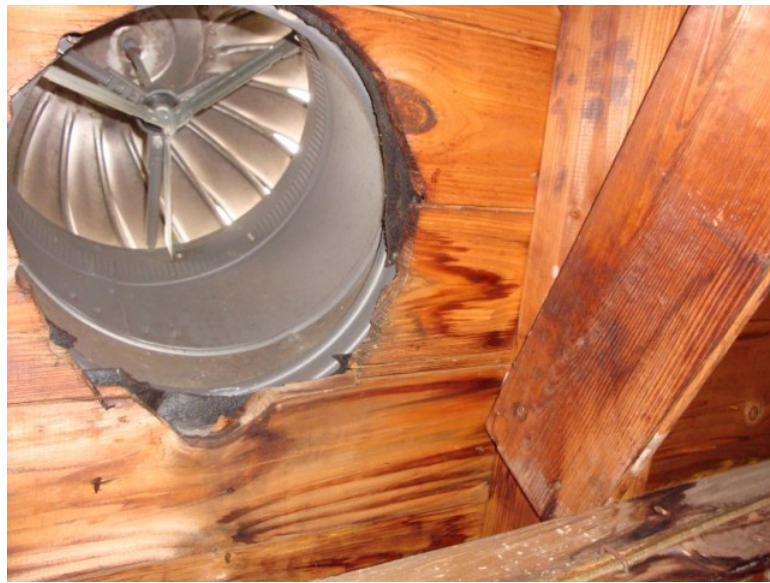
Water stain(s) observed in attic at attic vent.

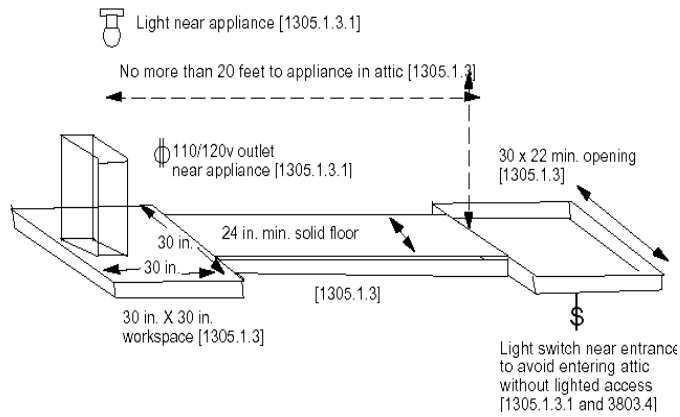
Inadequate attic walkway and/or platform to mechanical equipment in attic. Code violation, [UMC 908 & CABO 1401.5] requires 30 inch head clearance and a minimum 24 inch wide SOLID (no gaps or obstructions), floor to equipment for servicing and a 30 inch deep solid platform in front of equipment.

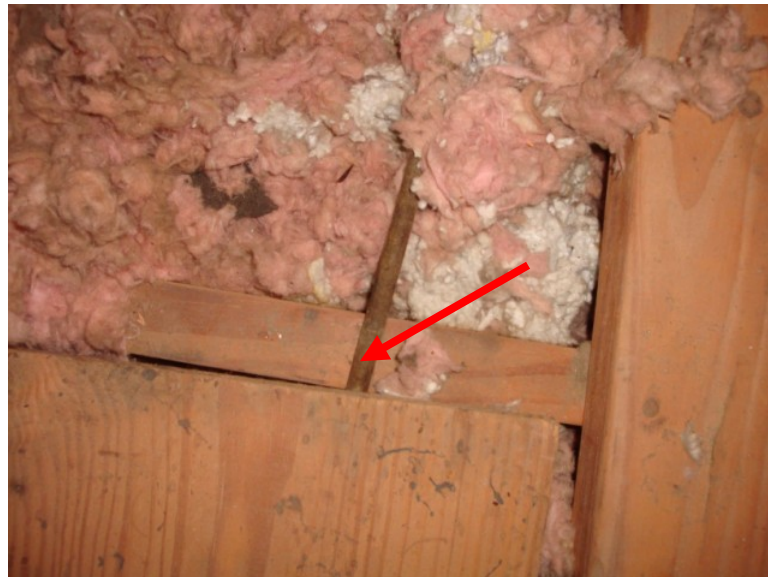
Floor decking in attic improperly installed over electrical wiring running over ceiling joist, pinching electrical wiring between deck and ceiling joist, fire hazard.

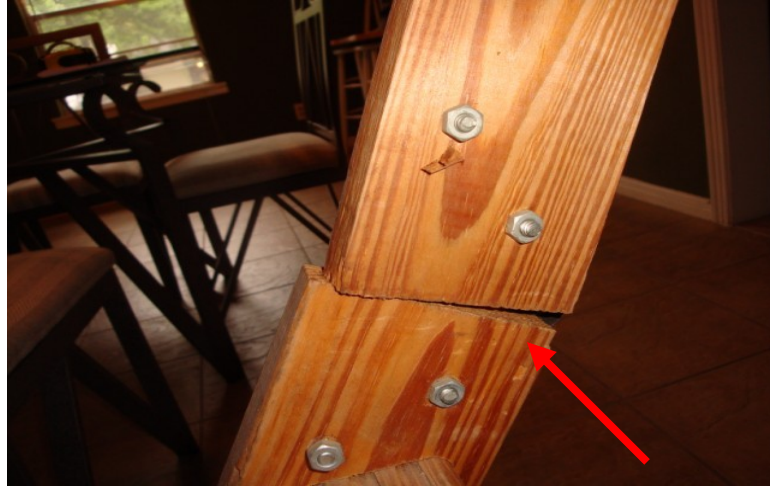
Not cut to fit properly, which puts undue stress on ladder; there should be no gaps at section ends.

Tighten loose / replace missing nuts and bolts on stairway sections.

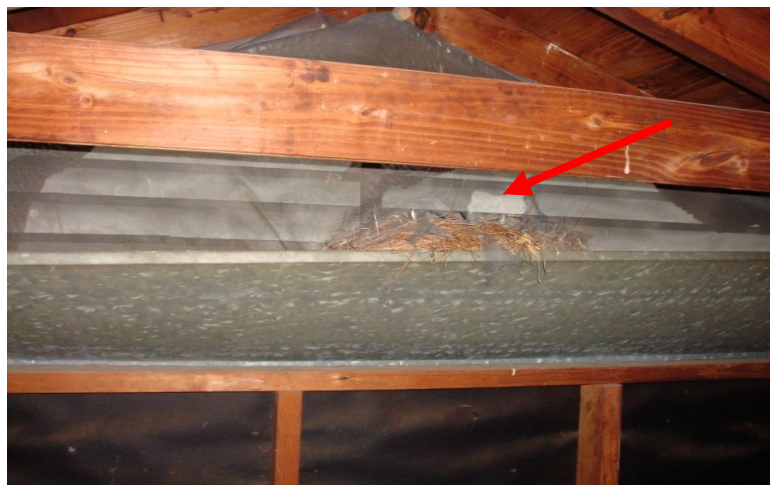
Gable vent screening damaged / torn at both ends.

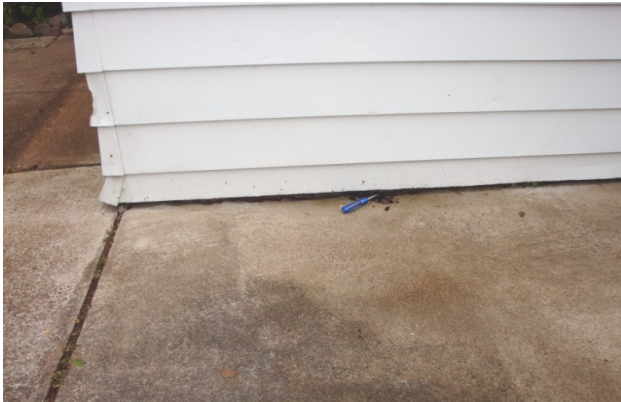
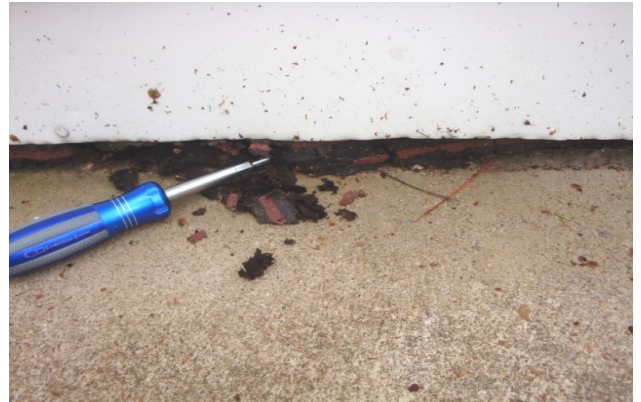
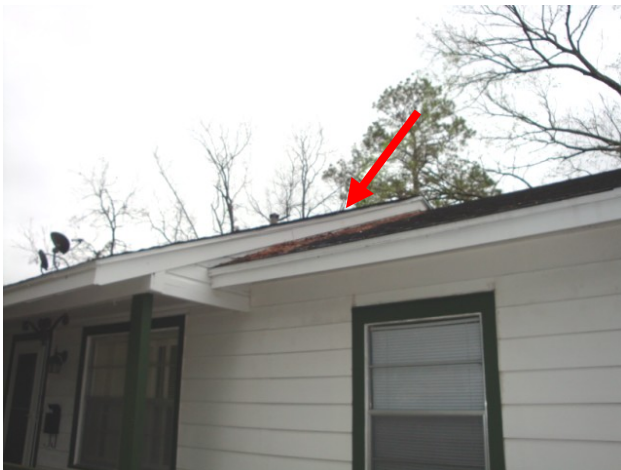
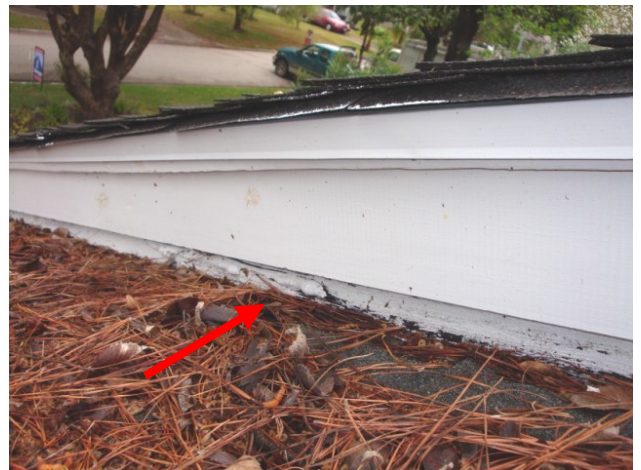
Wood rot observed on areas of house / garage. It appears the aluminum siding was installed over wood siding. Wood rot observed at the dining room/ driveway area.

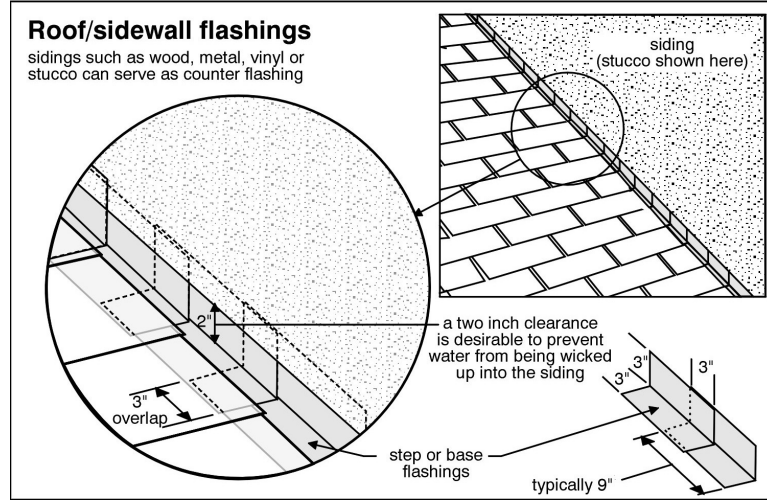
Most wood siding installation requirements specifically state “Leave 2” clearance between roofing and bottom edge of siding to prevent wood rot. Did not observe the normal 2” clearance from roof surface

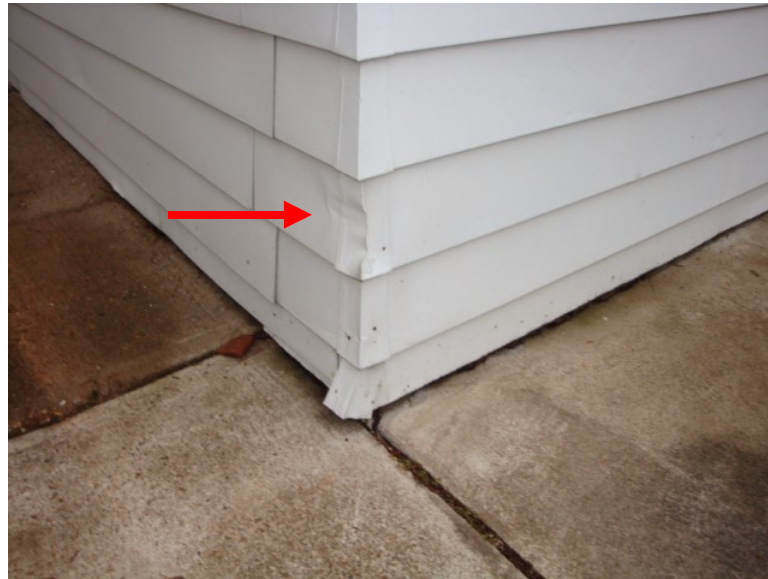
Damaged siding observed at the dining area corner.

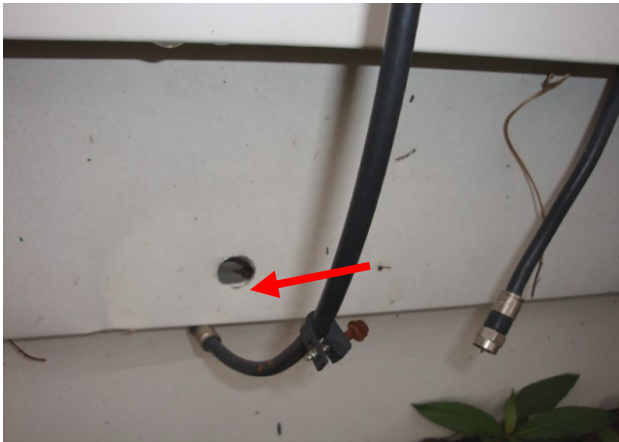
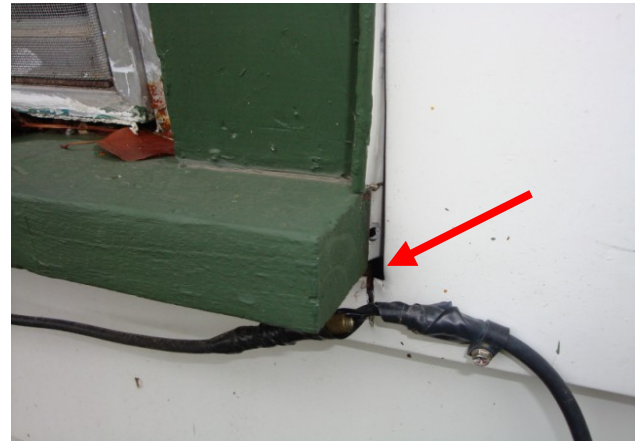
Multiple areas observed where aluminum siding may allow water penetrations.

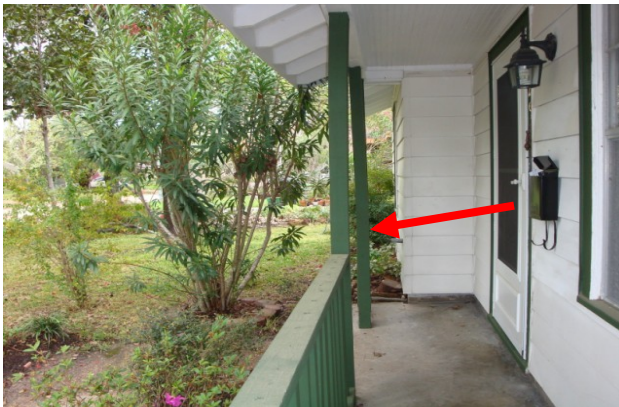
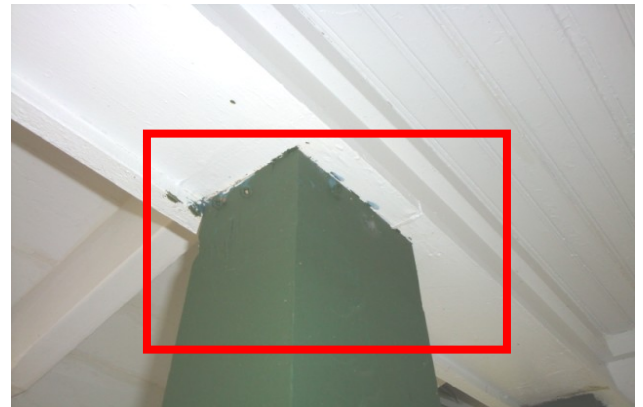
One of the wood columns is warping severely and the hand rail has detached as a result. The columns are not secured at the bottom with anchors and are simply toe nailed (screwed) at the top.

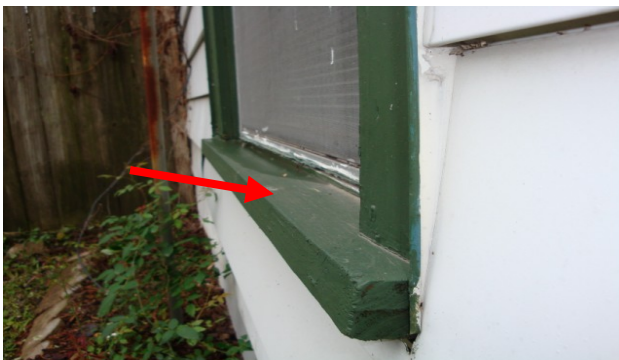
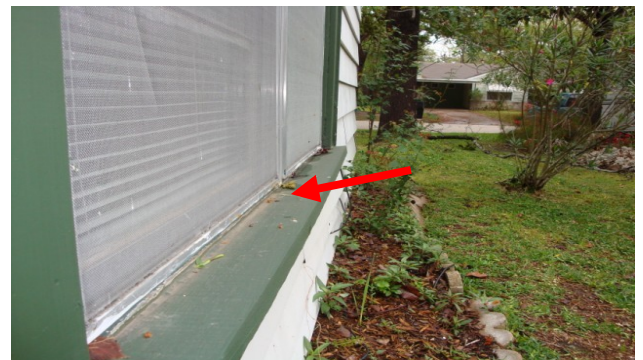
Window sills slant toward the windows. This makes windows more vulnerable to water penetration.

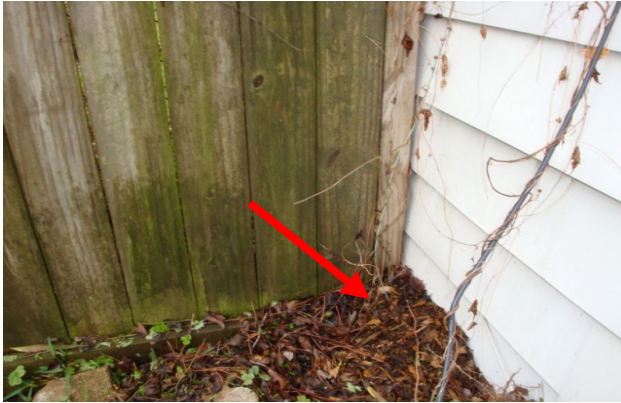
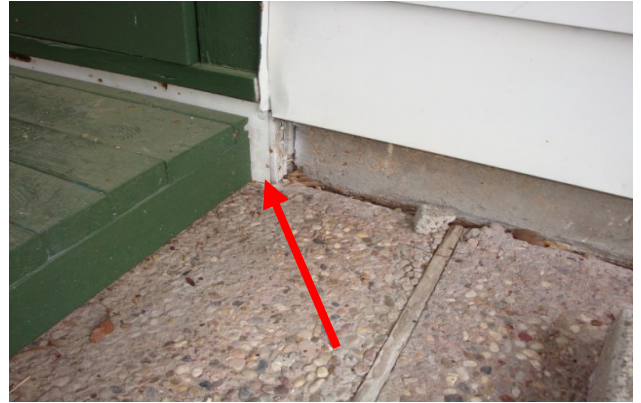
Earth wood contact in some areas, conducive condition to termite activity and wood rot.

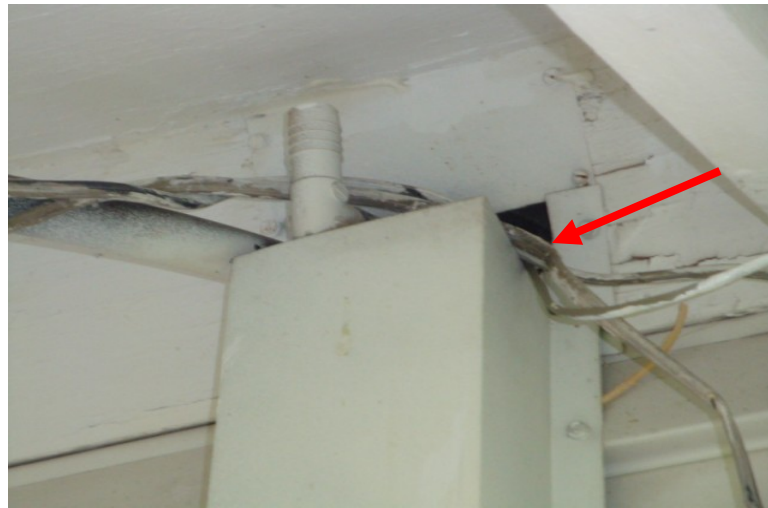
Potential rodent entry, where HVAC lines enter attic.

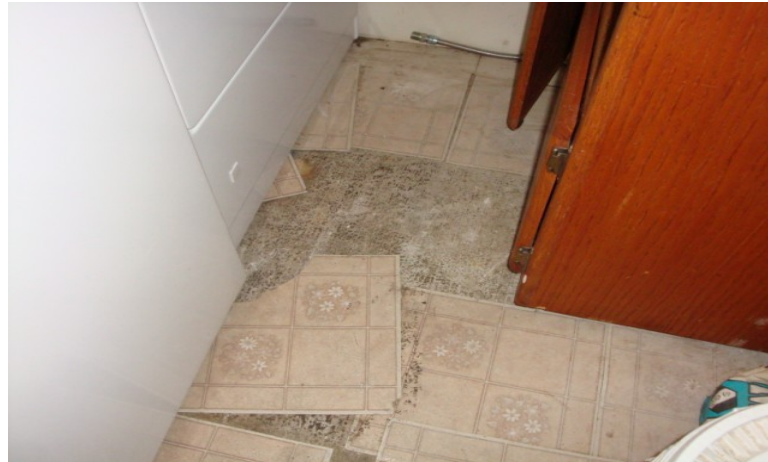
Observed one or more floor tiles not properly bonded to the slab/ sub floor and / or lifted in laundry room.

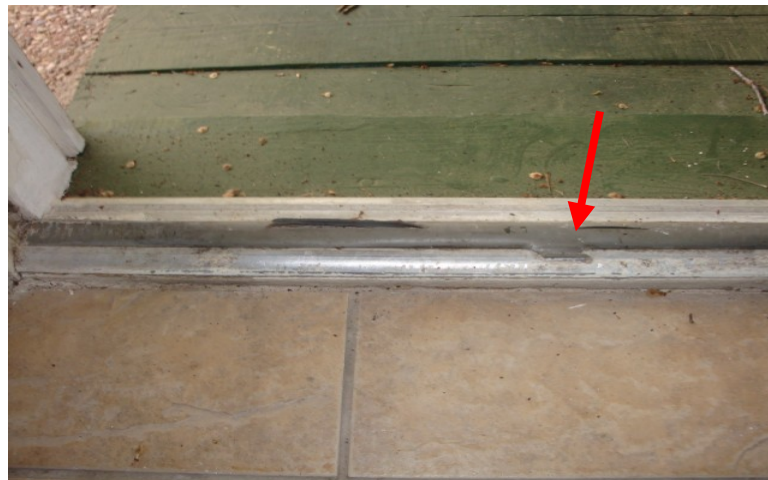
The back door jamb is not square/ plumb and the door sticks. There is no weather seal present and the threshold weather strip is damaged.

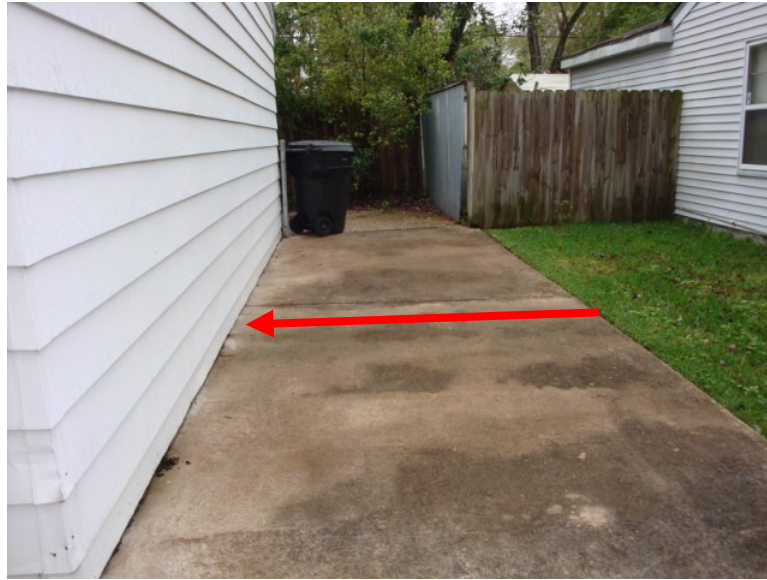
High soil and driveway obscures view of foundation and prevents visual inspection for termite and/or water penetration.

Driveway improperly slopes towards house. This condition tends to encourage water penetration during heavy rains.

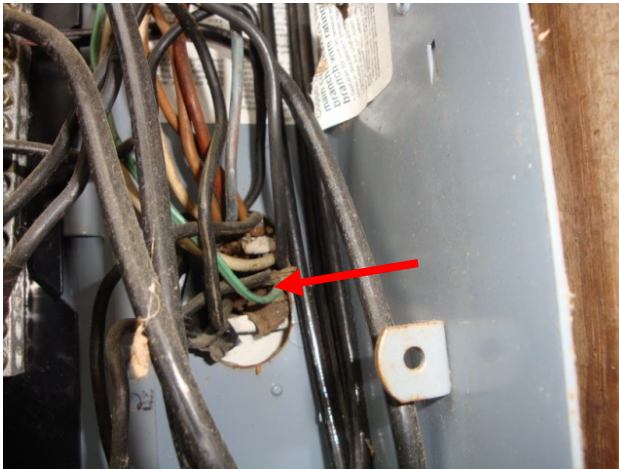
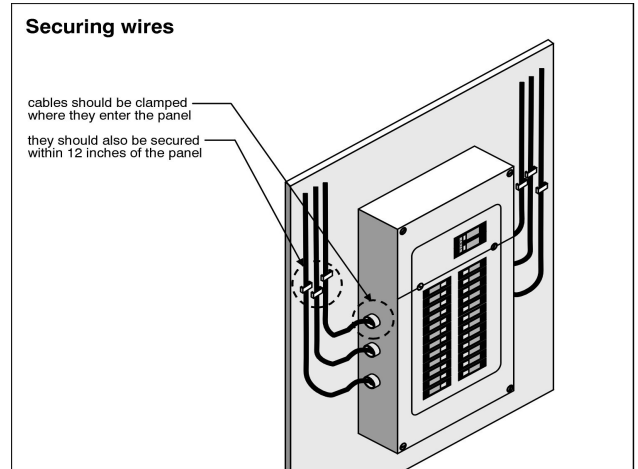
Dead front missing one or more securing screws. Need to ensure screws used do not have sharp / pointed ends that can penetrate live electrical wiring behind dead front and cause shock, fire, serious injury, and /or death.

Protective bushing not present around electrical wire as it passes through metal box.

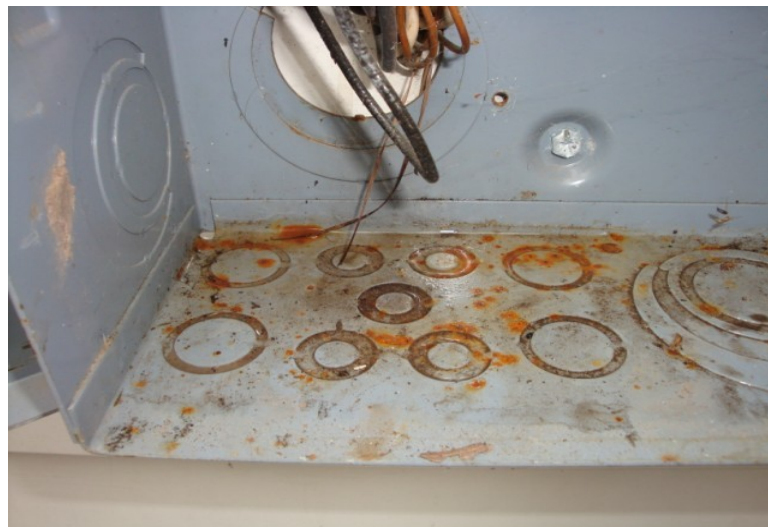
Water is entering the panel. Water observed in the feeder wire and rust noted at the bottom of the panel.

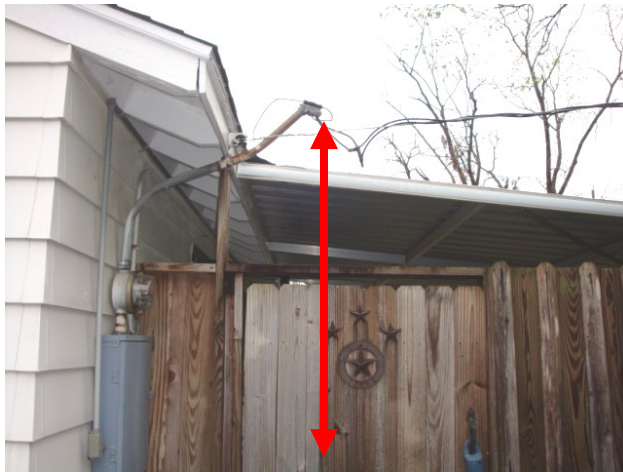
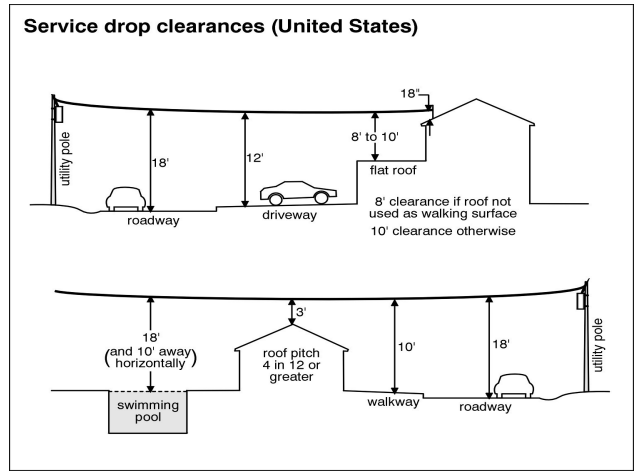
Low elevation of power lines at/near house/garage, electrocution hazard. Code requires a minimum clearance of 10 feet & 12 feet over walkways and driveways respectively; use caution when near, or have lines raised/buried.

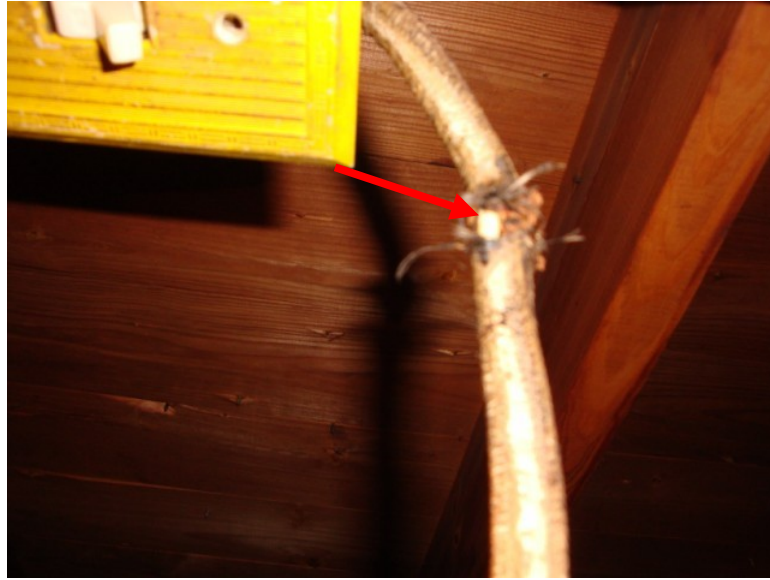
Romex outer insulation damaged at HVAC disconnect.

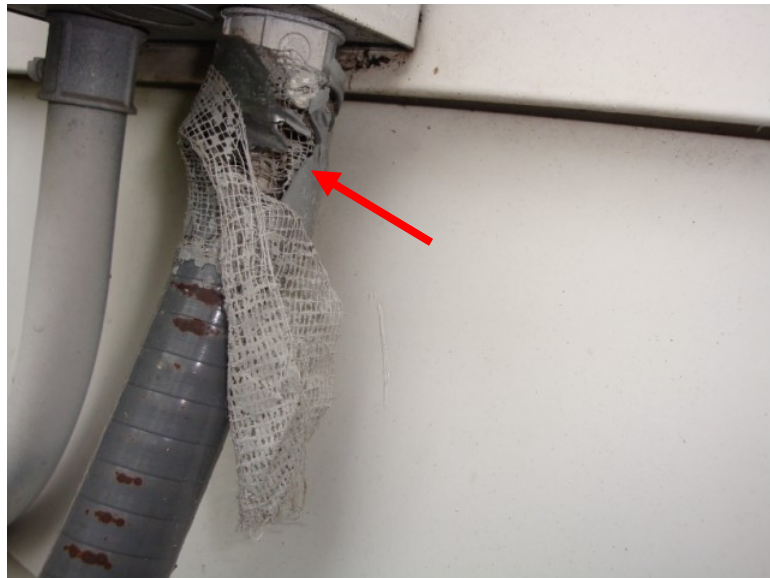
Electrical conduit is not secured to base of condensing unit disconnect.

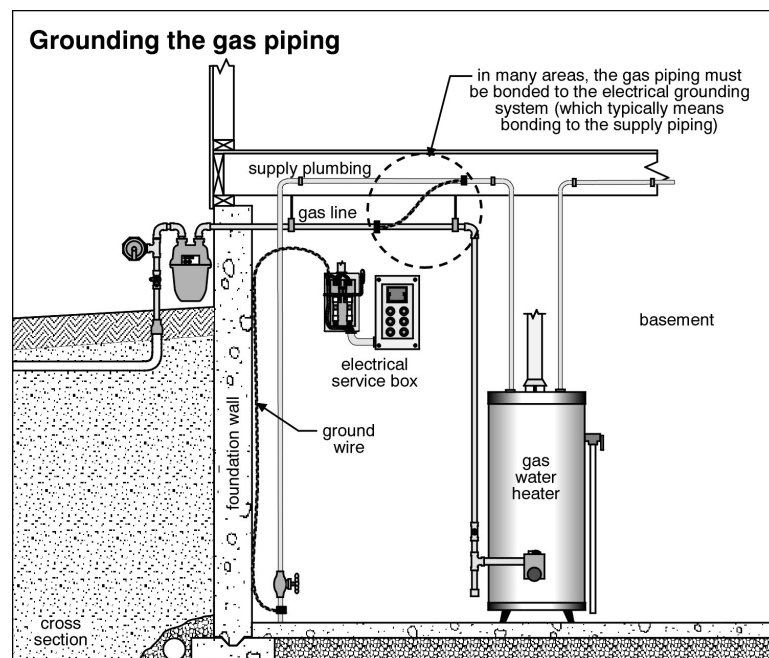
Gas and hot / cold water lines are not properly bonded near water heater. Does not comply with most recent electrical code. NEC 250-80b.

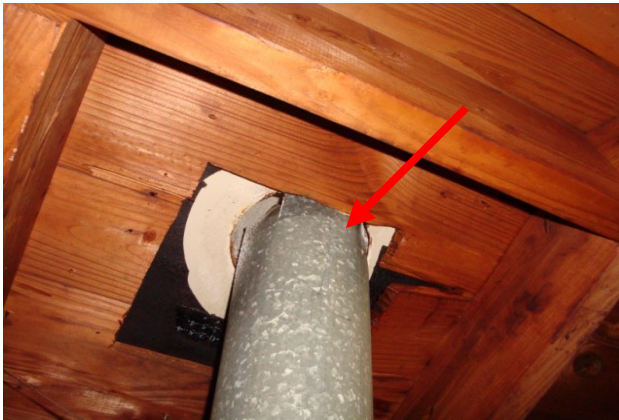
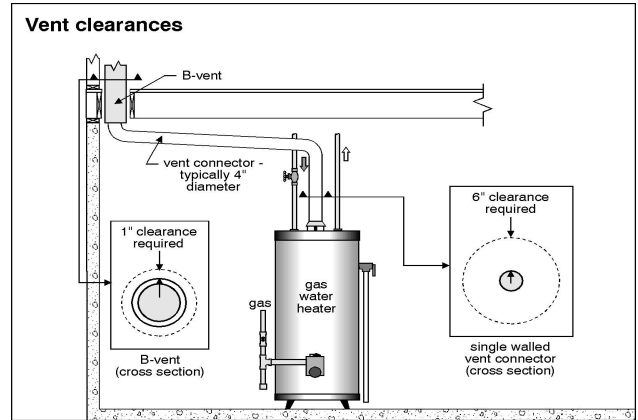
Exhaust vent pipe is in contact with combustible material, [wood roof decking]. Current industry standards (code) require 1" clearance for double wall vent pipe.

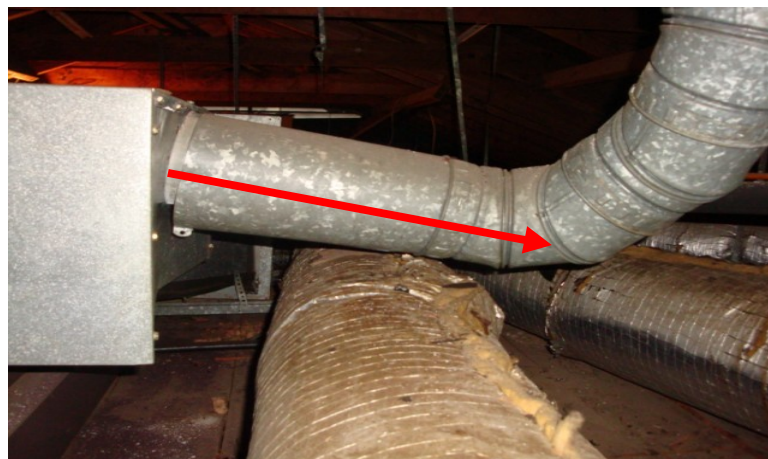
Reverse slope of house heater vent line, does not tilt upwards, possibly blocking proper venting. Ref. IRC 1803.3 "Connectors shall be installed with a slope of not less than 1/4 inch rise per foot of run."

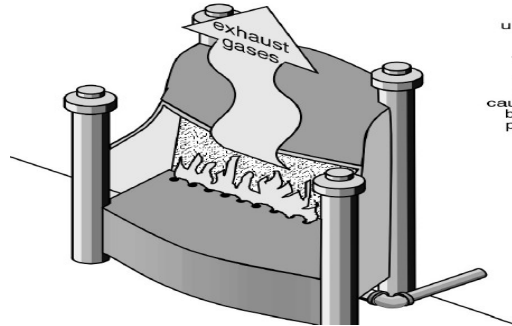
Gas space heaters shall not be located in bathrooms or bedrooms unless they obtain all combustion air directly from the exterior. Ref. IRC G2406.2.

unvented space heaters are not permitted in some areas
these are typically older units
the exhaust gases discharge directly into the living space - causing problems such as spillage backdrafting, carbon monoxide poisoning and excess humidity

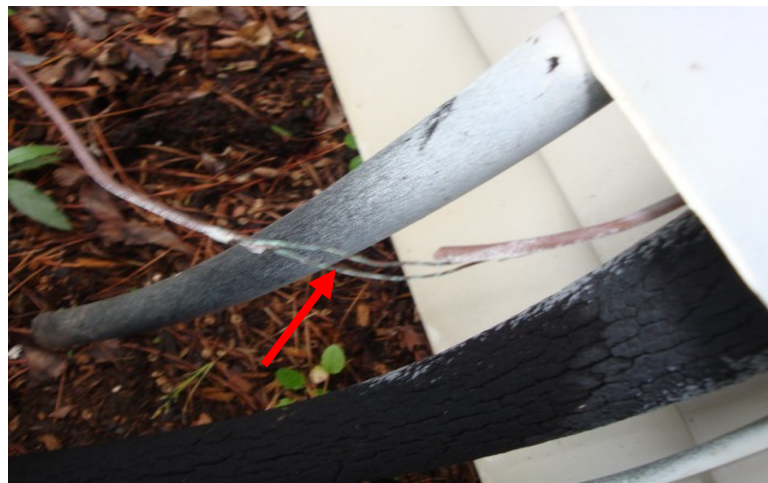
Low voltage control wire insulation damaged to condensing unit, in need of repair. If wires short together it can result in damaged transformer in attic.

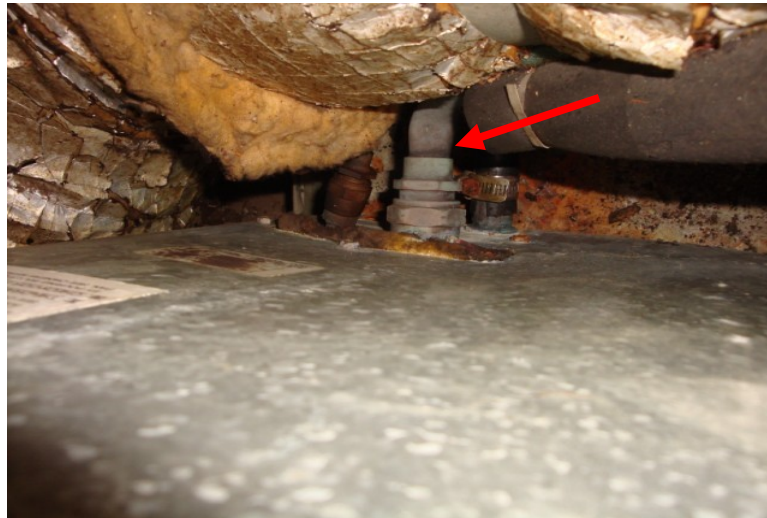
Section(s) of suction line insulation missing in attic near coil. Warm attic air condenses on cold suction line/expansion valve and drips condensation.

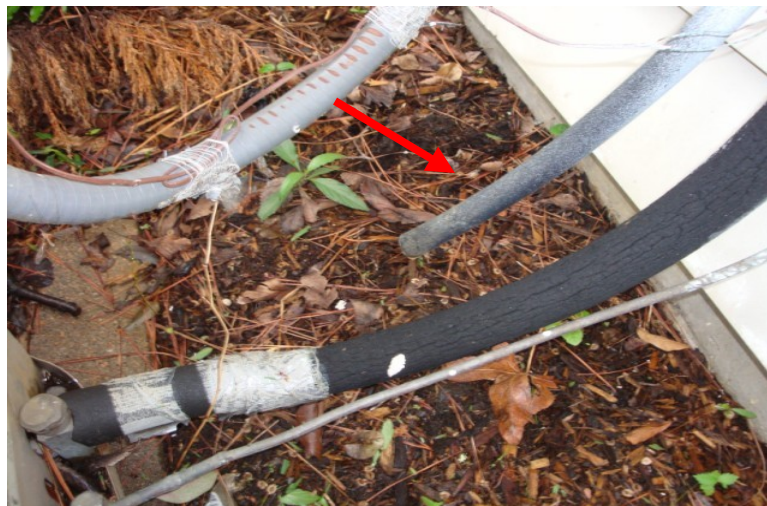
Primary drain line should not be allowed to discharge water right next to foundation.

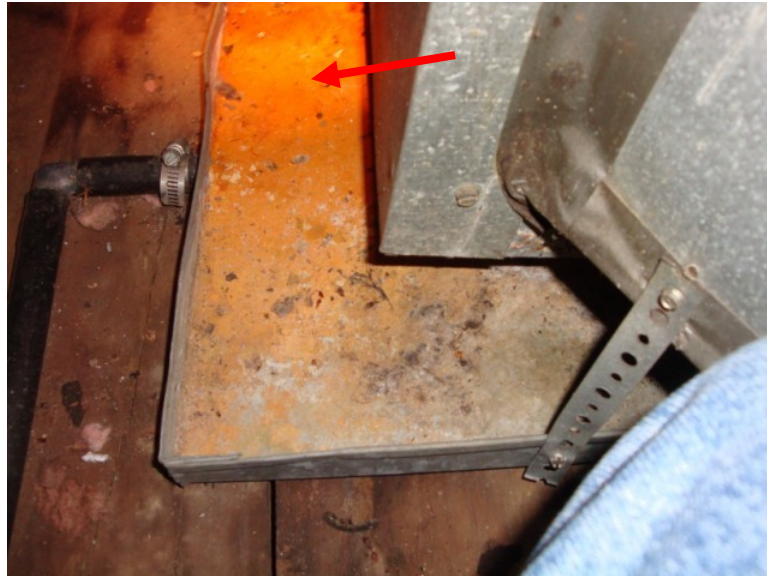
Secondary drain pan is rusted; indication coil (or previous coil) has history of leaking/dripping condensation into pan.

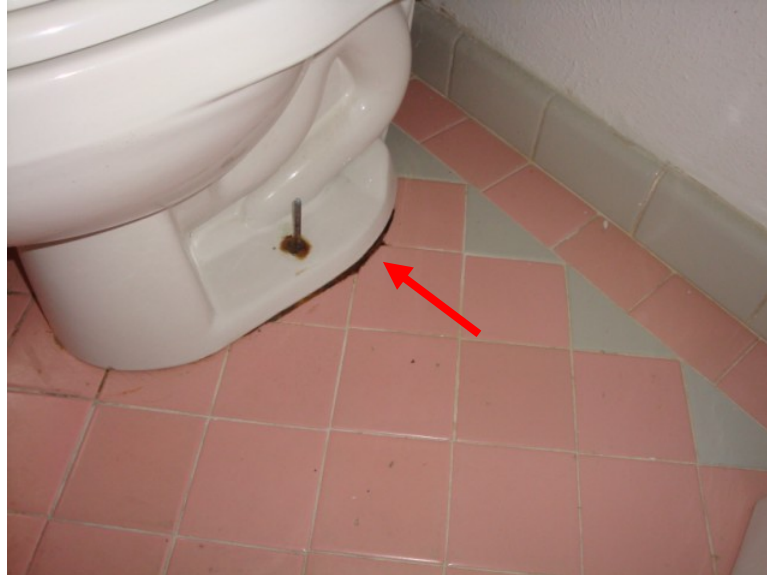
Not secured to floor, recommend removal of commode, inspection of flange serviceability, install type of wax ring with foam gasket inside wax and new securing bolts. Stain at base suggests toilet may be leaking at wax ring.

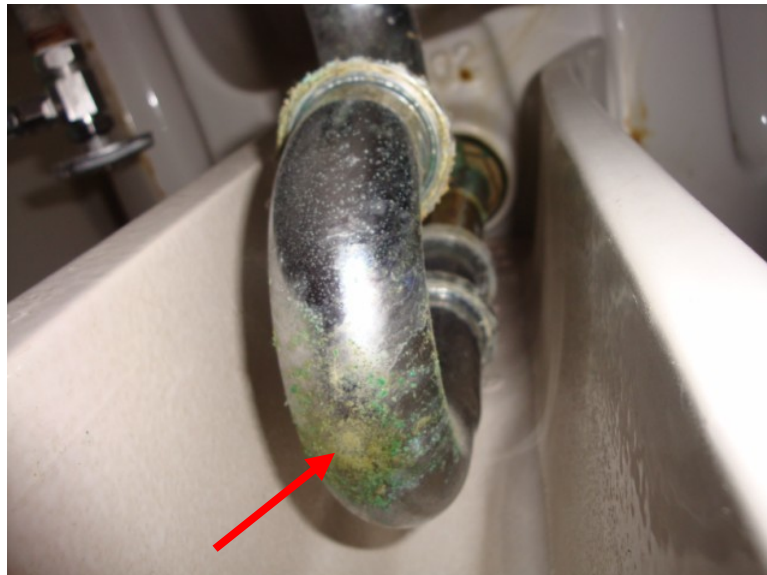
Corrosion noted at "J" trap and/or drain lines below one or more sinks.

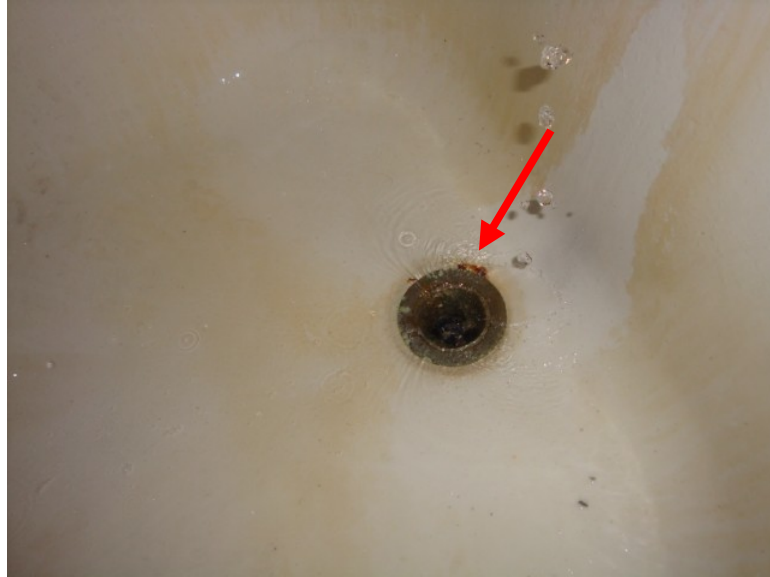
Porcelain damaged/chipped on steel tub and drain hole;

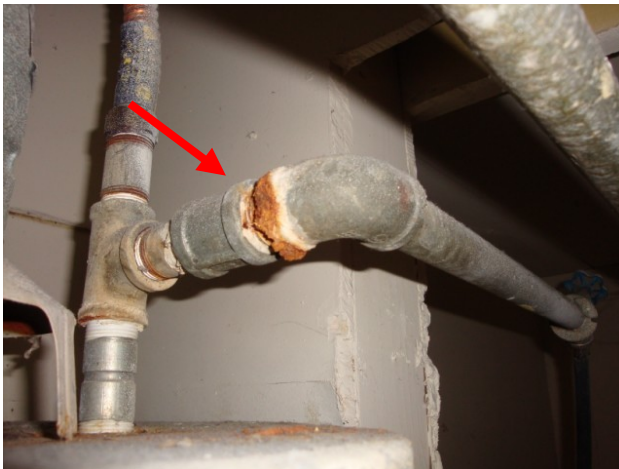
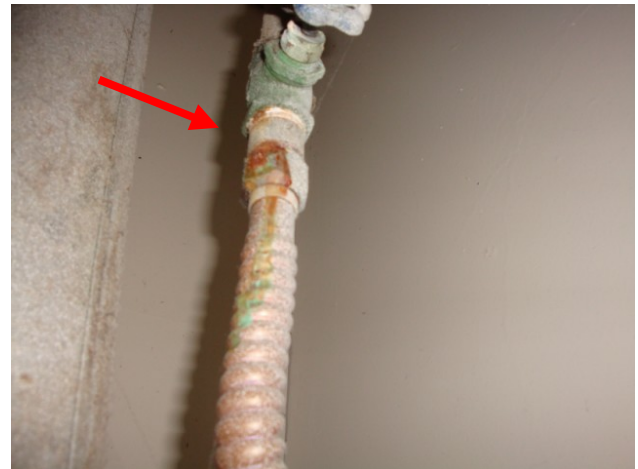
Corrosion observed at shut off valve and/or connections on top of water heater.

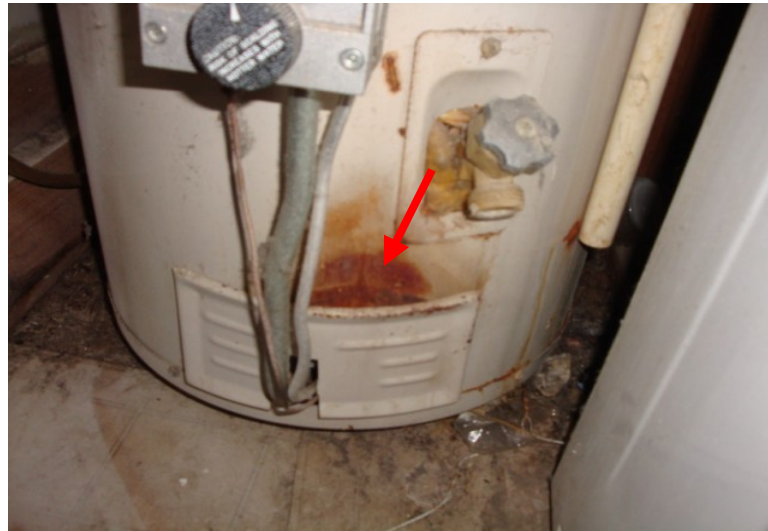
Evidence of flame roll out at lower combustion area.

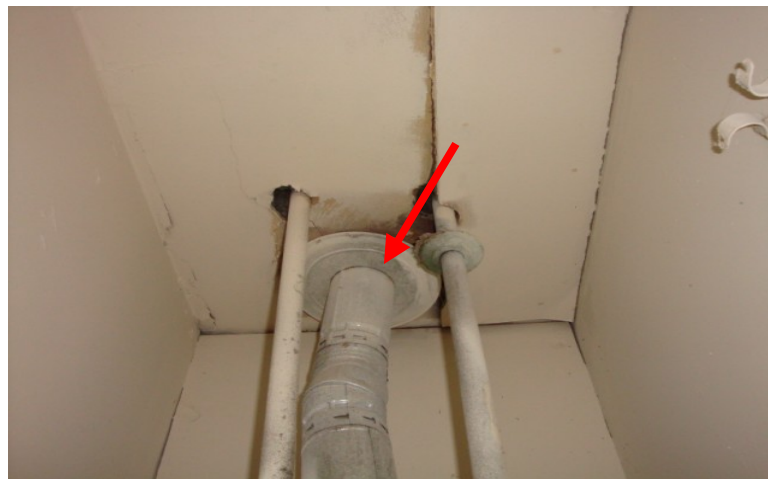
Vent collar not secured around vent pipe at ceiling and/or is missing.

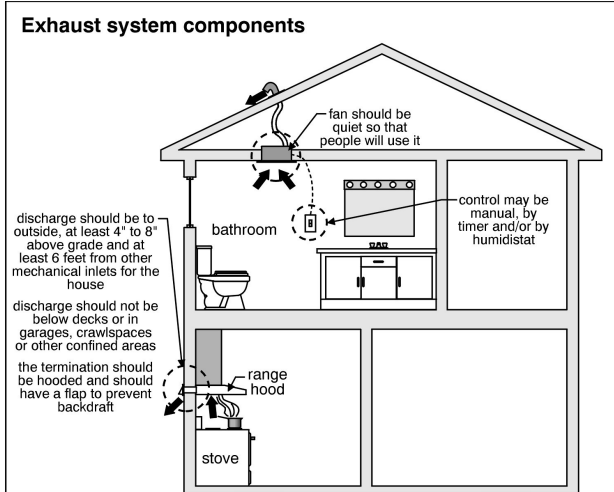
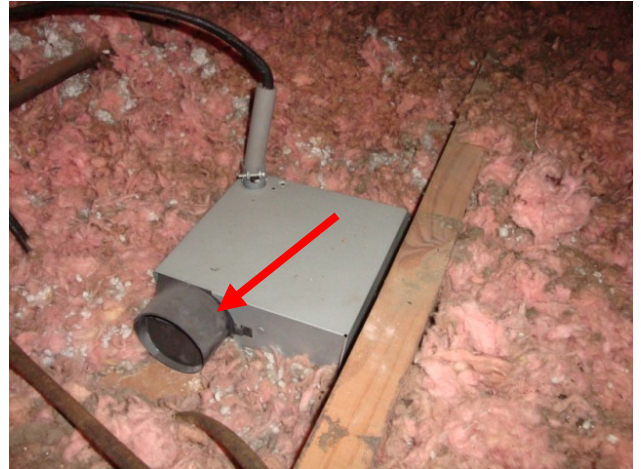
Improperly vents into attic. Should vent to exterior.

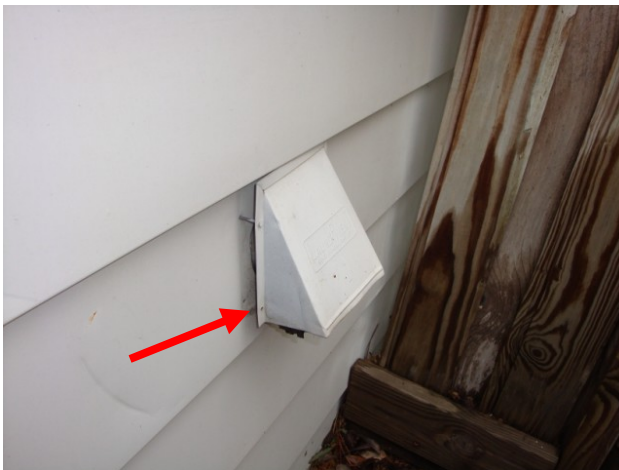
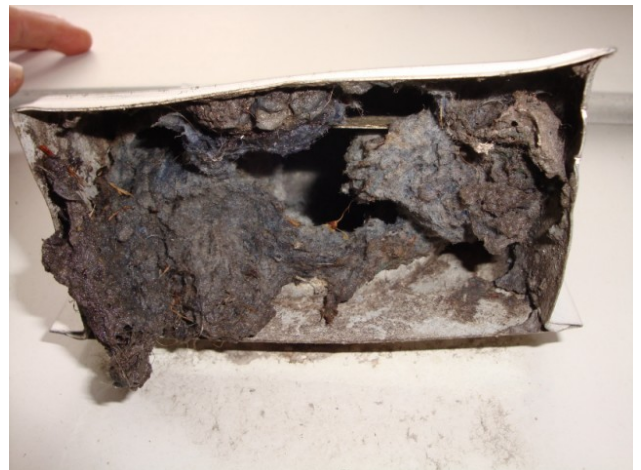
Exterior dryer flapper door stuck open (remove lint) and/or damaged and not secured.
