### **2006 Heights Annex Home Inspection**

# ***PROPERTY INSPECTION REPORT***

**Concerning:** 2006 Heights Annex Home Inspection  
(Address or Other Identification of Inspected Property)

March 7, 2009  
(Date)

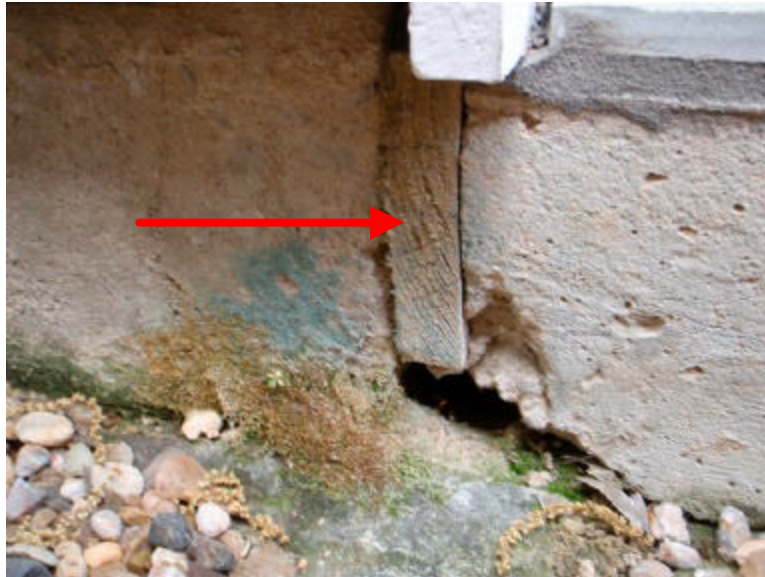
*Wood form board(s) around foundation should be removed to reduce chance of wood destroying insect activity. Back of house.*

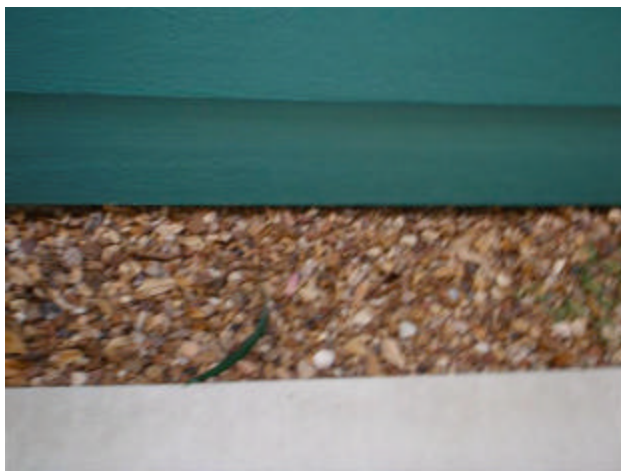
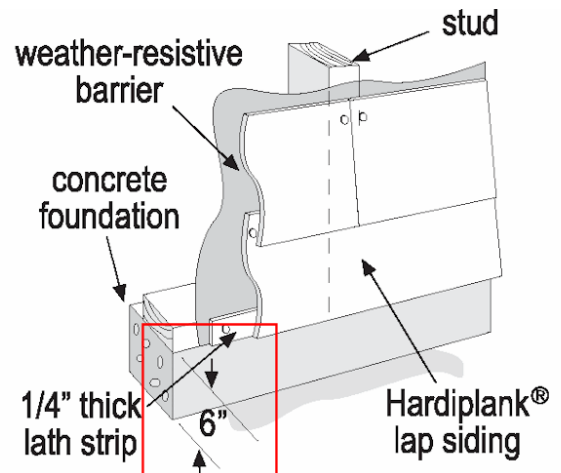
Soil level too high, or close to Hardi plank siding, promotes wood rot and is considered a conducive condition to termite activity at one or more locations around house/garage.

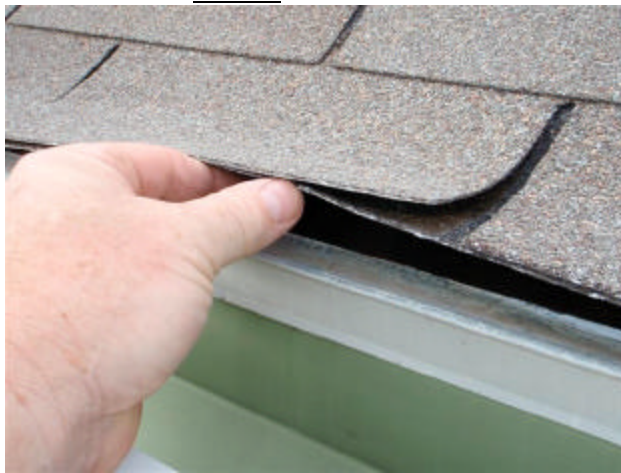
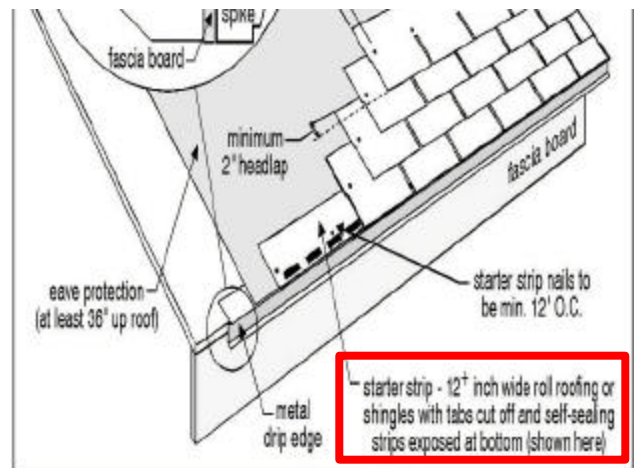
Improper installation of shingle starter course, not installed per manufacture’s installation instructions on every bundle of shingle that instructs glue / sealing tabs to be located near lower edge of roofing. When starter course is not installed properly, high winds can peel roofing off. Reference: shingle bundle wrappers. Recommend addition of roof sealant dabs on lower course to mimic / gain effect of properly installed starter course.

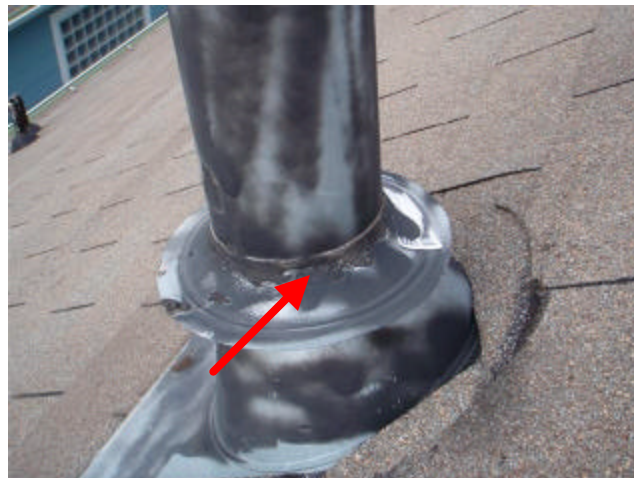
Storm collar needs caulking on all house and water heater vent pipes.

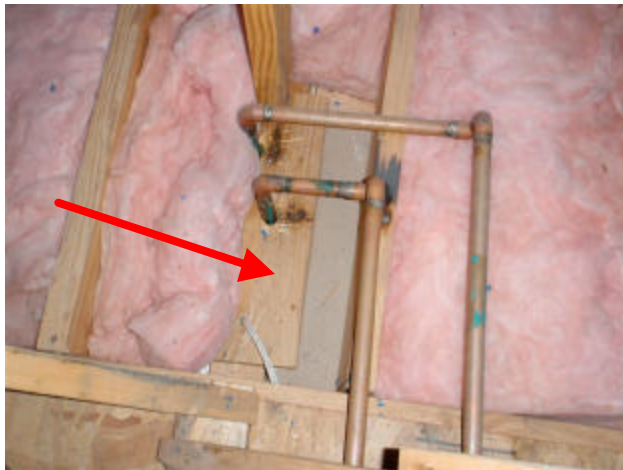
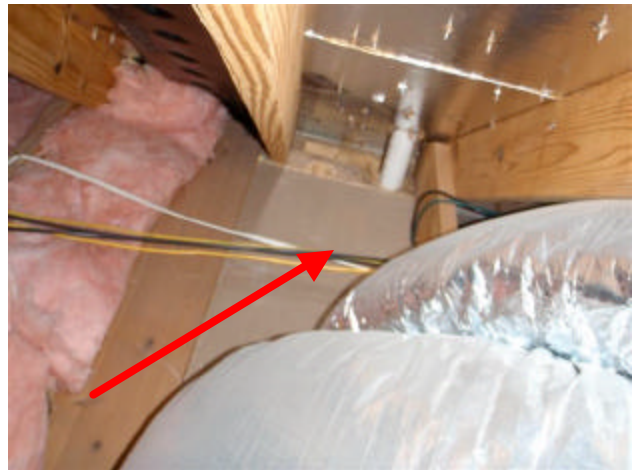
*Insulation not properly positioned/missing in areas, etc.*

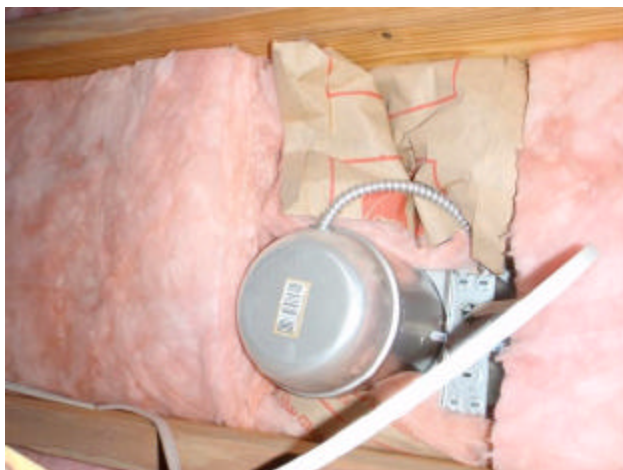
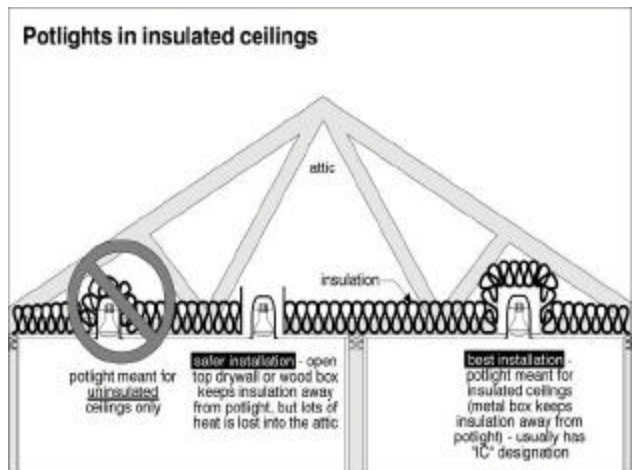
Ensure insulation is maintained a minimum of 3 inches and wood a minimum of 1 inch from around all recessed lights to reduce possible fire hazard.

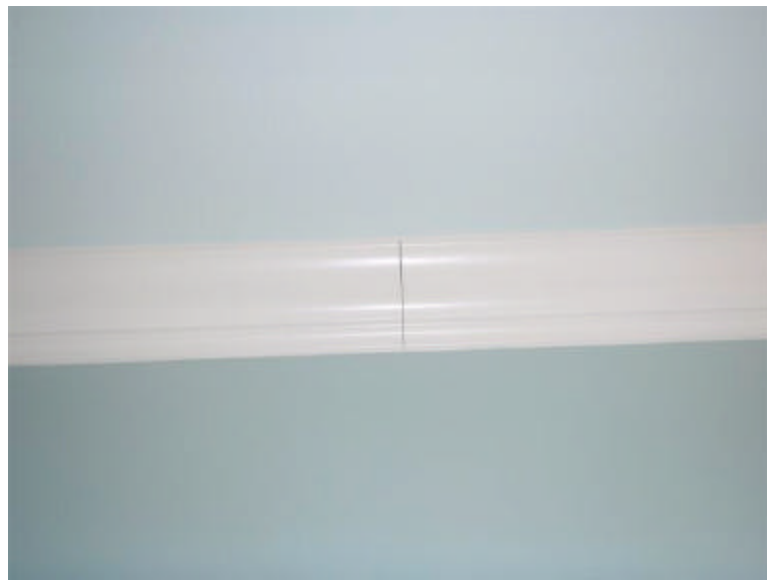
Crown molding separated in 2<sup>nd</sup> floor bedroom.

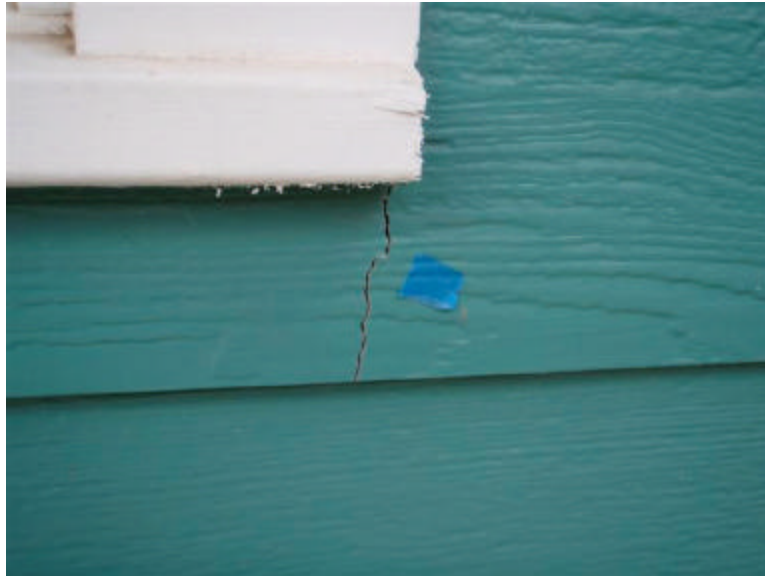
Cracked siding observed at back porch/patio.

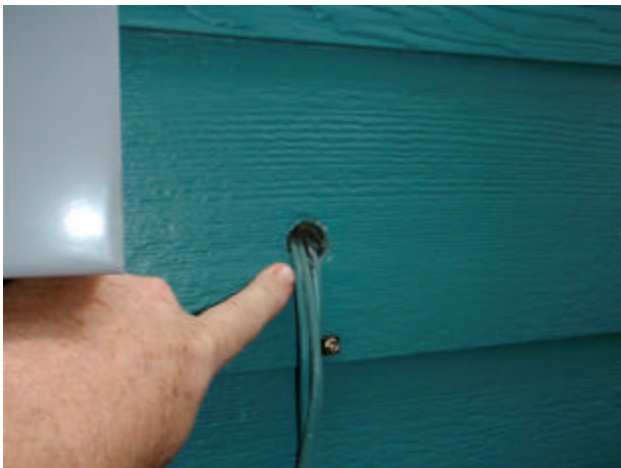
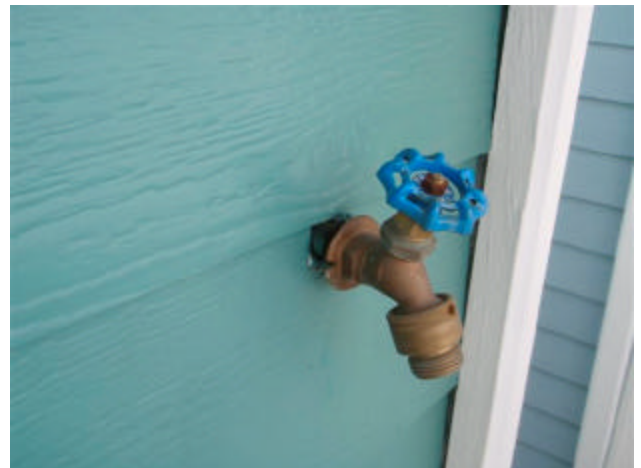
Need sealing / caulking around all holes and exterior siding penetrations on top and both sides, (leave bottom open) to prevent water entry. Including but not limited to dryer, bath and range top vents, light fixtures, etc.

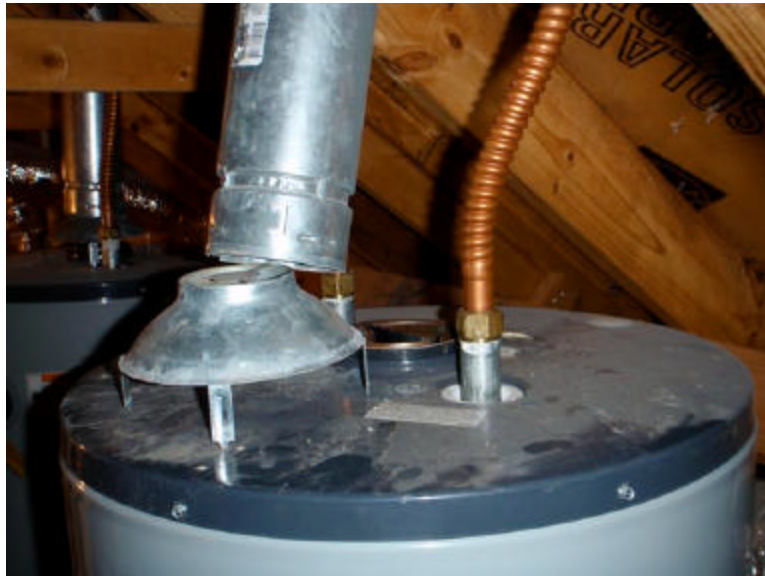
Improperly vented, vent pipe not properly aligned at top of water heater allowing products of combustion (bad gas) to vent into house/attic.

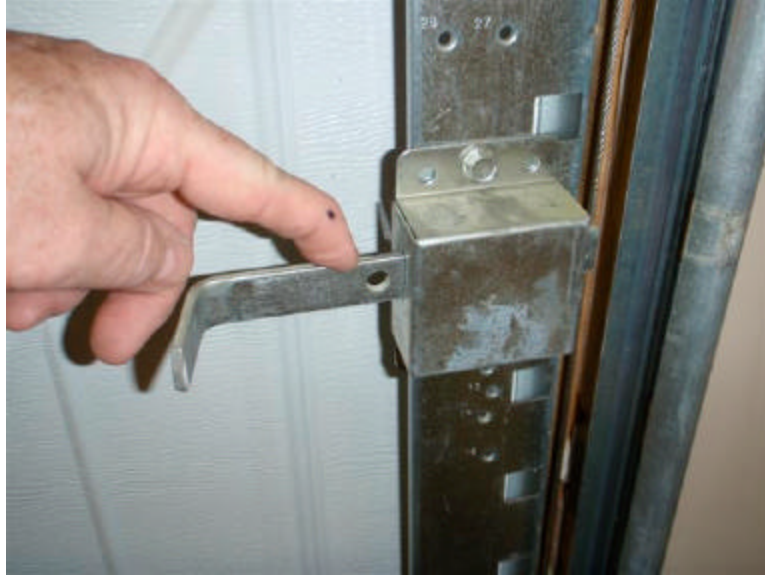
Locks should be made non-operational on garage doors equipped with openers.
