### **2002 Humble Home Inspection Report**

# ***PROPERTY INSPECTION REPORT***

**Concerning:** 2002 Home, Humble, Texas 77338  
(Address or Other Identification of Inspected Property)

March 9, 2009  
(Date)

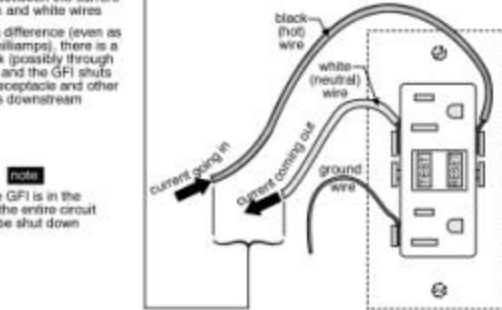
Space between face plate and edge of electrical junction box exceeds ¼ inch allowable by code. Missing required spacer ( spark ring) on all kitchen / bath counter top outlets and switches with tile back splash. Reference NEC 370-20 & IRC E3806.5. In walls of concrete, tile or other noncombustible material, cabinets (outlet & switch boxes) and panel boards shall be installed so that the front edge of the cabinet will not set back of the finished surface more than 0.25 inch.
