1955 Inside 610 Loop

PROPERTY INSPECTION REPORT

Concerning: 1955 Inside 610 Loop, Houston, Texas 77025
(Address or Other Identification of Inspected Property)

March 24, 2009
(Date)

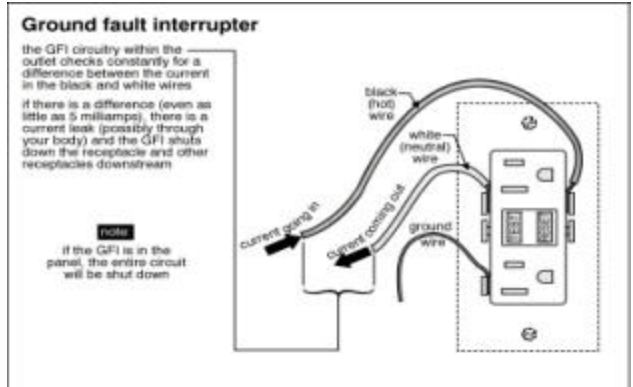
3-prong outlet not grounded, including but not limited to; all but a few in the kitchen.

One or more outlets are not secured well in wall, those identified were marked with red dots on cover screws.
