1967 Timbergrove Manor Home Inspection Report

PROPERTY INSPECTION REPORT

Concerning: 1967 Timbergrove Manor, Houston, Tx. 77008
(Address or Other Identification of Inspected Property)

March 4, 2009
(Date)

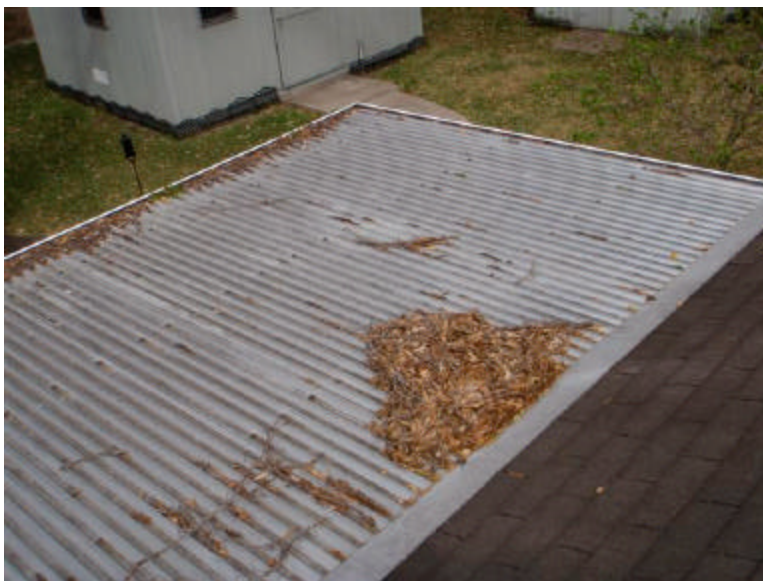
VISIBLE FLASHING:

Not all lead flashing of drain waste vents are properly rolled down interior of plumbing vent pipes and/or are damaged by squirrels, may allow some rain water entry.
