FIG Services LLC d/b/a FOX INSPECTION GROUP  
Forensic Inspection Report # 090302aw  
11227 Endicott Lane Houston, TX 77035  
(Office) 713.723-3330 (Email) [office@foxinspectiongroup.com](mailto:office@foxinspectiongroup.com)

**Concerning:** Northwest Freeway Houston, Texas 77040

This is a Thermal / Infrared Inspection on a Commercial Roof System

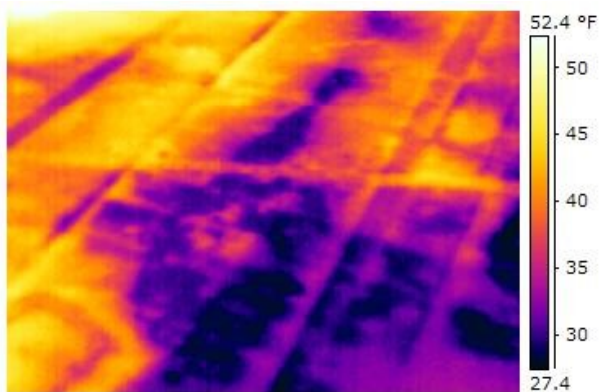
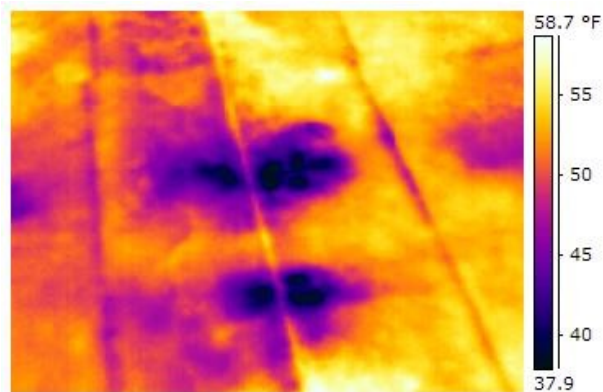
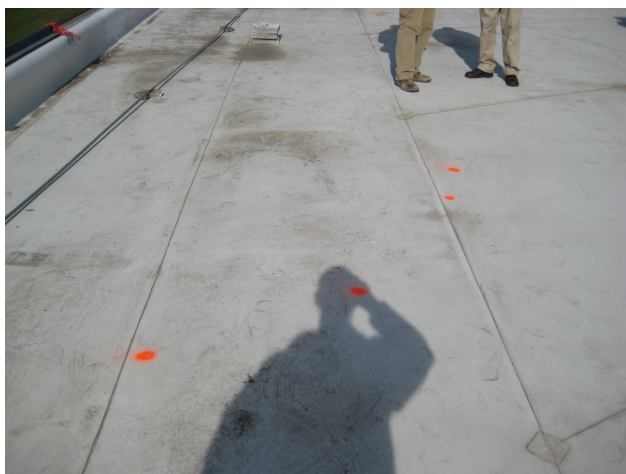
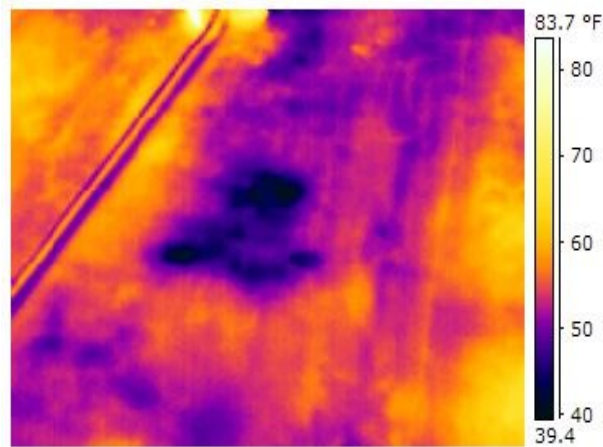
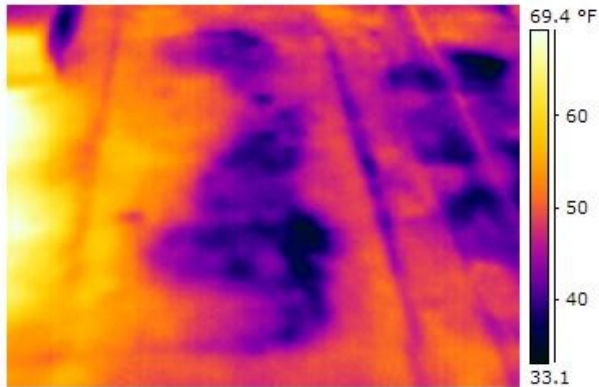
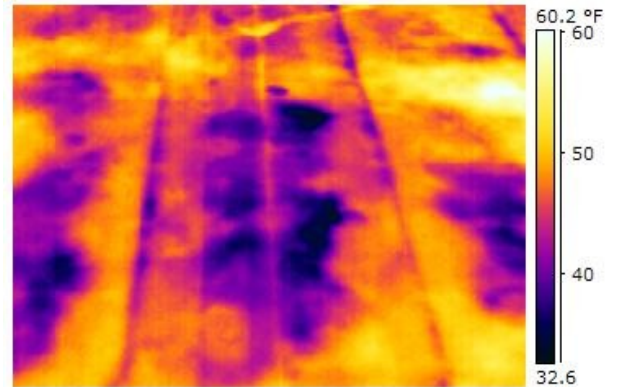
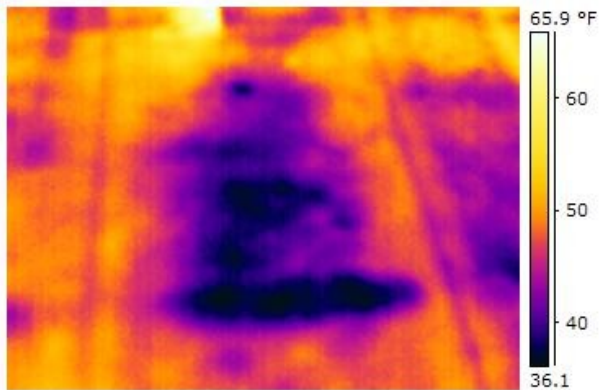
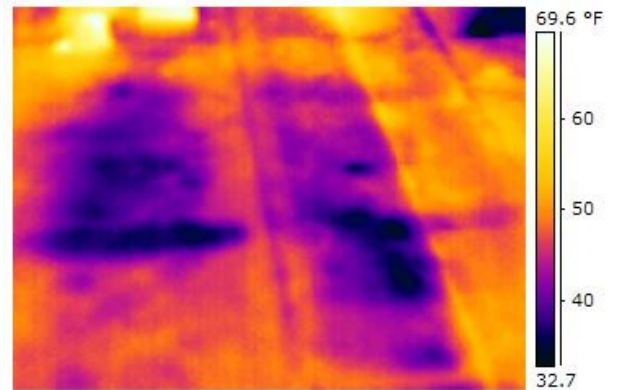
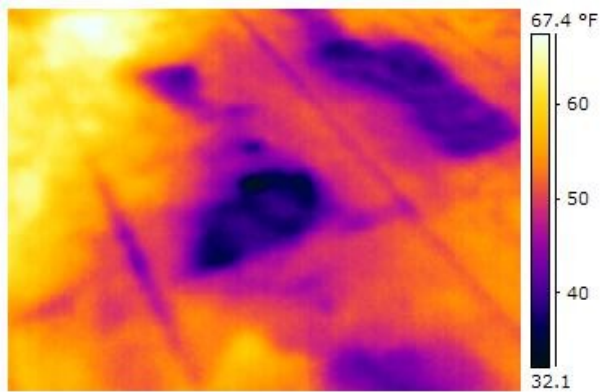
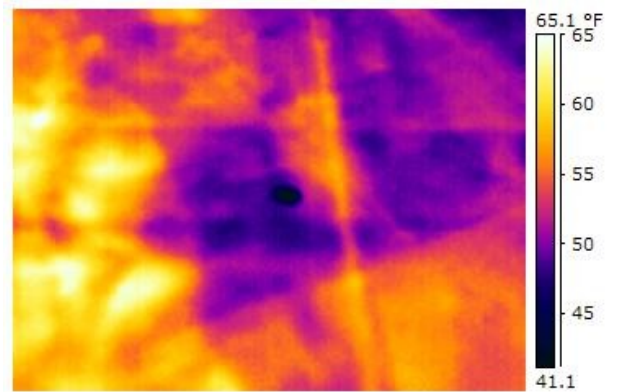
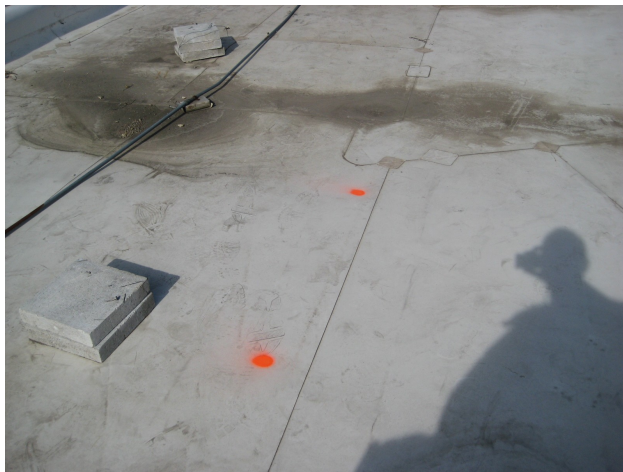
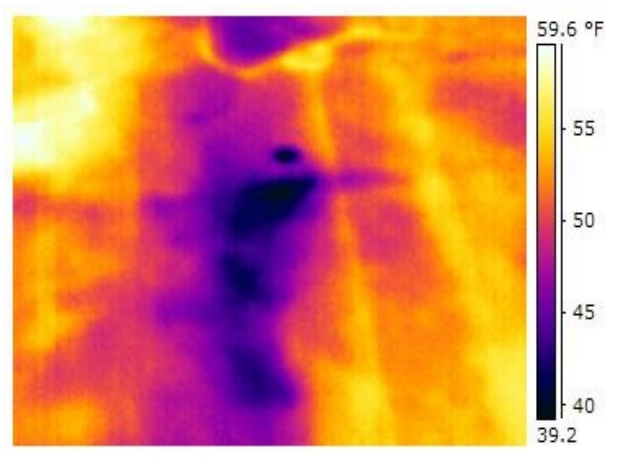
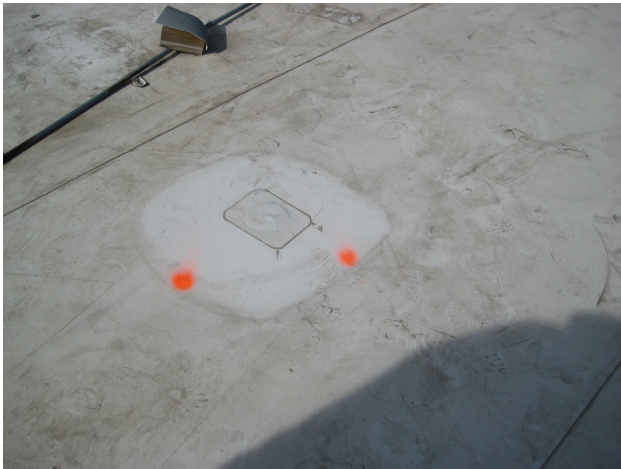
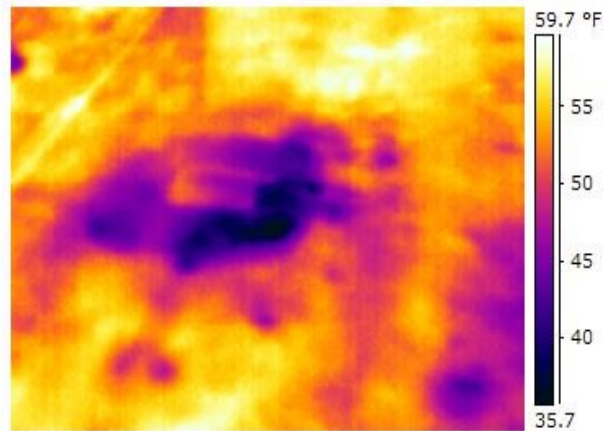
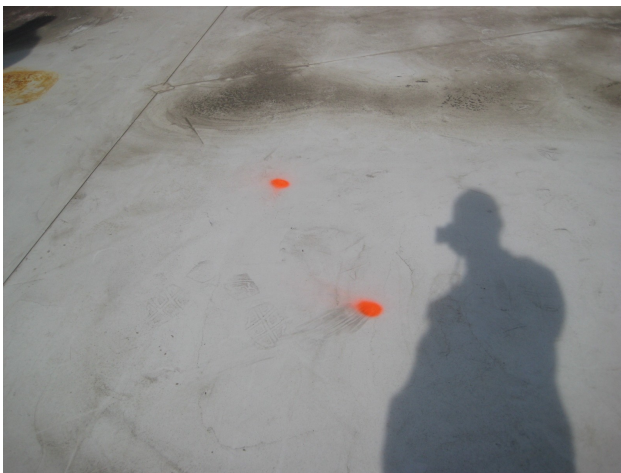
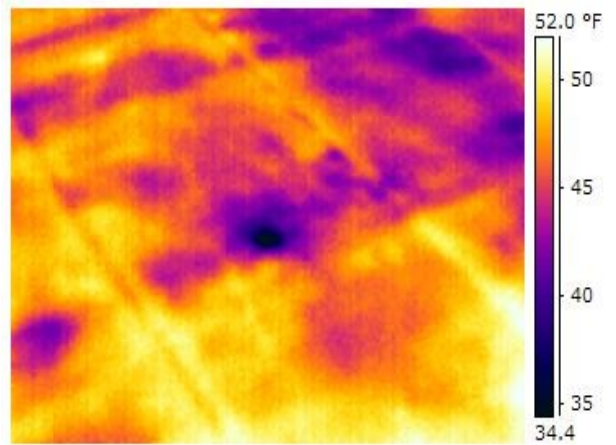
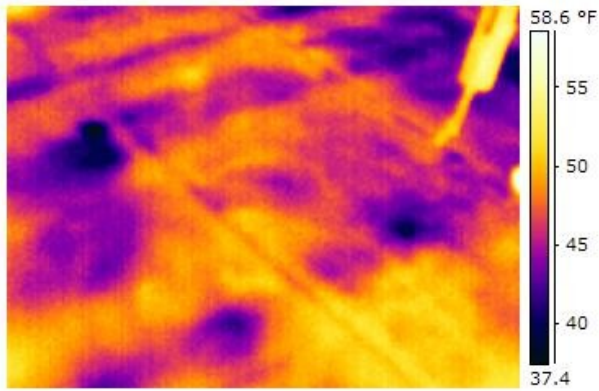
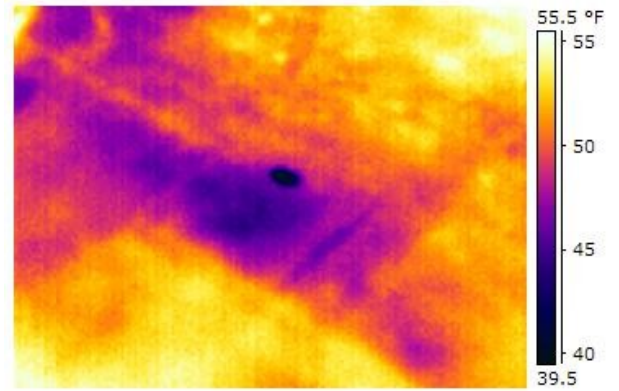
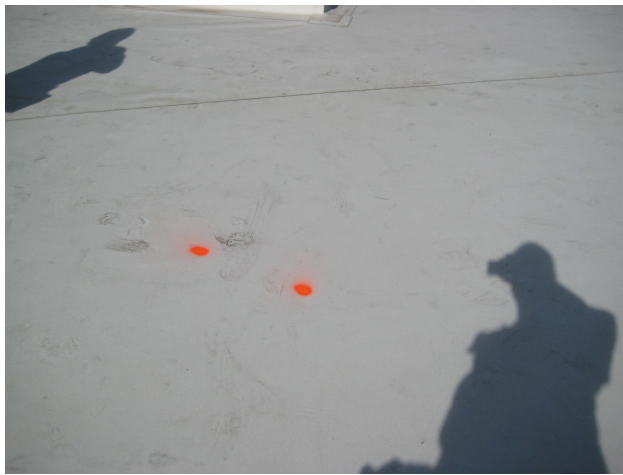
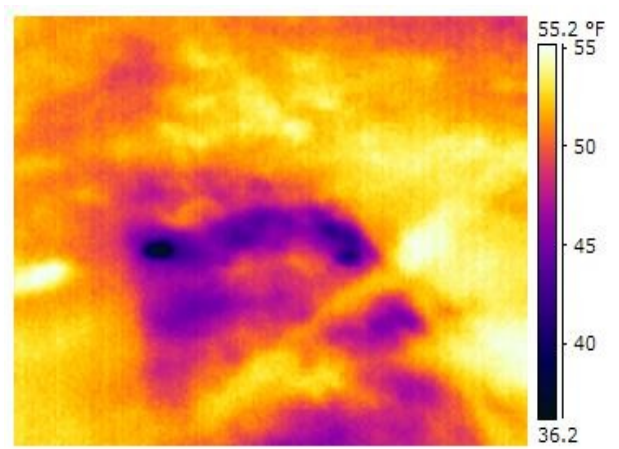
1. Thermal camera indicated multiple anomalies on the roof surface. Suspect areas were marked with orange paint.
2. Sections of roof were opened up by Civil Concepts at random areas and indicated moisture below the roof surface and/or powdered/soft concrete decking in some areas.

Photos were taken of thermal anomalies observed during the inspection. Darker areas indicate the possible presence of moisture.

1. Recommend further invasive testing on the sections of roof that have been marked with orange paint to confirm presence of moisture and condition of roof and deck materials.
